Arctic Home Inspections

Property Inspection Report

Inspection prepared for:
Date of Inspection: 2/22/2022

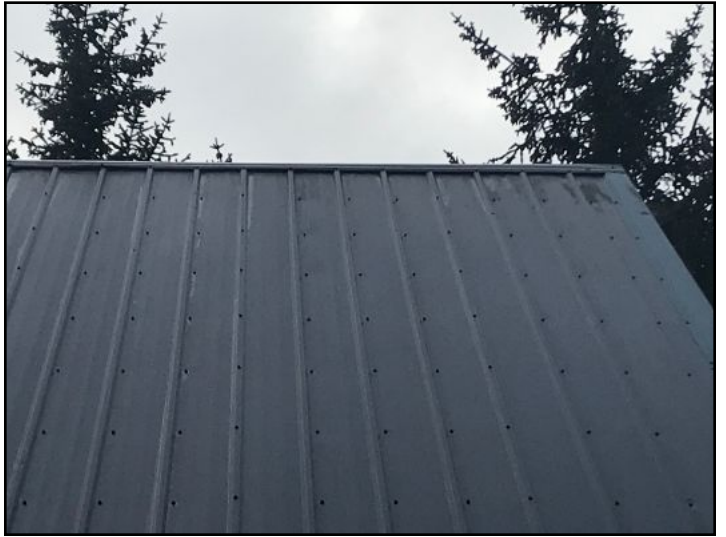
1. Roof Condition

- Serviceability of roof is questionable; it should be evaluated and repaired as necessary by a professional roofing contractor.
- Some areas not visible from inspection level.
- Recommend roofing contractor to evaluate.
- Note that experts recommend that any roof over 10 years old receive a roof certification by a local roofing specialist.
- The roof of the house was replaced back in 1991. This was in the paperwork from the city that I have looked up. This makes the roof 31 years old and is at the end of its serviceable life.
- Both roof **valley**s on the front and rear of the house is in need of repair or replace.

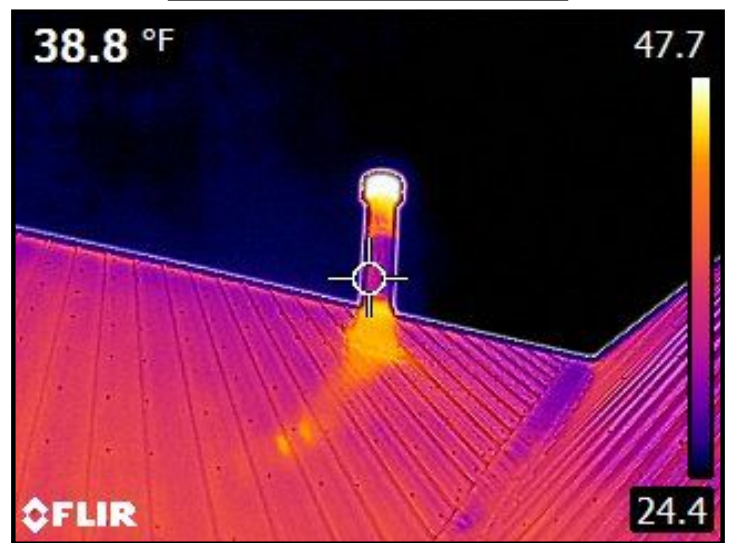
- No major system safety or function concerns noted at time of inspection.
- Flashing at base of chimney appears to need some maintenance to ensure a continued waterproof seal.
- Crown and Flashing intact where visible
- Unable to determine condition or presence of liner due to accessibility.

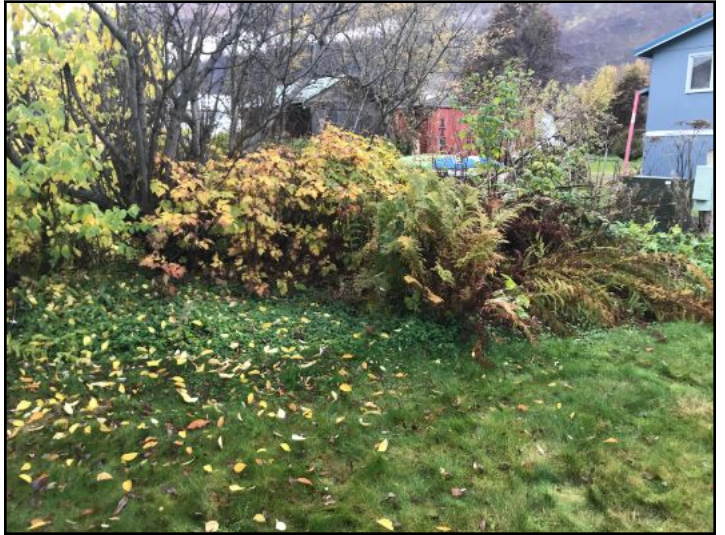
- Shrub in the front of the garage can be trimmed and pruned to not be so close to the siding of the house.
- There is two large trees in close proximity to the house. The roots may cause problems with any underground plumbing and the roots reach out to the foundation of the house. They pose a trip hazard in the yard.

- Trees also covers a good part of the house during the day. No sunlight can help dry anything that is covered by the shadow of the trees.

- Tree limbs within 10 feet of roof should be trimmed away to provide air and sunlight to roof, while minimizing debris & dampness.
- Maintenance Tip: When landscaping, keep plants, even at full growth, at least a foot (preferably 18 inches) from house siding and windows. Keep trees away from foundation and roof. Plants in contact or proximity to home can provide pathways for wood destroying insects, as well as abrade and damage siding, screens and roofs.

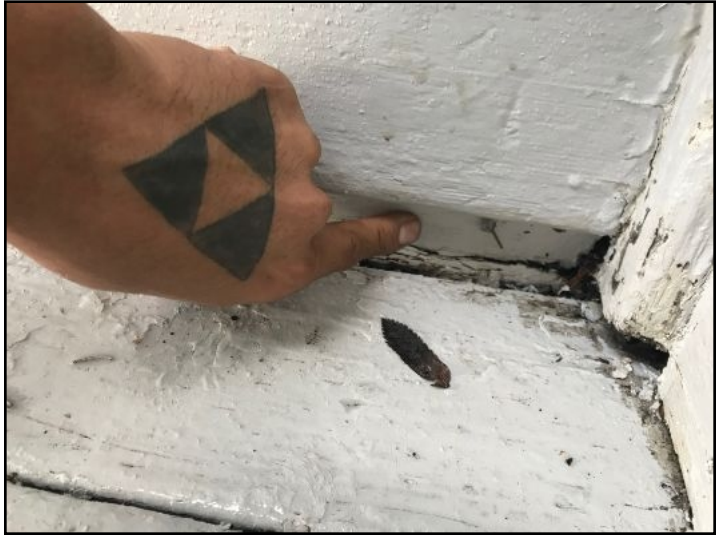
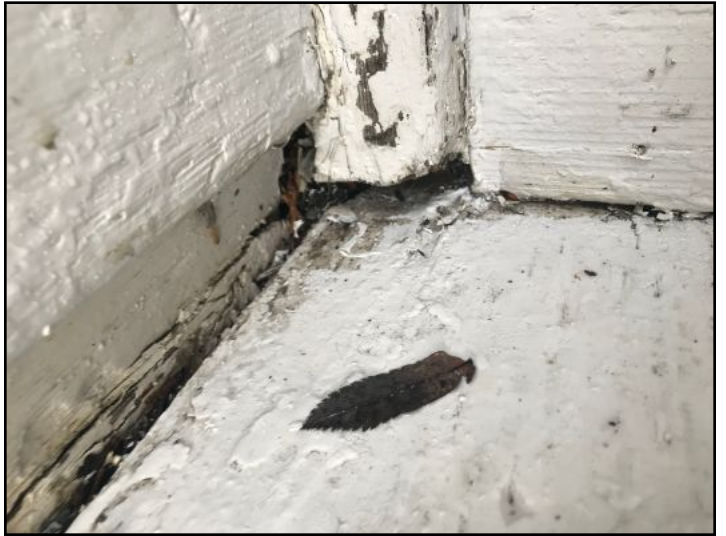
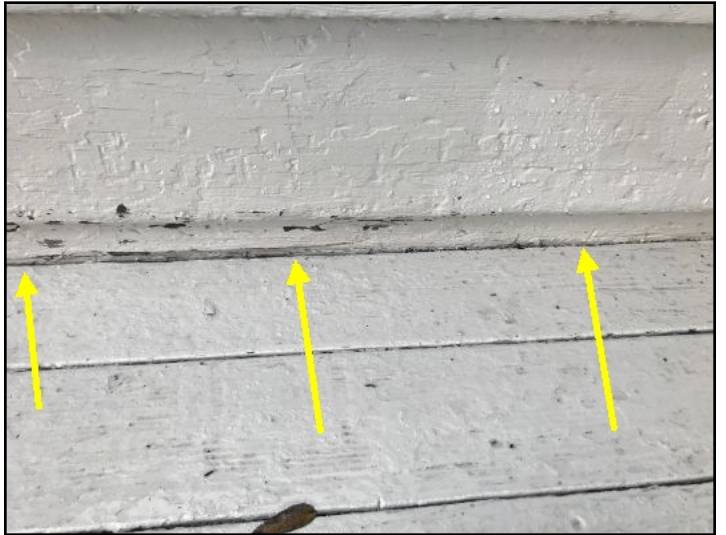
- There is moisture intrusion in the house siding where the deck meets the home from rain not being directed away from the home. Seasonal rain gutters will help with directing any rain from the deck and home. Flashing will also help to divert any rain from the house and deck.

- Guard rails were stored away for the coming winter, and I was not able to inspect them at time of inspection.
- **No flashing present.**
- **There is moisture intrusion in the house siding where the deck meets the home from rain not being directed away from the home. Seasonal rain gutters will help with directing any rain from the deck and home. Flashing will also help to divert any rain from the house and deck.**

- **The trees in the front yard cover any sunlight during the day that would help to dry the deck.**

- **Clean and Seal Deck:** Recommend cleaning deck and treating with a waterproof sealant claiming to waterproof, block ultraviolet light, and stop mildew.

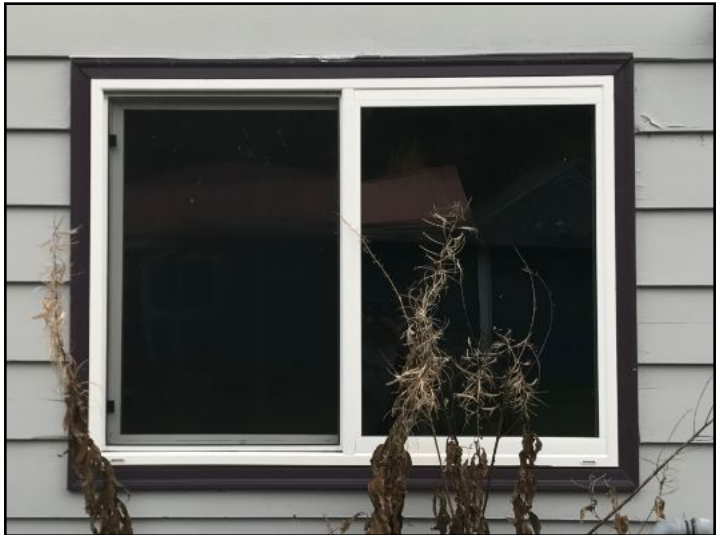
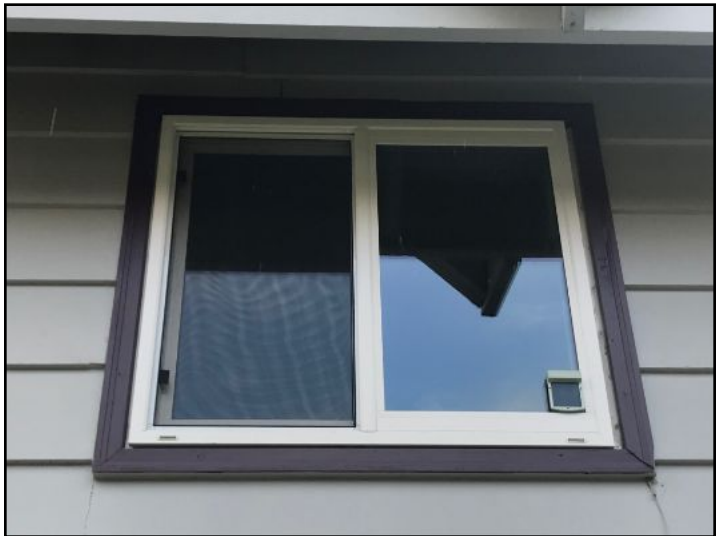
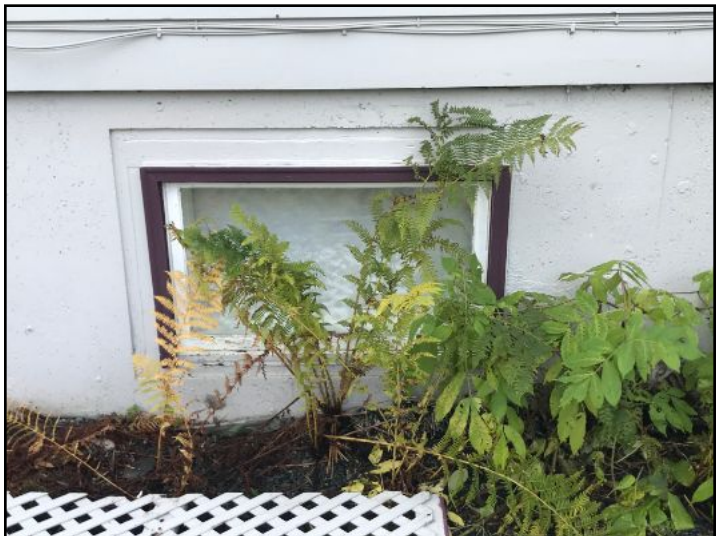
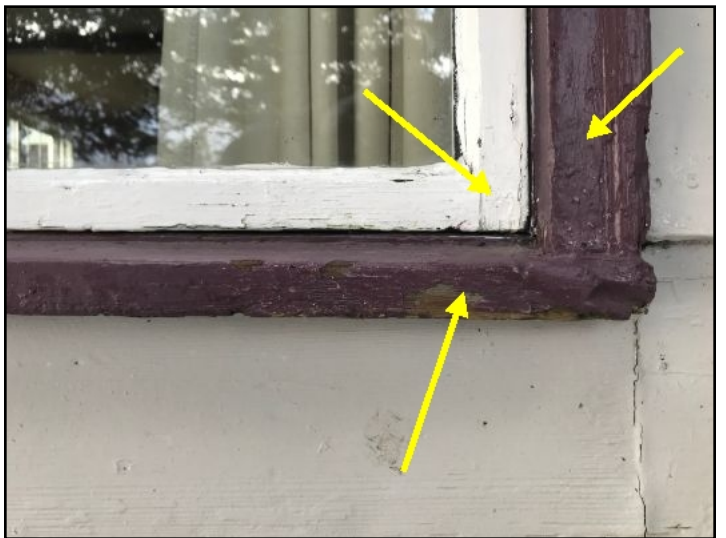
2. Window Condition

- Components appeared in satisfactory condition at time of inspection.
- No major system safety or function concerns noted at time of inspection.
- Some window screens missing. Check with seller to determine if they are on the property.
- Basement windows are overgrown with vegetation. This is not letting the window sill to dry properly and causing damage to the window sill.
- South facing window on the patio deck is showing signs of water damage shown in the pictures.

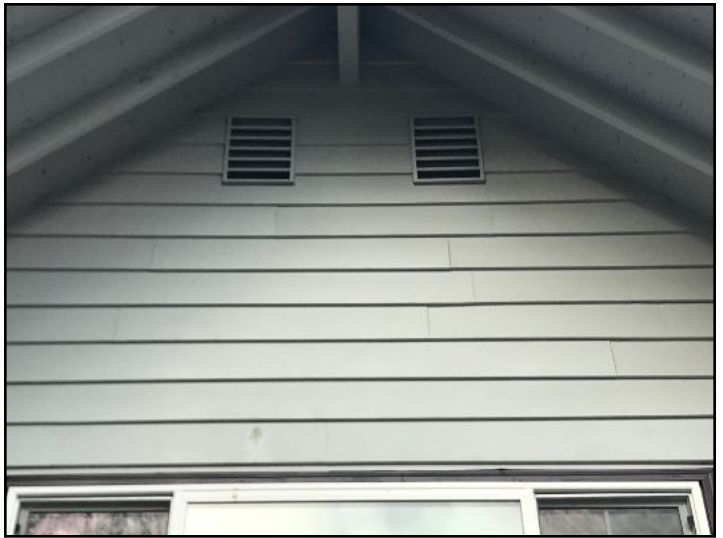
3. Siding Condition

- No major system safety or function concerns noted at time of inspection.
- Some areas need priming and repainting.

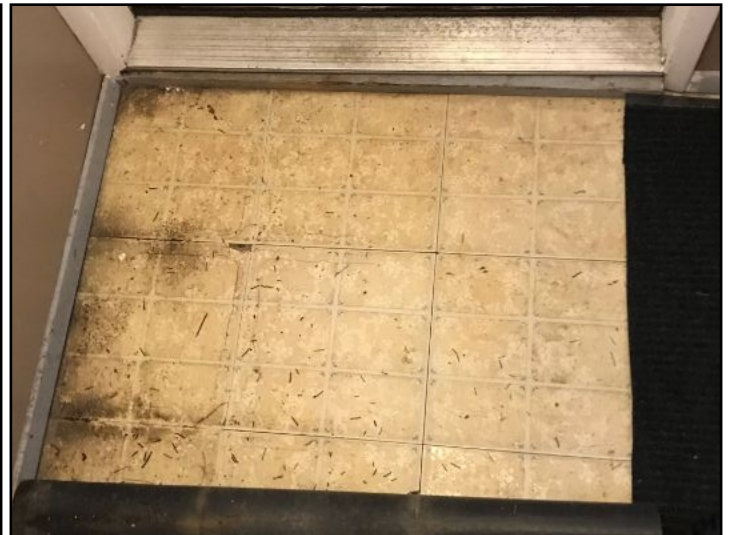
1. Floor Condition

- Flooring appears to have damaged sub floor due to water leak from the outside. Recommend a licensed contractor to repair or replace flooring in the arctic entryway.

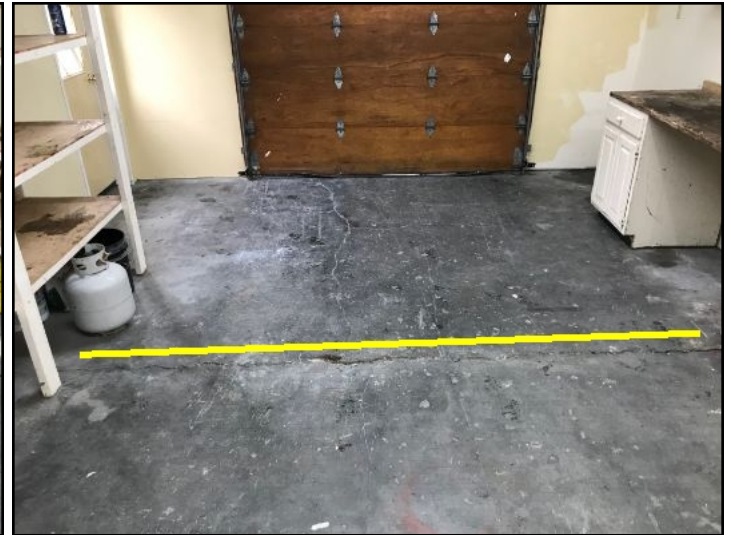
2. Floor Condition

- Common cracks noted.
- Recommend review by a qualified professional for repair or replacement, as necessary, prior to close.
- Recommend sealing cracks/voids.

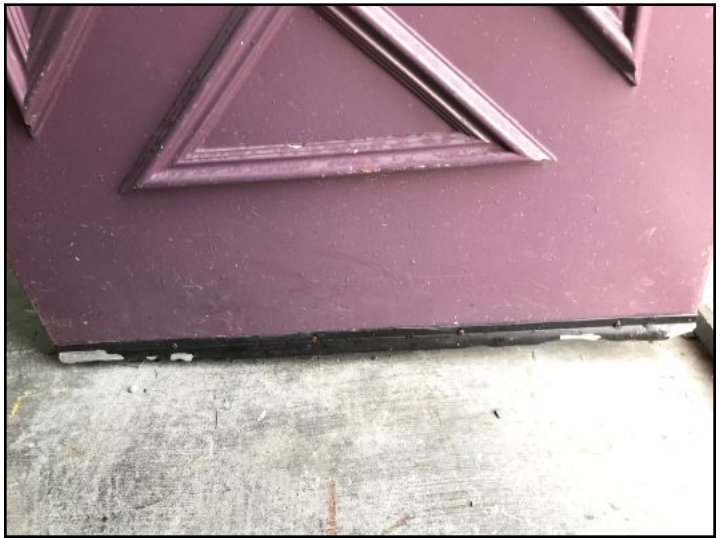
- Appeared functional, at time of inspection.
- Door sill looks to be showing its age. Recommend replacing to help seal garage better.
- Recommend replacing door seals to help keep cold whether out.

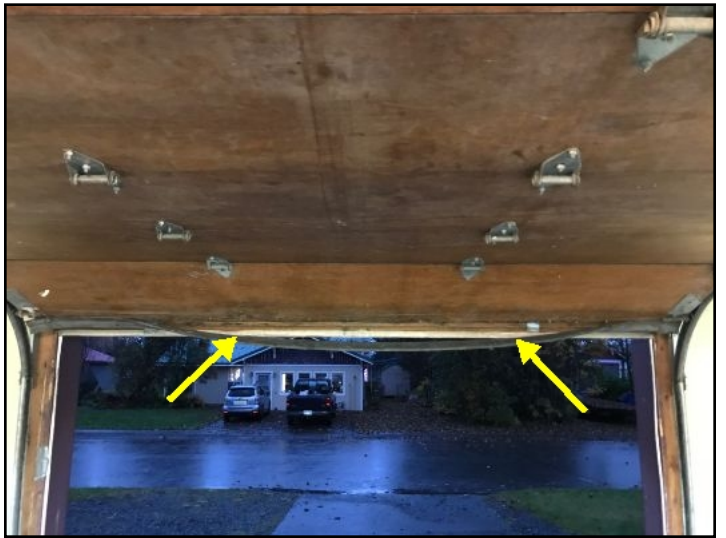
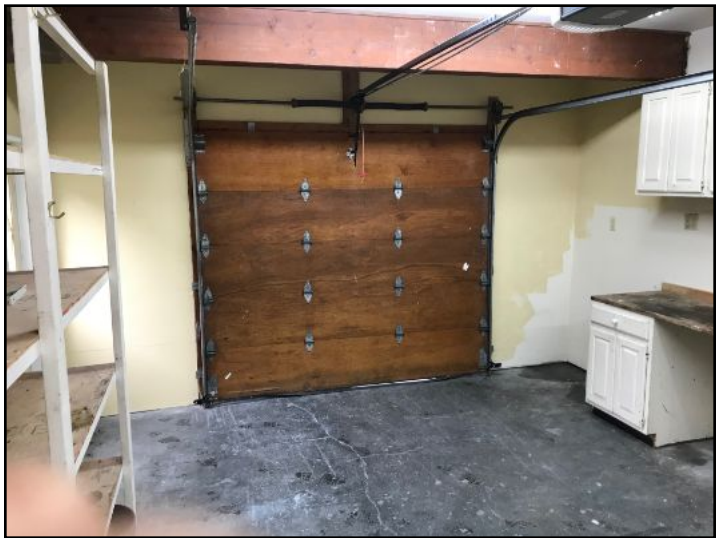
7. Garage Door Condition

- Maintenance repairs needed.
- IMPROVE: Consider future replacement with new steel triple-layer insulated type doors.
- Garage Vehicle door weatherstripping is damaged.
- weathered
- missing handle

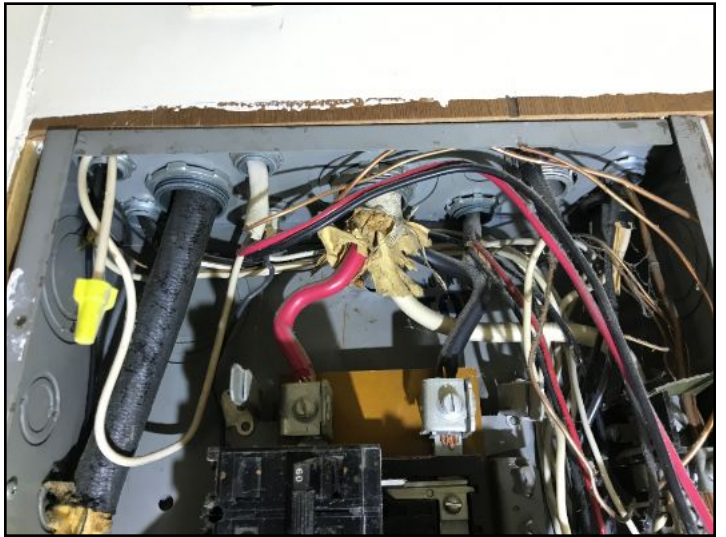
- Panel box appears to be older than the projected effective life (25 years) of panel buss bar and breakers; recommend electrician evaluation of panel box and associated wiring, including non-tripping **GFCI**s on property.
- Recommend upgrading service.
- **Open breaker panel slot(s) at panel box cover. Electrocutation hazard.**
- **Grounding / Bonding questionable at panel box.**
- **Have electrician ensure that ground is continuous, see photo.**
- **There appears to be grounding wire that has come loose or has broken off. This may be the cause of grounding issues in the home.**

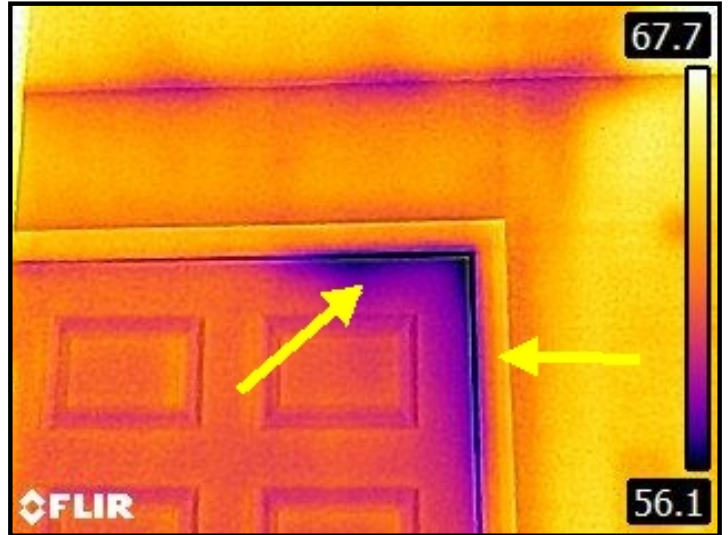
- Entrance door for living room was in good serviceable condition at time of inspection.
- There are gaps on the door seal. Recommend repair/replace with new door seals.

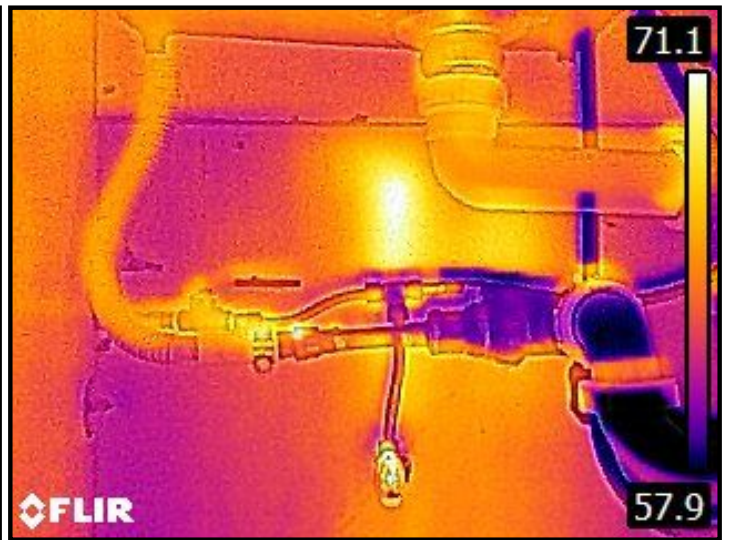
- Proper P trap installed and no leaks detected in the draining plumbing.
- Water line for sink wand leaks. Recommend repair or replace to prevent any water damage.
- Visible leaking noted under the sink. We recommend contacting a licensed plumbing contractor for repair options.

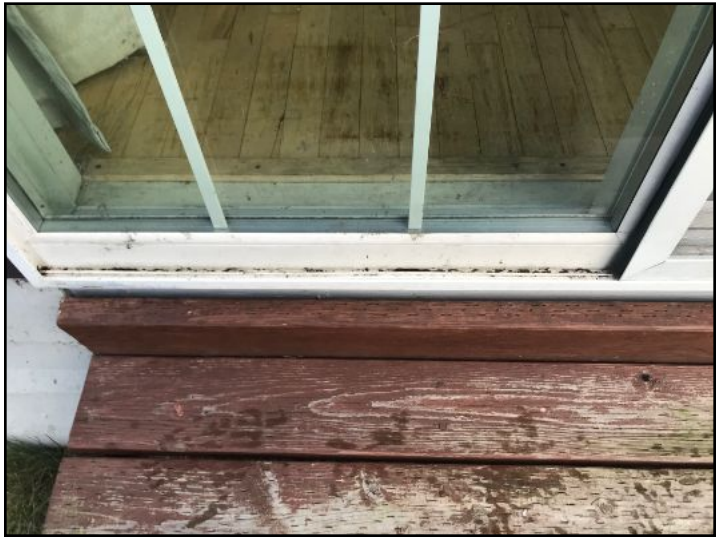
11. Patio Doors

- The sliding patio door was functional during the inspection.
- The doors hardware is showing signs of wear and may be at the end of its useful life. We recommend budgeting for replacement.
- The sliding door tracks appeared dirty at the inspection making the door difficult to operate. We recommend cleaning the tracks and lubricating the doors rollers.
- Tempered glass noted in the patio door.
- **Flashing and sealing is recommended over the top of the patio door. This will help shed water and prevent any water intrusion.**

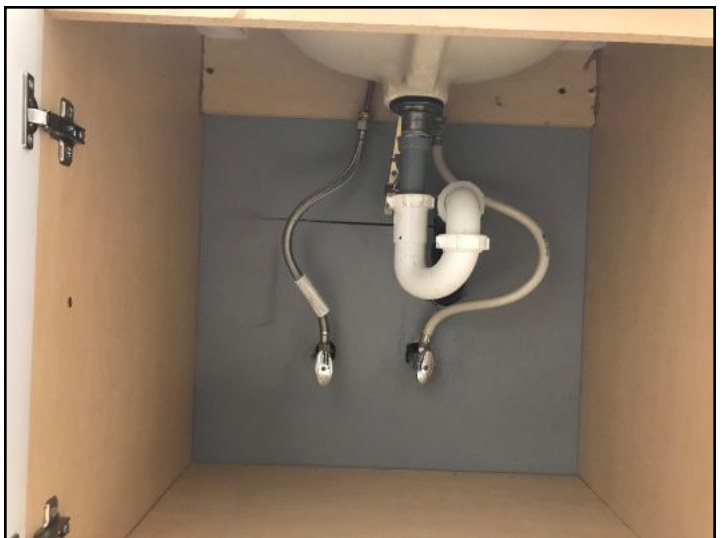
- Operated normally, at time of inspection.
- **Faucet leaks at base. Recommend a plumber to repair or replace faucet.**
