Arctic Home Inspections

Property Inspection Report

Inspection prepared for:
Date of Inspection: 2/22/2022

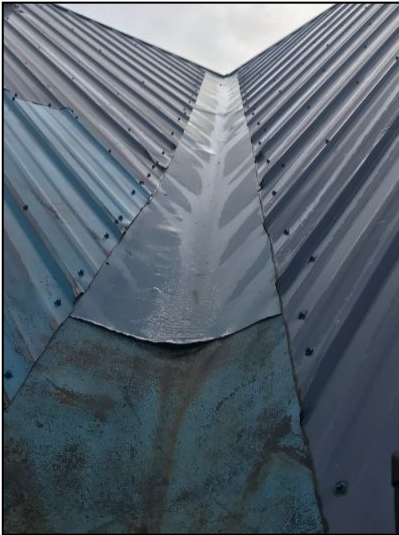
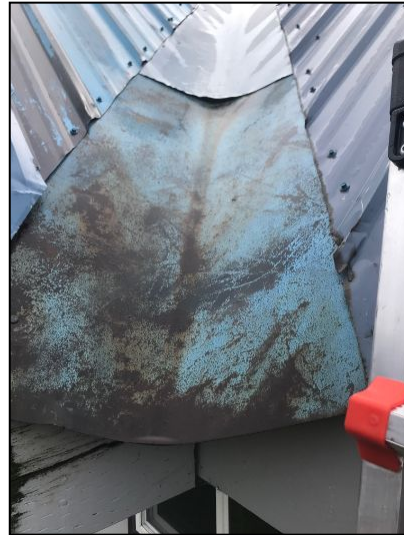
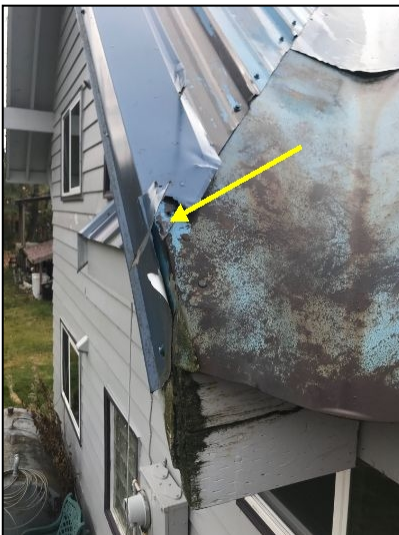
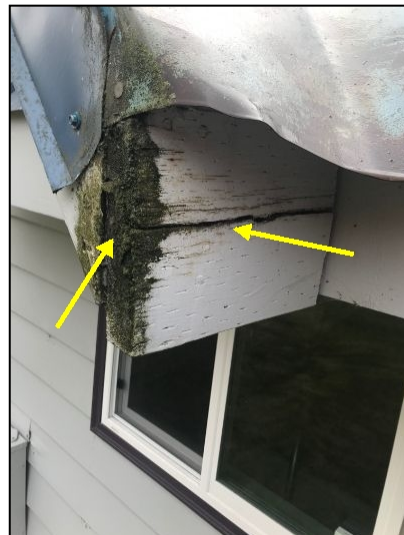
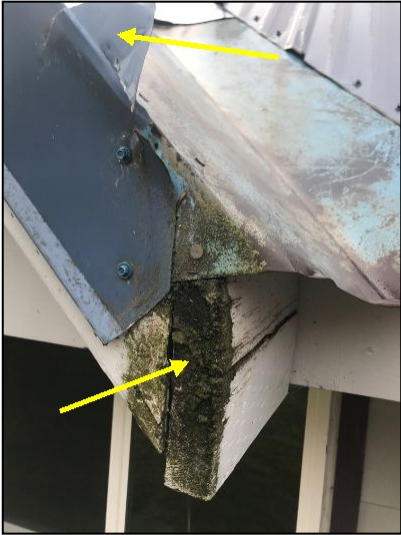
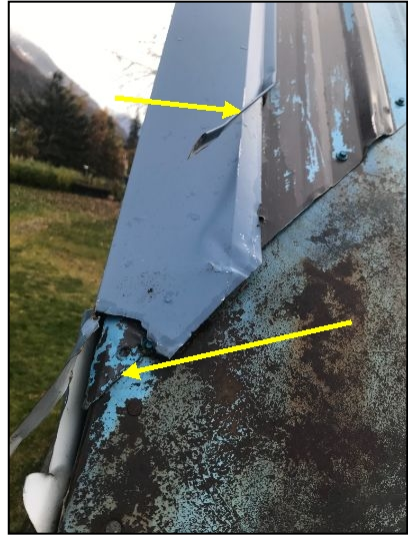
1. Roof Condition

- Serviceability of roof is questionable; it should be evaluated and repaired as necessary by a professional roofing contractor.
- Some areas not visible from inspection level.
- Recommend roofing contractor to evaluate.
- Note that experts recommend that any roof over 10 years old receive a roof certification by a local roofing specialist.
- The roof of the house was replaced back in 1991. This was in the paperwork from the city that I have looked up. This makes the roof 31 years old and is at the end of its serviceable life.
- Both roof **valley**s on the front and rear of the house is in need of repair or replace.

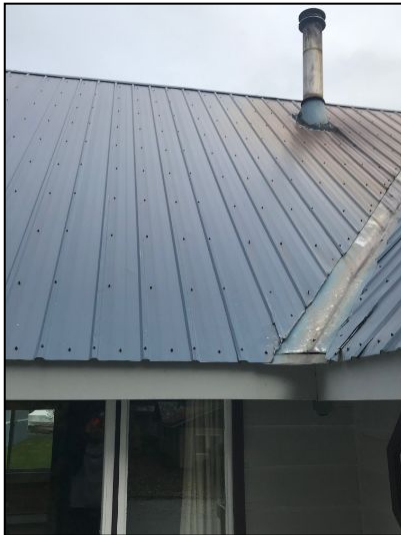
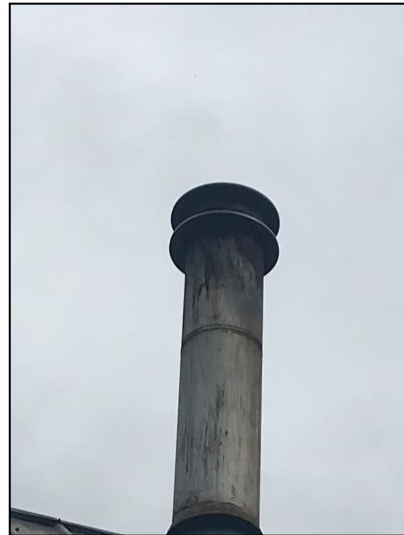
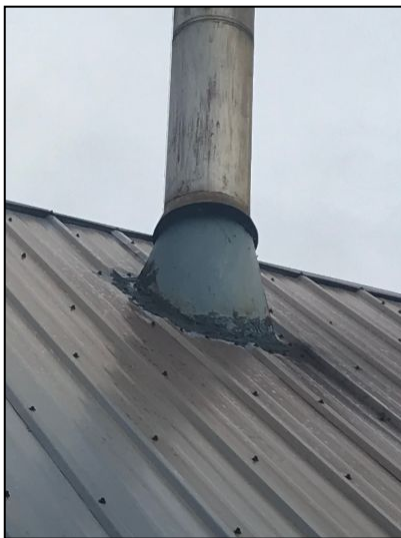
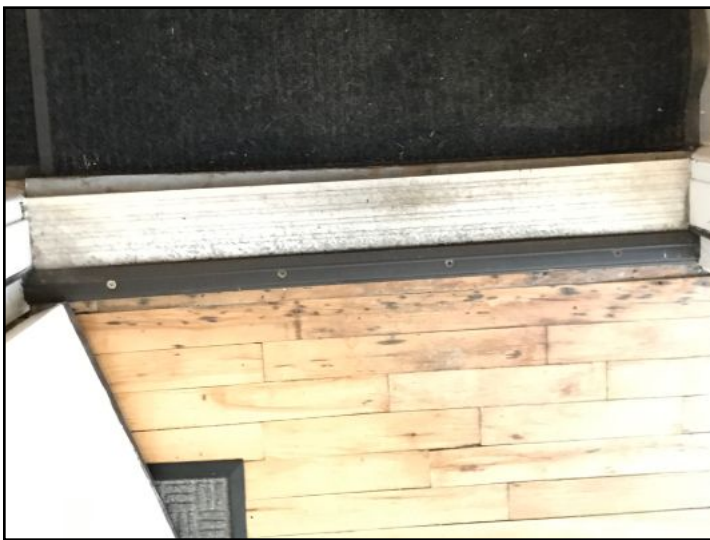
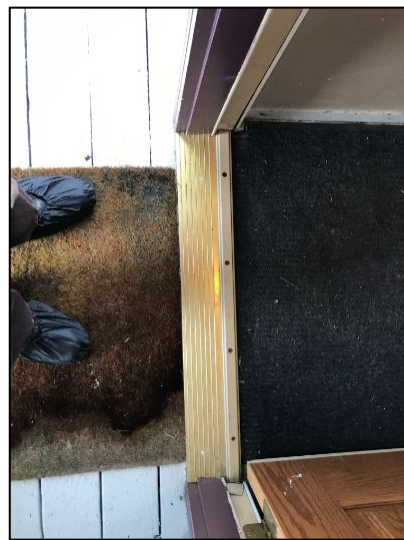
2. Chimney

- No major system safety or function concerns noted at time of inspection.
- Flashing at base of chimney appears to need some maintenance to ensure a continued waterproof seal.
- Crown and Flashing intact where visible
- Unable to determine condition or presence of liner due to accessibility.

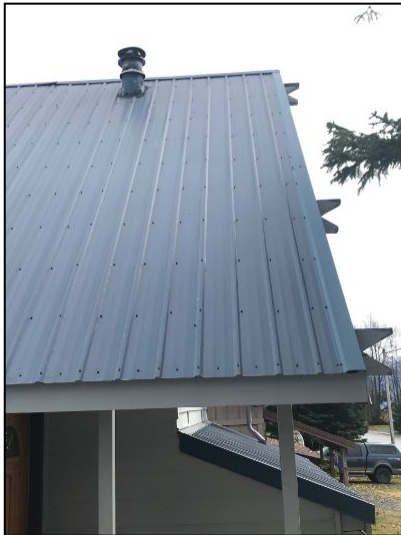
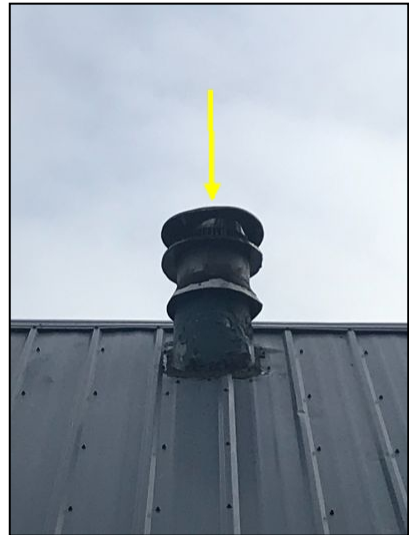
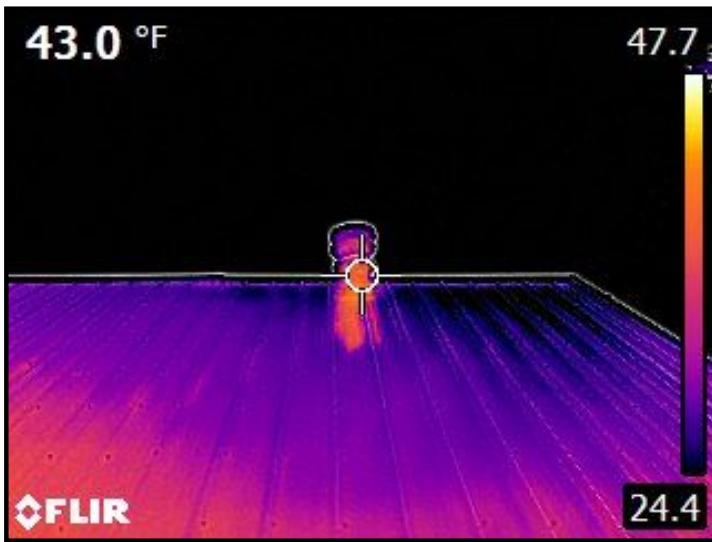
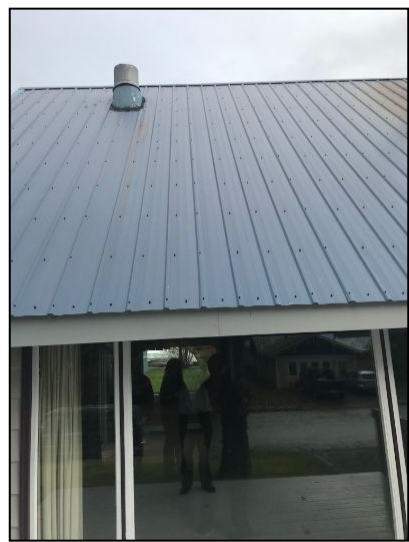
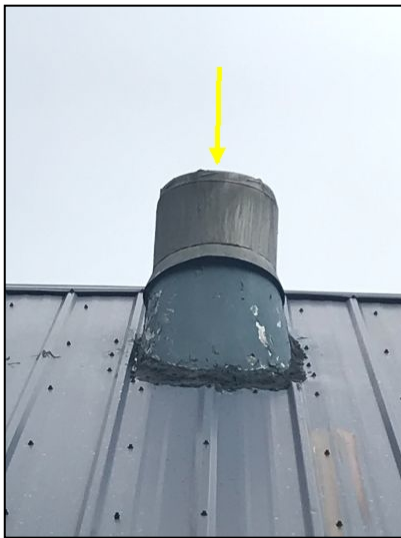
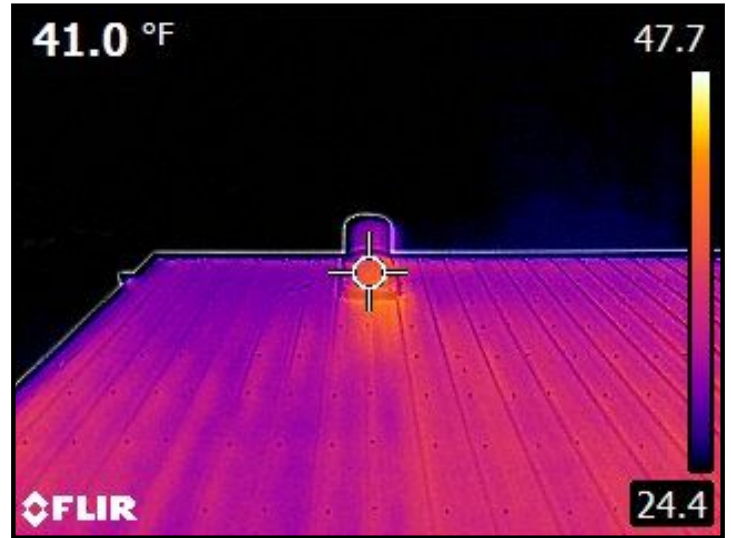
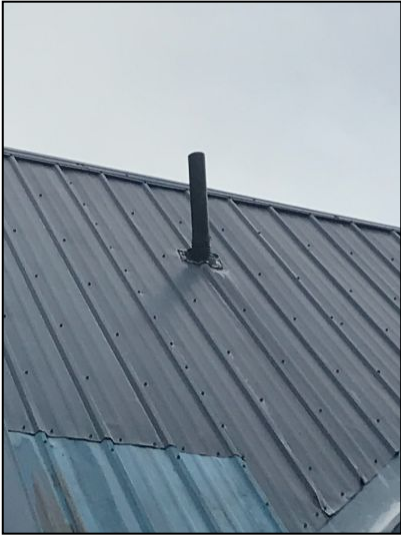
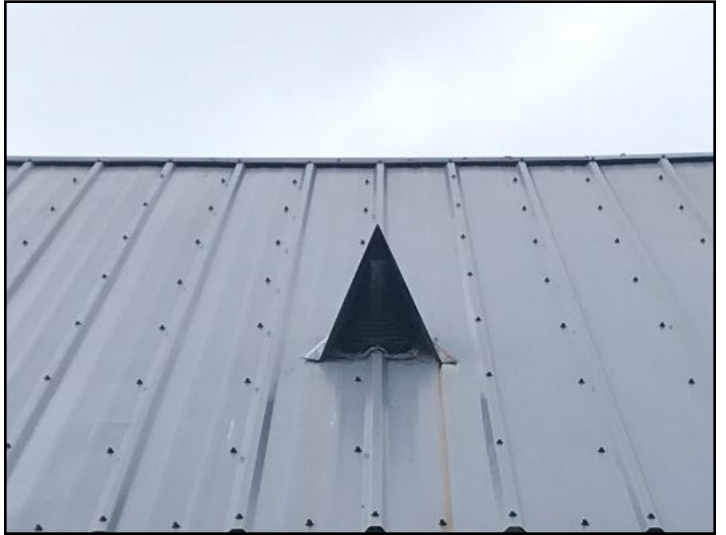
- Two of the house venting or exhaust is not in use anymore and capped off.
- Flashing appears to be in working order for vents at time of inspection.

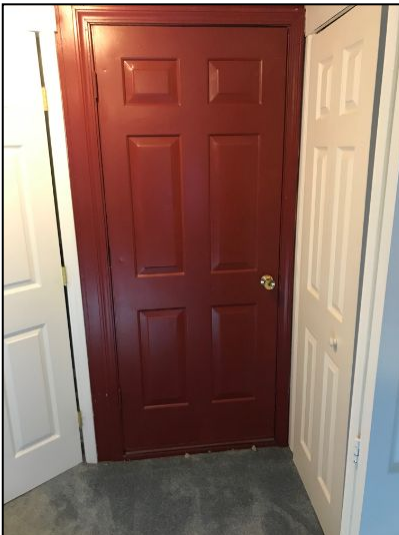
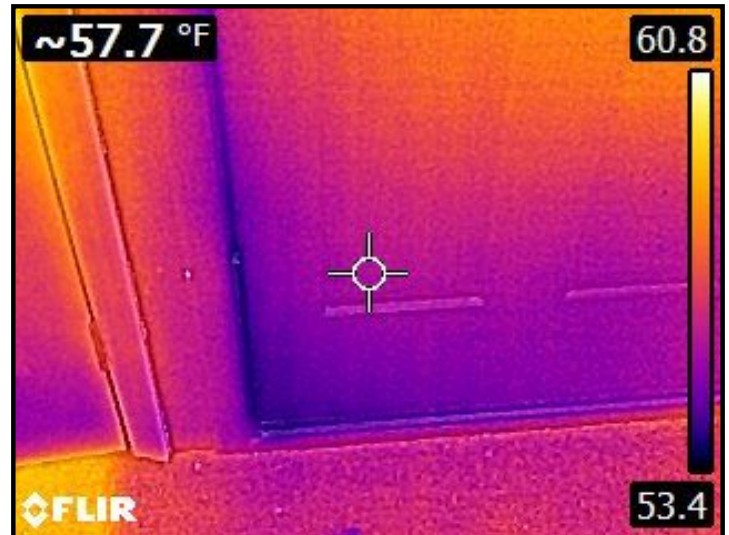
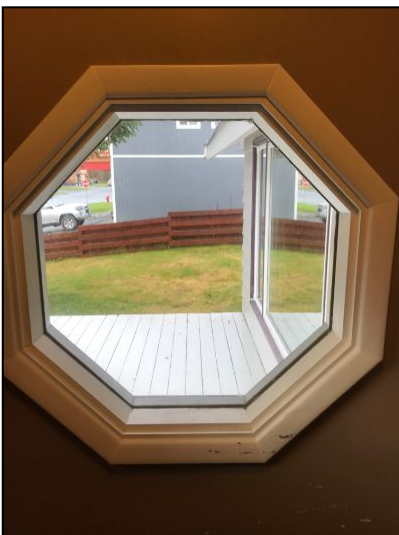
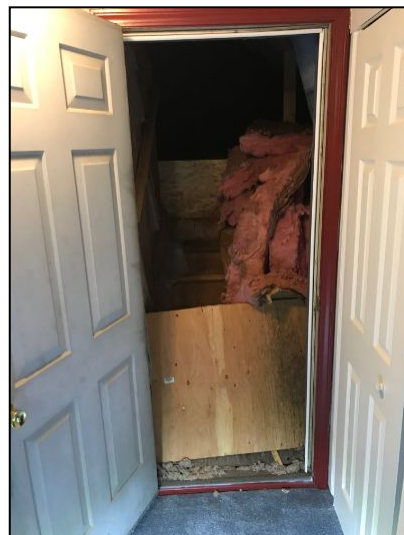
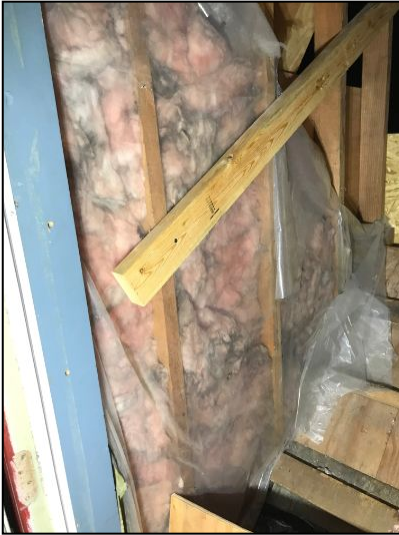
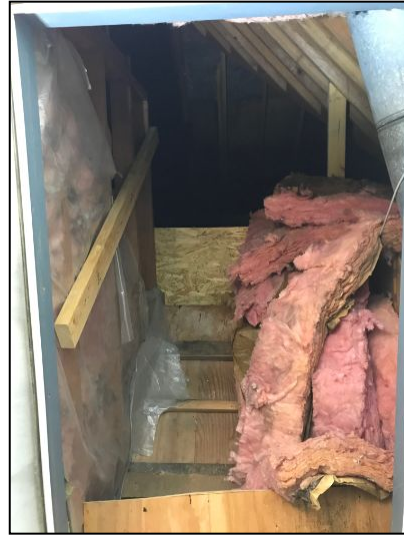
- Attic access is in working order. I moved insulation to get a better look in the attic space. I moved everything back after the inspection to help keep the house warm.
- **Entering attics that are heavily insulated can cause damage to the insulation and attic framing. Attics with deep insulation cannot be safely inspected due to limited visibility of the framing members upon which the inspector must walk. In such cases, the attic is only partially accessed, thereby limiting the review of the attic area from the hatch area only. Inspectors will not crawl the attic area when they believe it is a danger to them or that they might damage the attic insulation or framing. This is a limited review of the attic area viewed from the hatch only.**

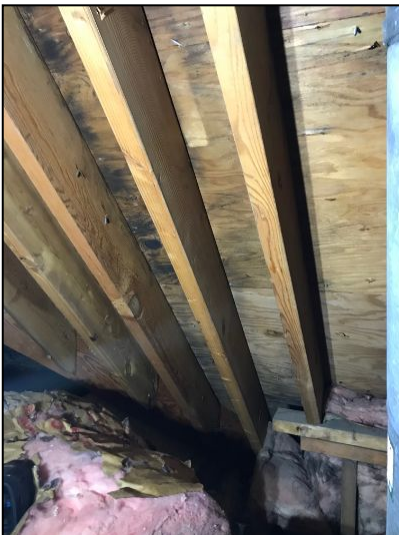
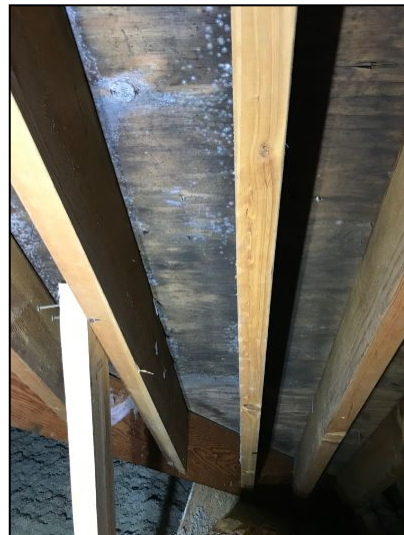
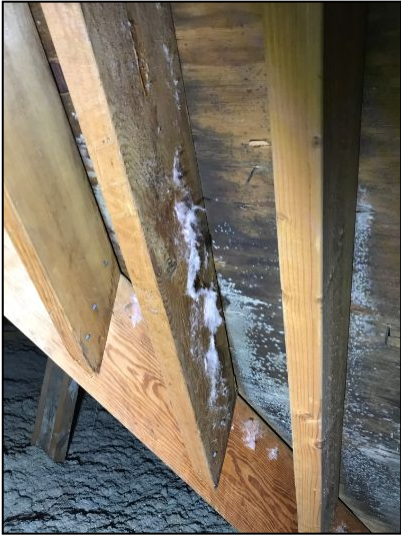
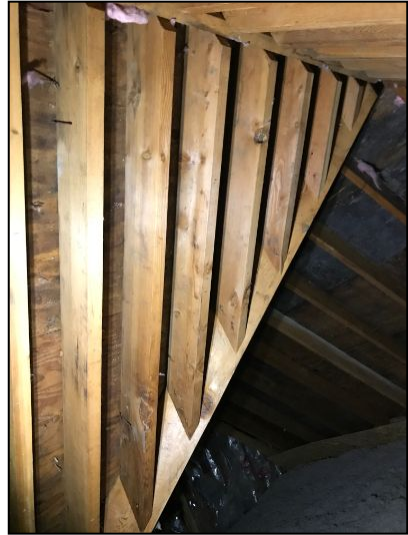
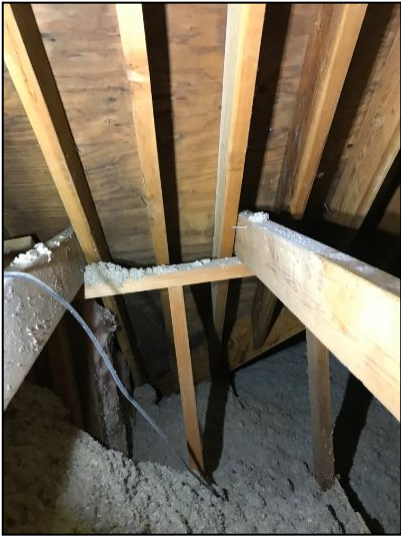
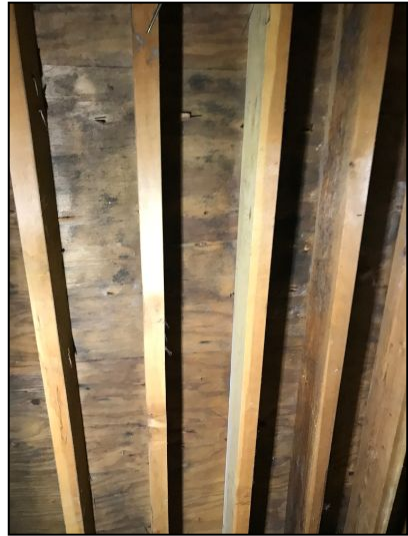
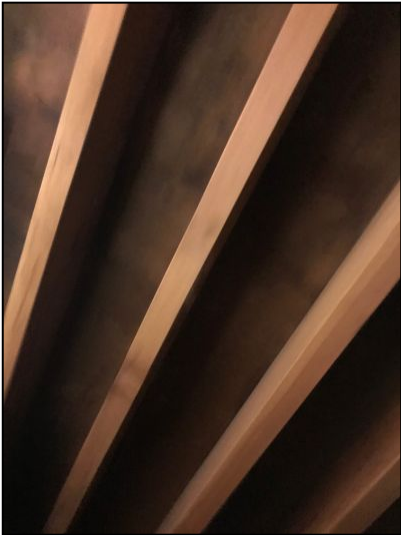
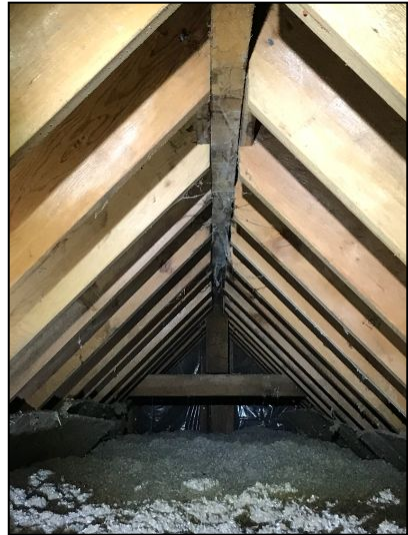
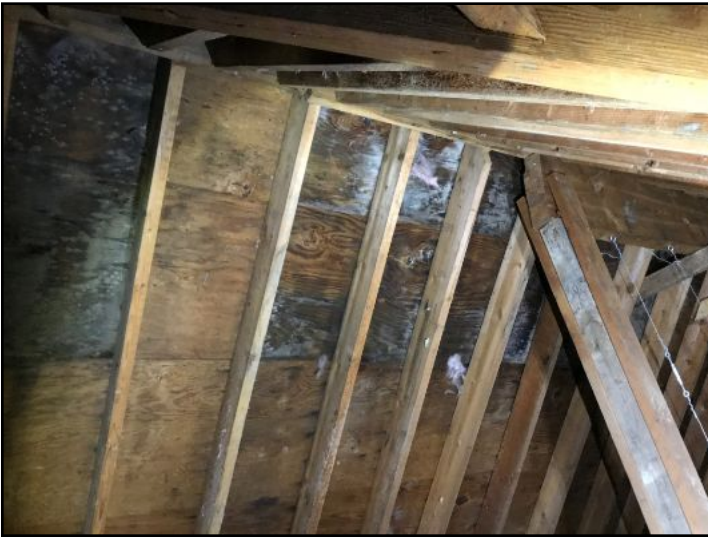
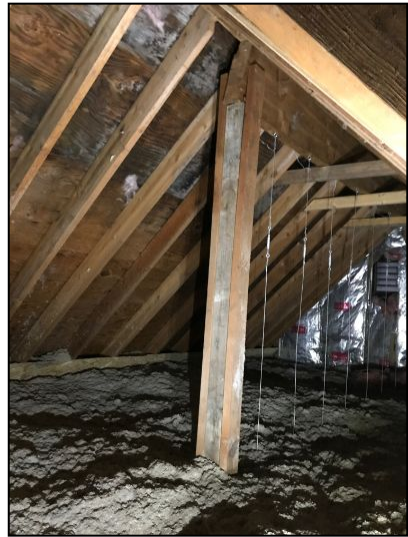
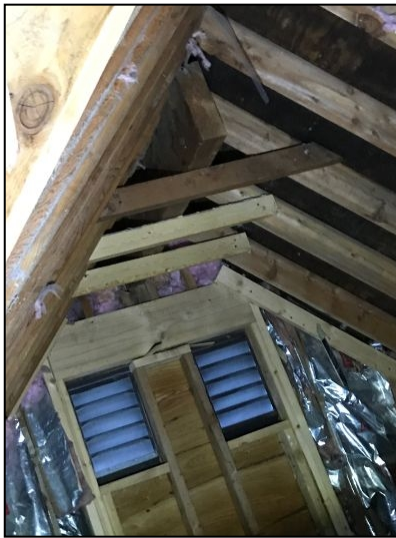
2. Structure

- Some areas of attic sheathing are blackened, and inspectors cannot determine cause (soot, possible organic substance, or even stains from prior use). The United States Environmental Protection Association (EPA) states, "If you believe that you may have a hidden mold problem, consider hiring a professional." (Brief Guide to Mold, p.14, EPA). If any area of the residence is suspected of having organic growth, or any member of your family or household is sensitive to mold, we are lab-certified to conduct a Mold Inspection / Sampling to identify the types of mold (or any other airborne allergens) present. If necessary, we are also lab-certified to perform radon, meth, asbestos and other environmental testing services.
- Limited review due to insulation installed between the rafters.
- Unable to determine condition due to insulation.

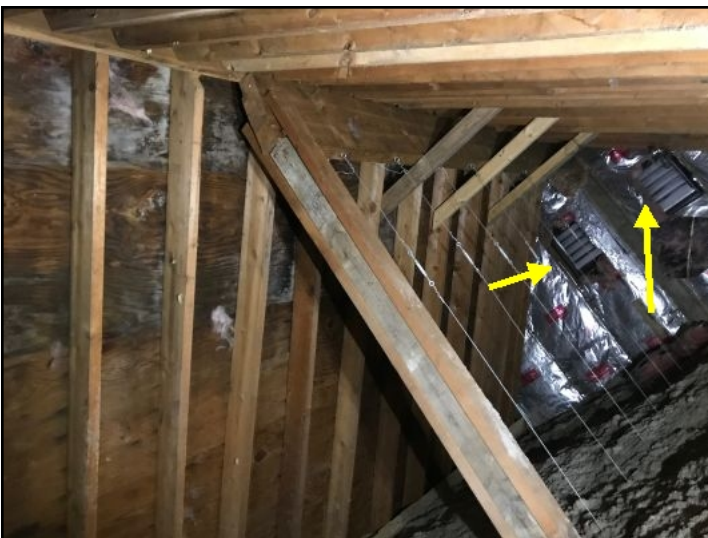
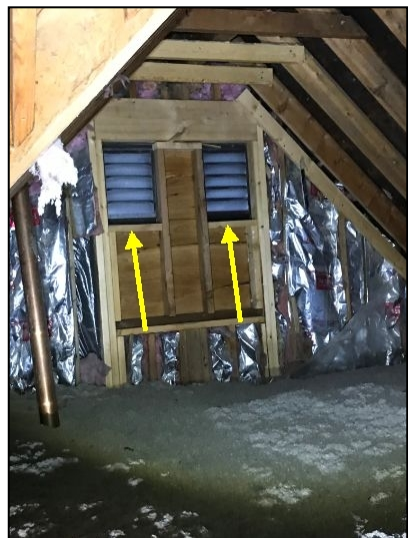
3. Ventilation

- Under eave soffit inlet vents noted.
- Gable louver vents noted.

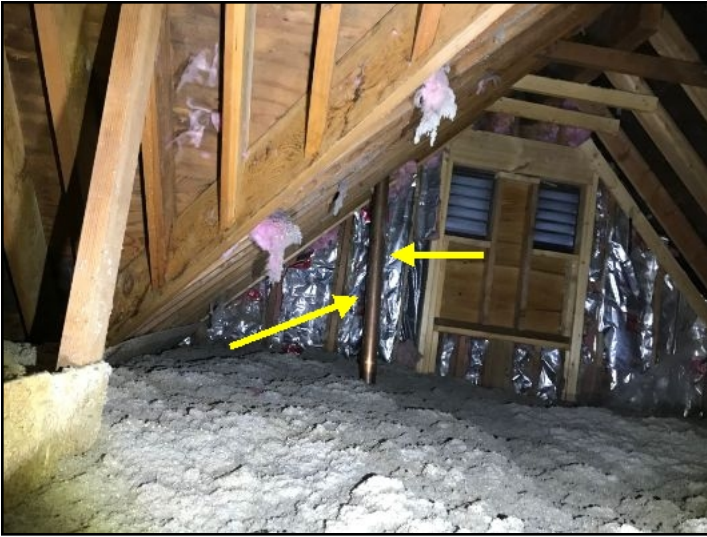
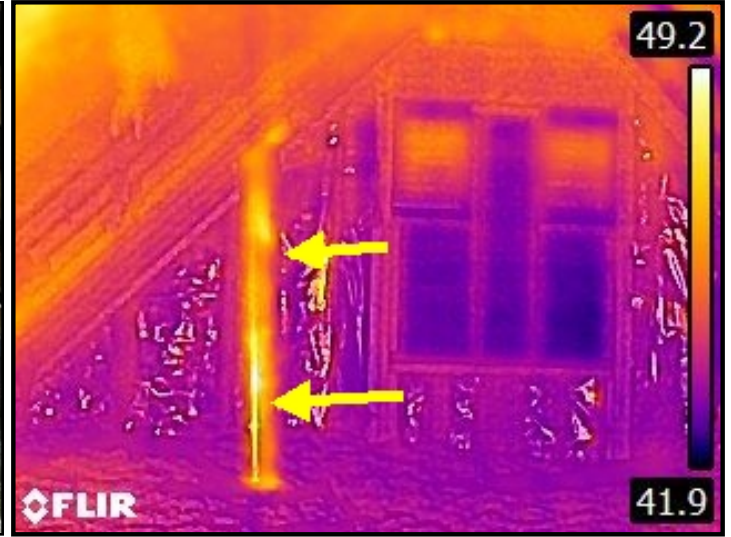
4. Attic Plumbing

- Copper plumbing vent piping

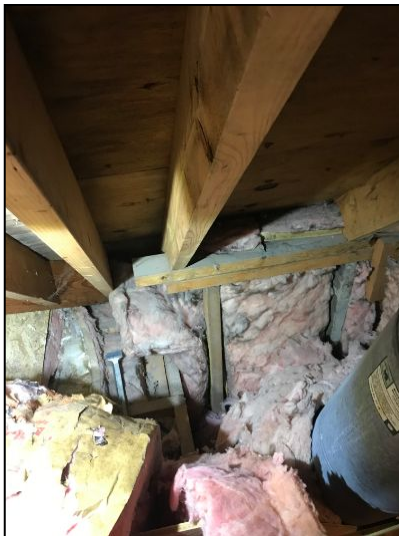
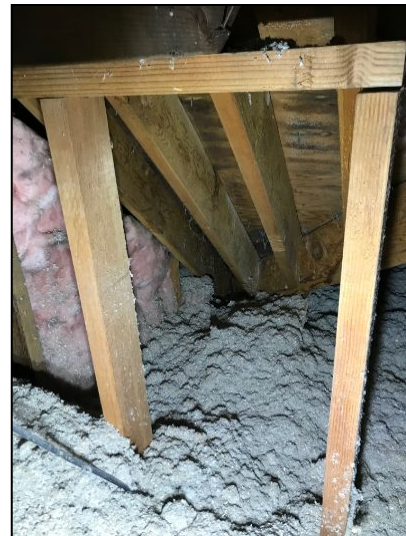
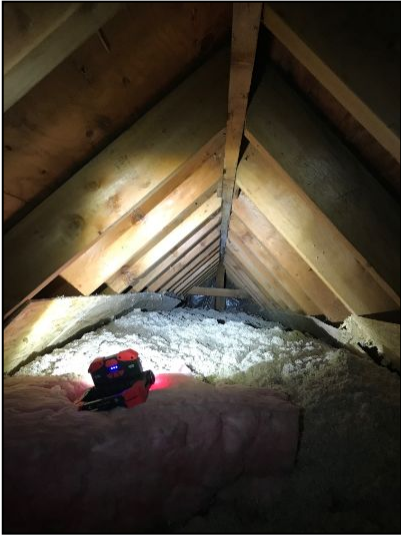
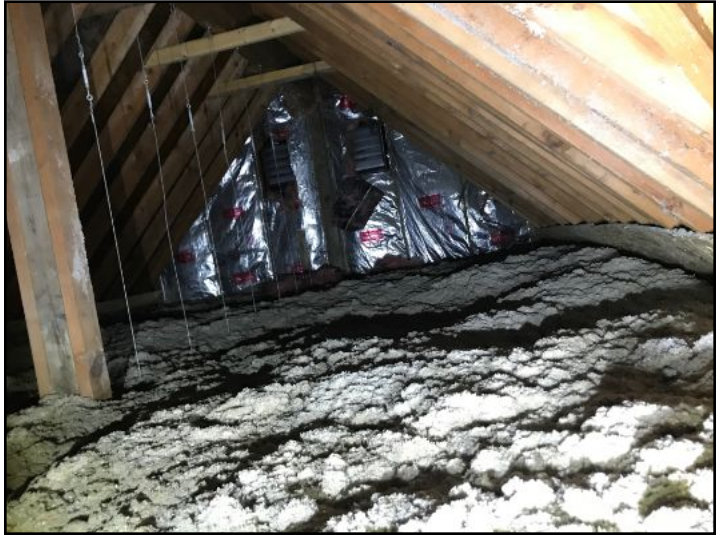
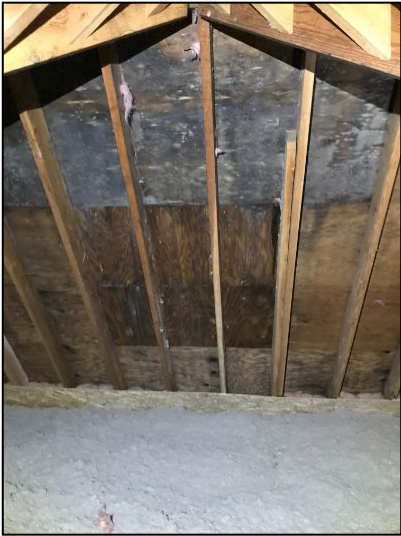
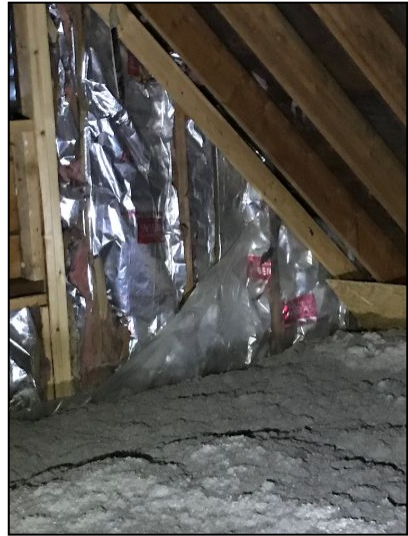
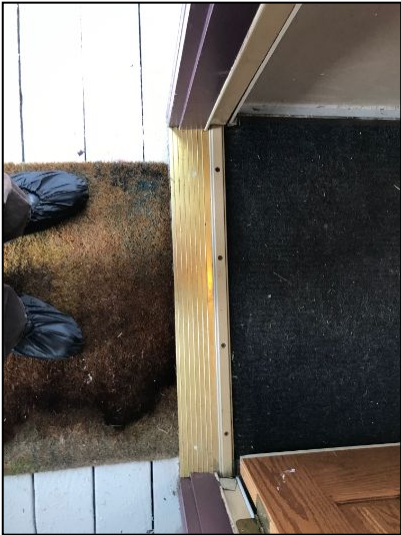
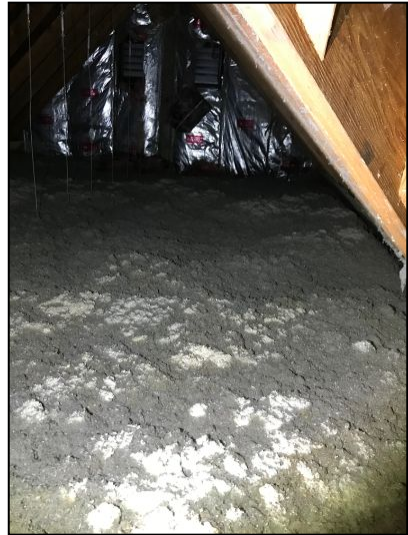
5. Insulation Condition

- Insulation level in the attic is typical for homes this age
- Insulation appears adequate.
- Insulation is sparse in some areas.

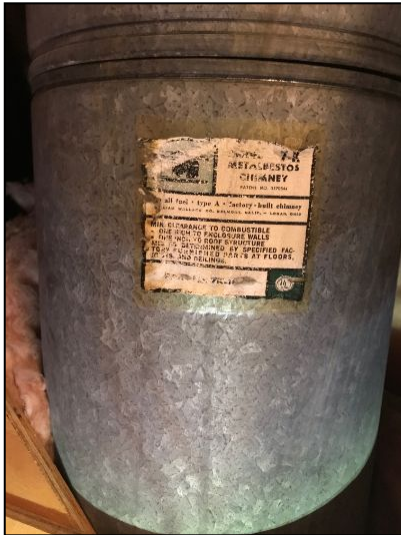
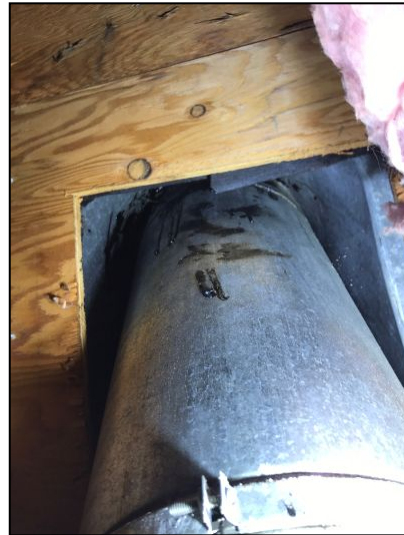
6. Chimney

- Crown and Flashing intact where visible.
- Recommend review by a qualified chimney professional for repair or replacement, as necessary.
- Limited review. Our chimney review is limited to visible accessible components only. If further review is desired, we suggest review by a qualified professional prior to close.

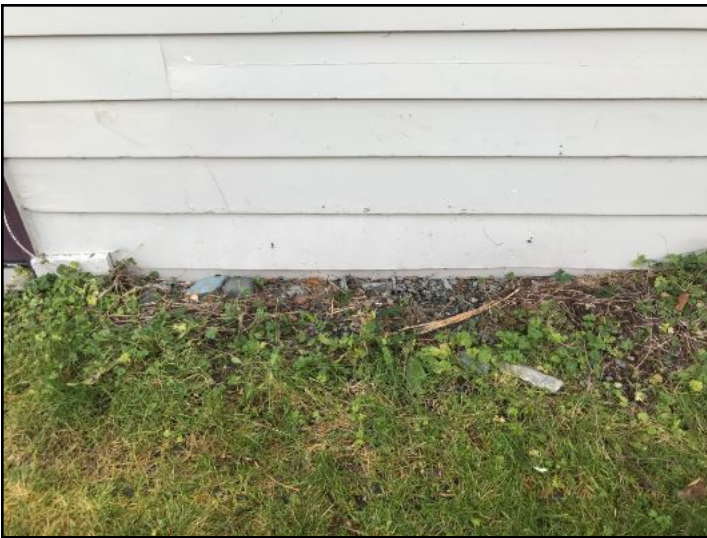
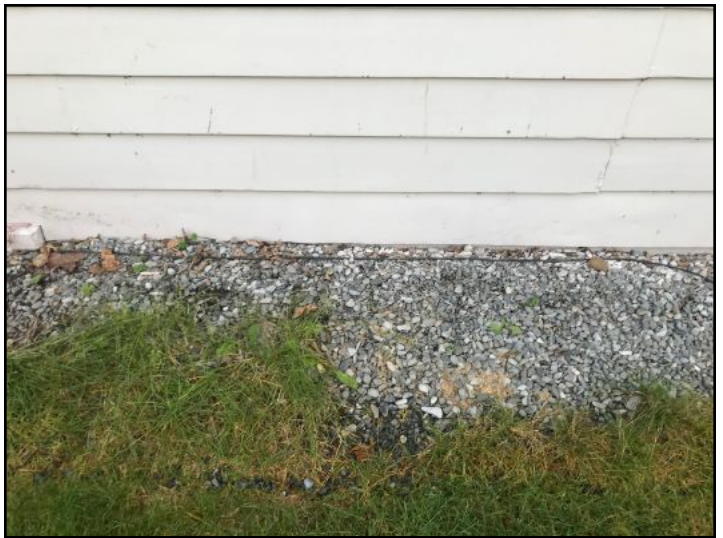
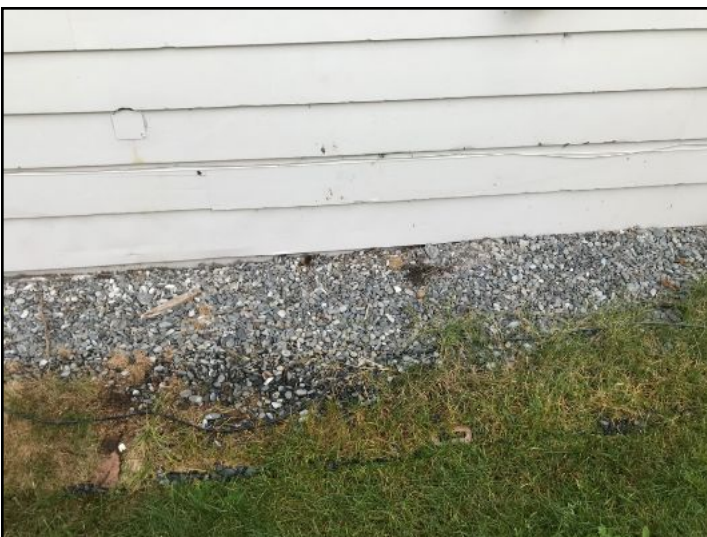
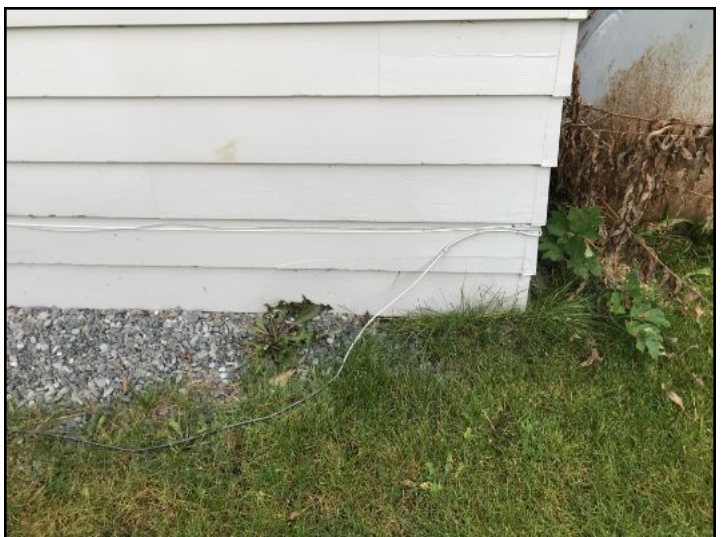
1. Foundation Perimeter

- No deficiencies were observed at the visible portions of the structural components of the home.

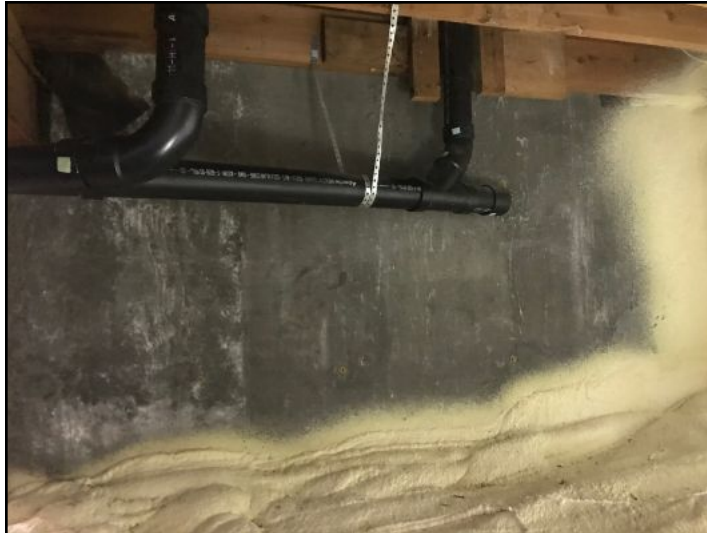
2. Foundation Walls

- Limited review due to insulation cover and finished walls.
- Limited review of unfinished area due to insulation cover.
- Recommend review by a qualified professional for repair or replacement as necessary.
- No deficiencies were observed at the visible portions of the structural components of the home.

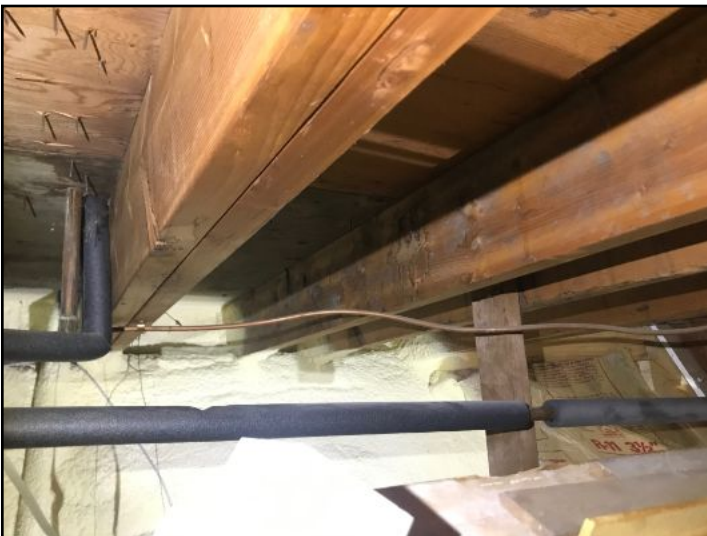
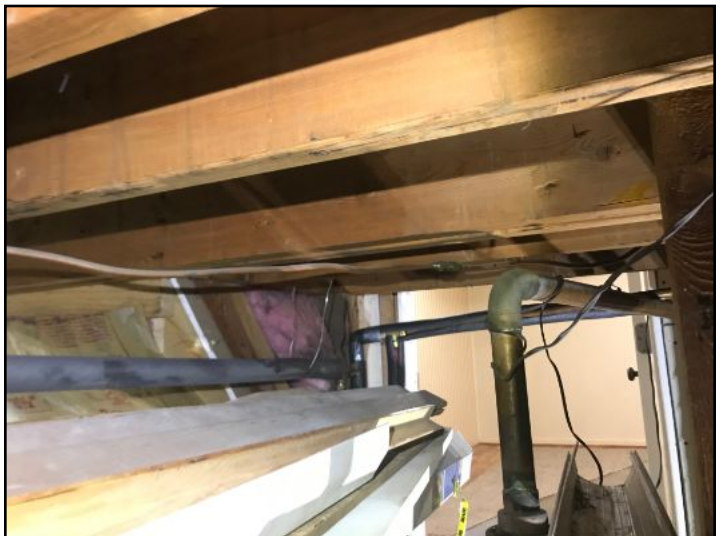
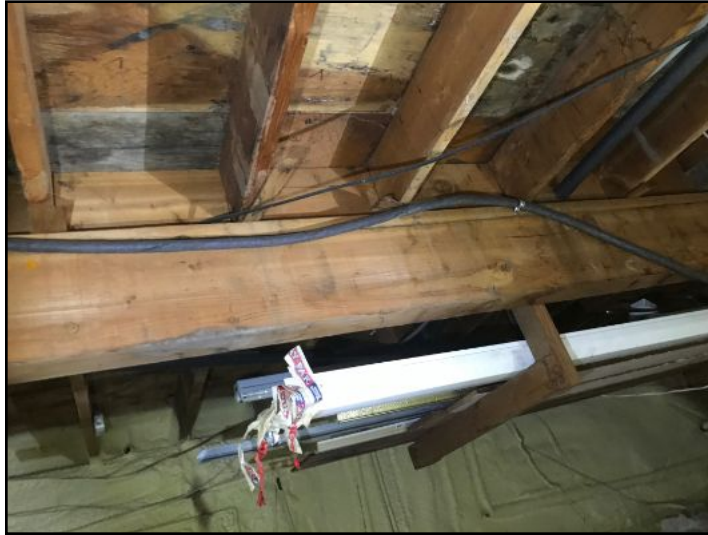
3. Post and Girders

- Support Material: Wood/Bearing Wall
- Foundation supports for most of the house are not visible for inspection. Consider consulting a contractor or structural engineer.
- No deficiencies were observed at the visible portions of the structural components of the home.

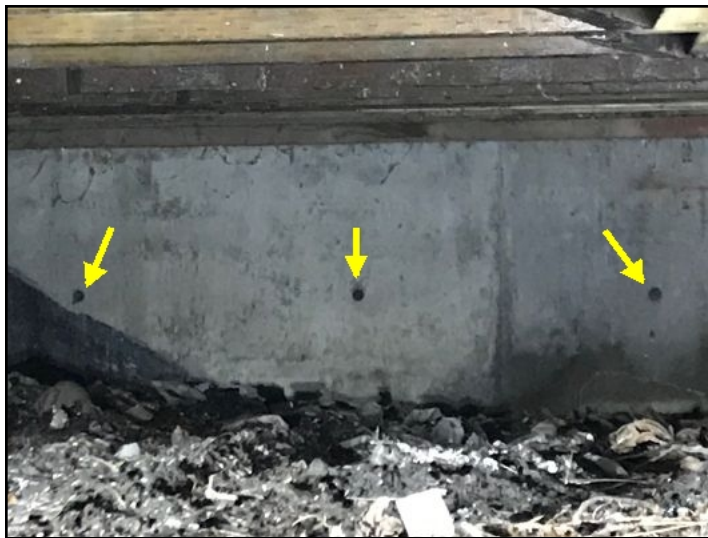
4. Anchor Bolts

- The anchor bolts were inspected and appear to be serviceable.

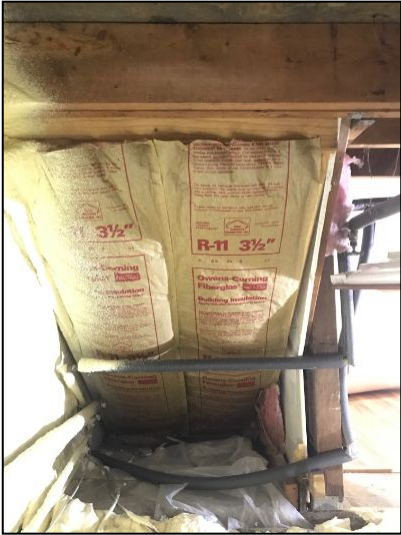
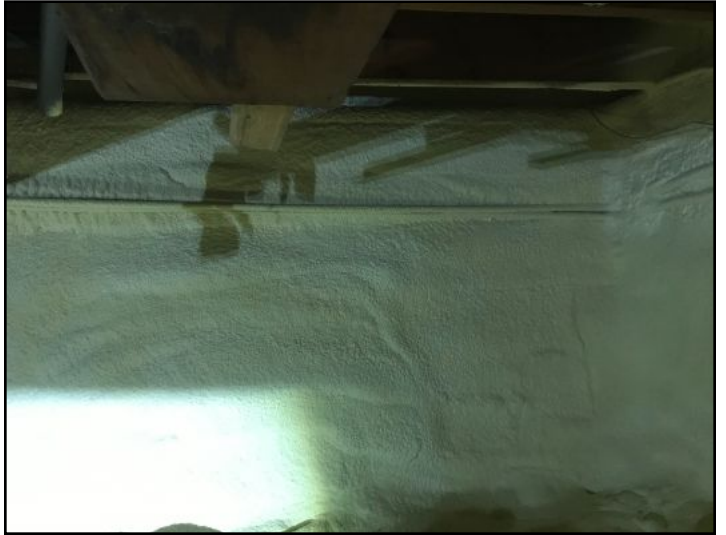
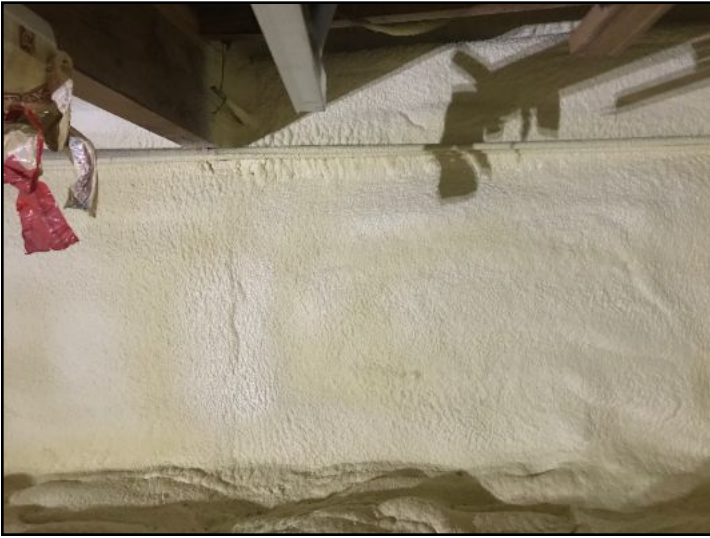
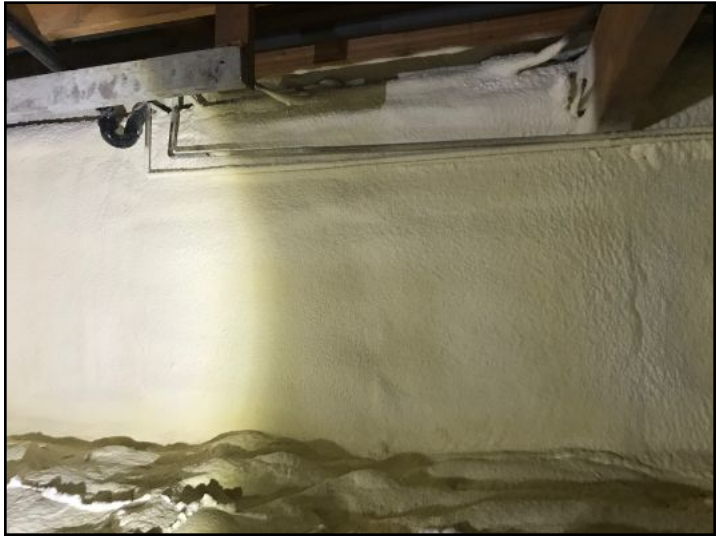
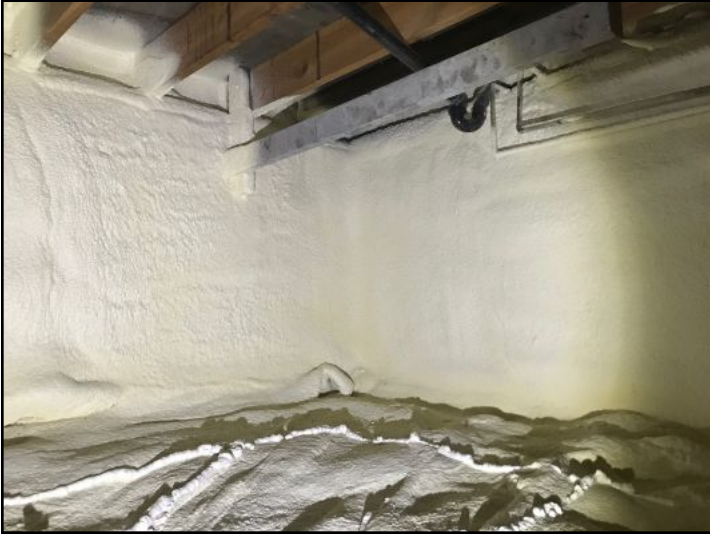
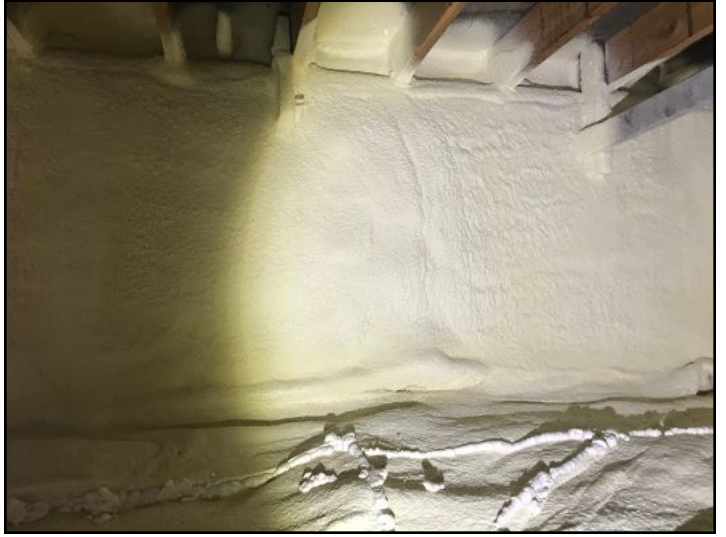
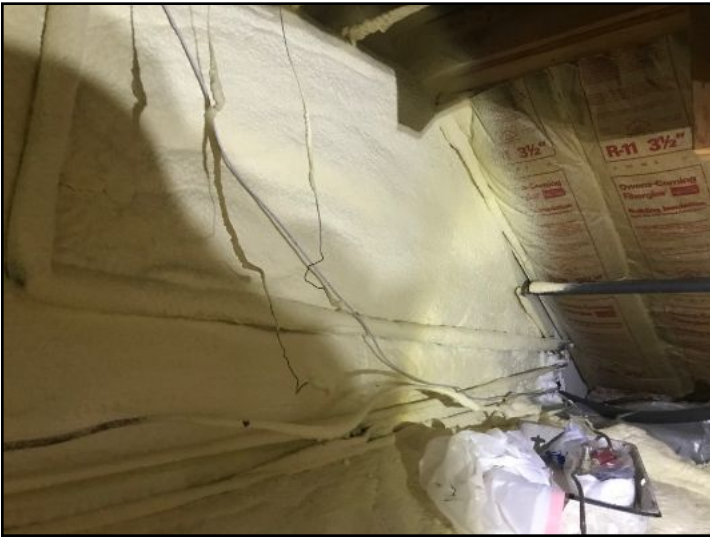
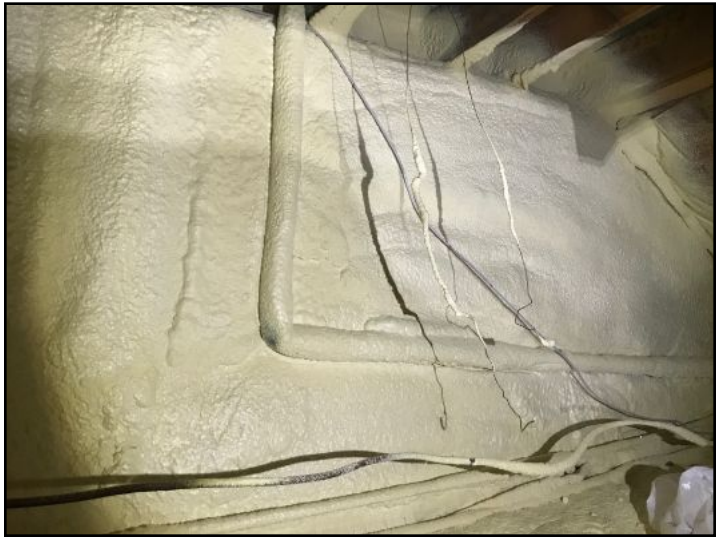
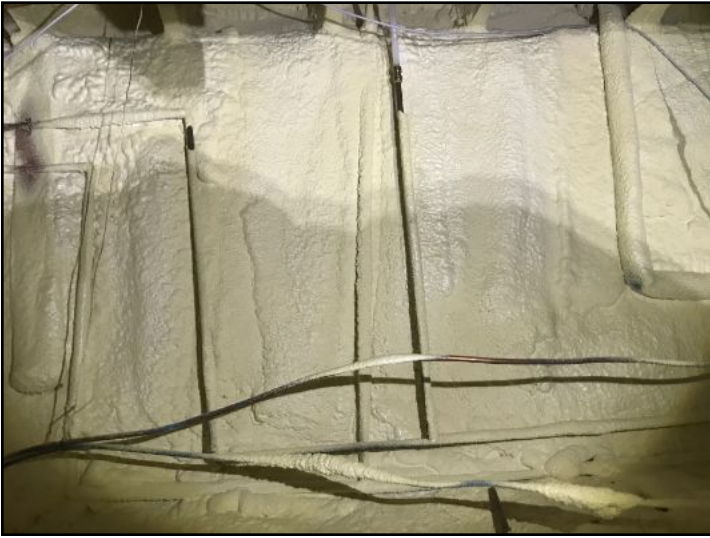
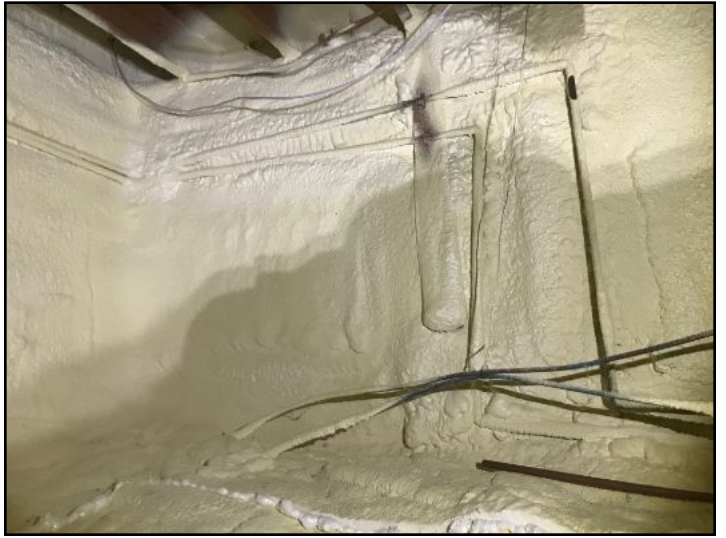
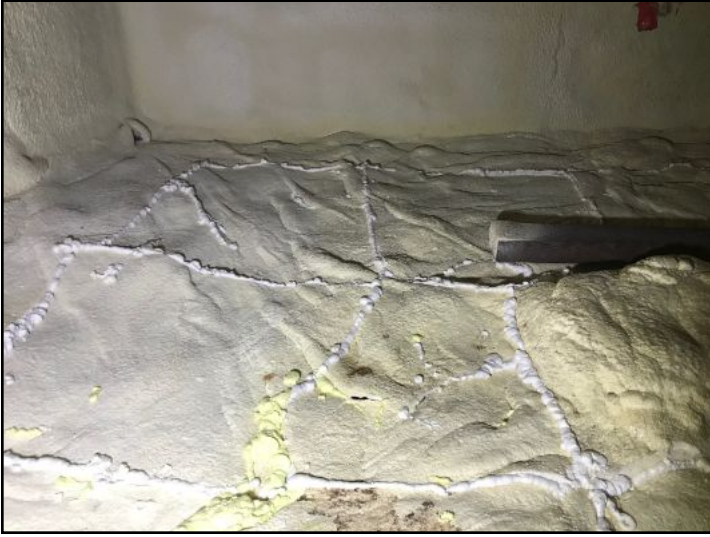
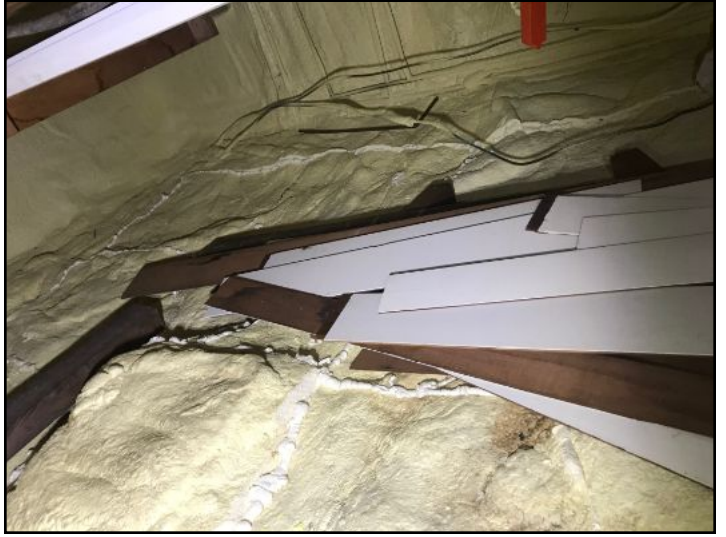
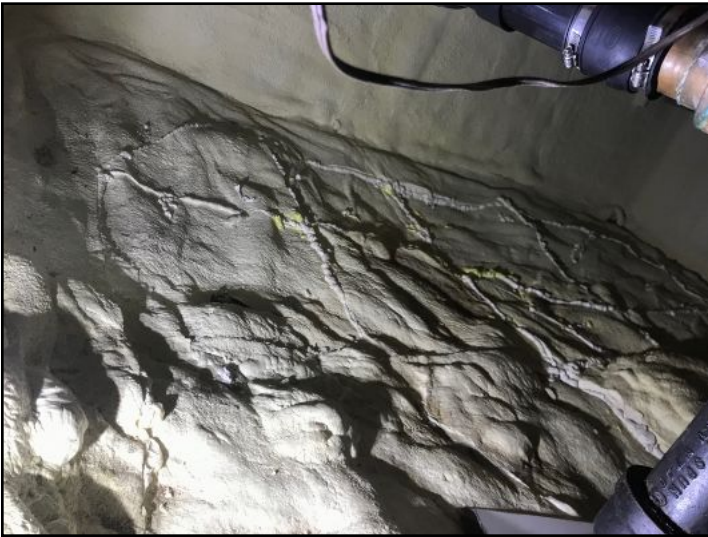
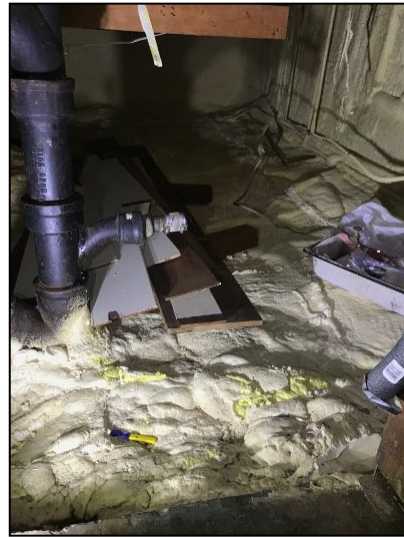
- Crawlspace is insulated with spray foam around the whole perimeter and floor.
- No deficiencies found with the insulation at time of inspection.

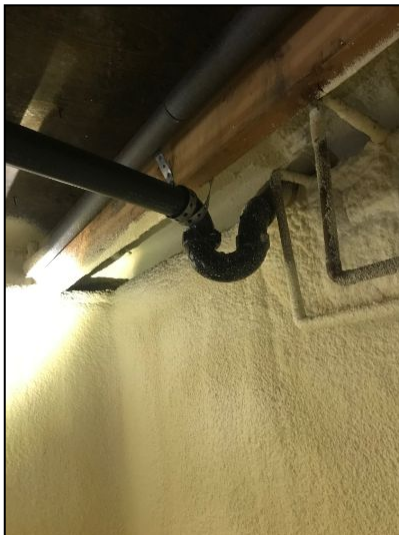
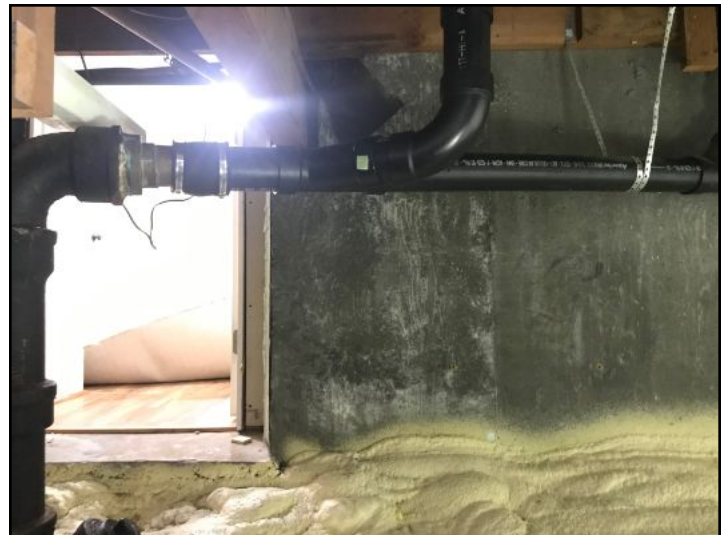
3. Plumbing Materials

Materials: Appears Functional. • Inspection of all areas of the drain pipes was not possible due to limited access/finished walls and ceilings to check for defects such as, but not limited too:leaks, corrosion, improper workmanship, and damage. • Plumbing pipes not fully visible for inspection due to finished ceilings and walls. • Recommended considering PEX (Cross Linked Polyethylene) as an economical means of repair to damage/deteriorated water lines. Please visit <http://pexinfo.com/> for more info on pex and installation practices. • Pipe insulation is recommended to eliminate condensation from forming on cold water supply lines causing stains on floors/ceiling coverings and excess moisture in dwelling as well.

- **ABS**
- Cast Iron
- Copper
- Pex
