Arctic Home Inspections

Property Inspection Report

Inspection prepared for:
Date of Inspection: 2/22/2022

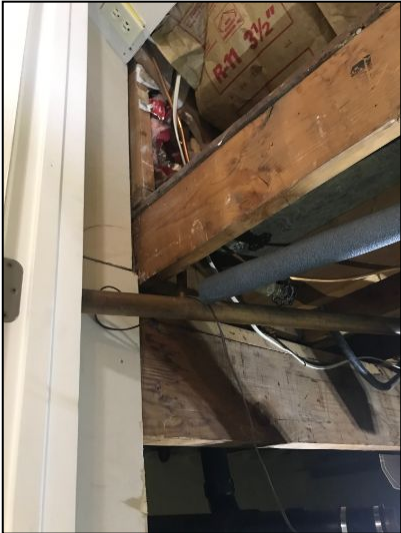
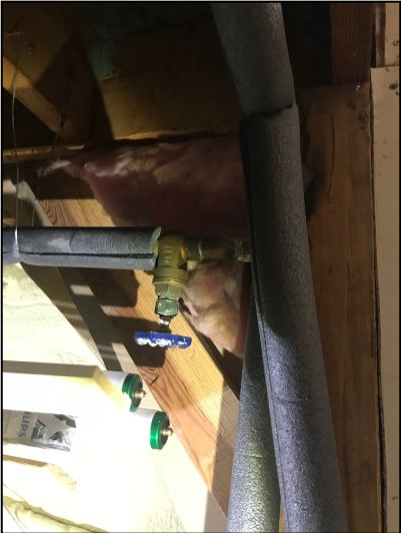
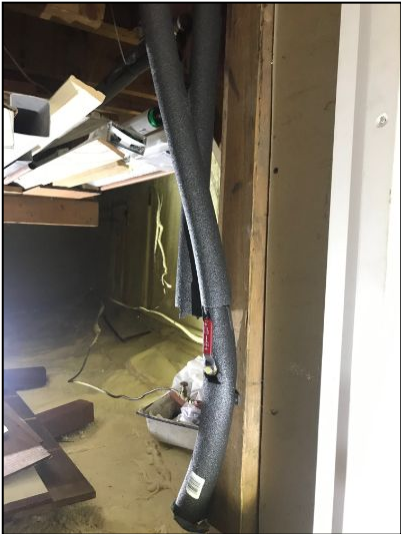
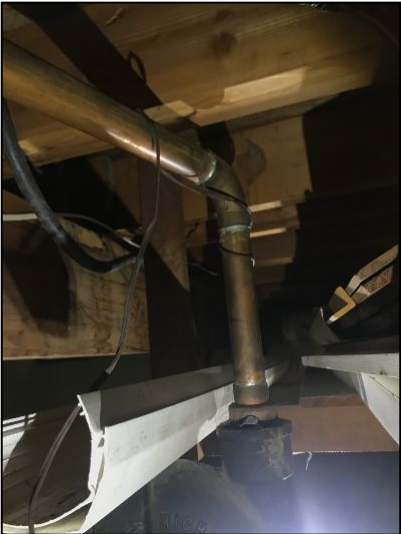
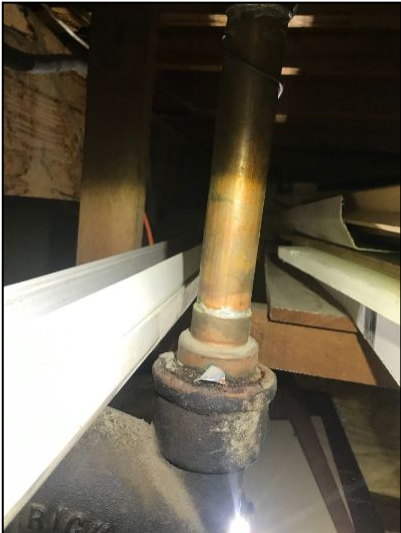
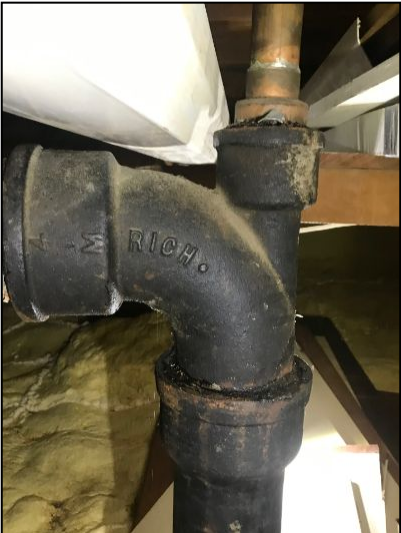
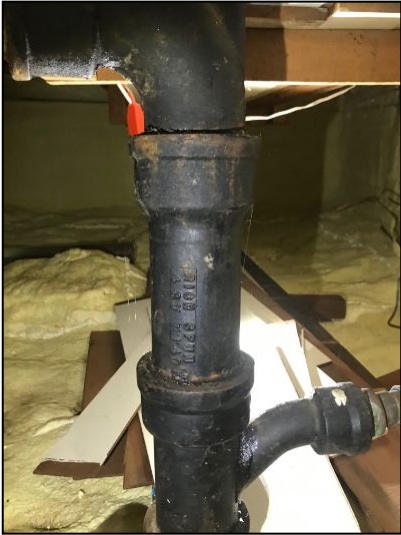
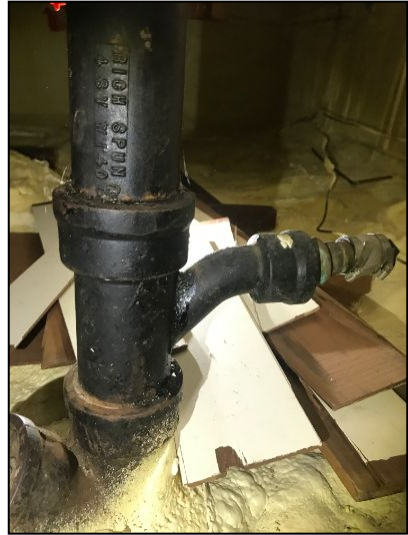
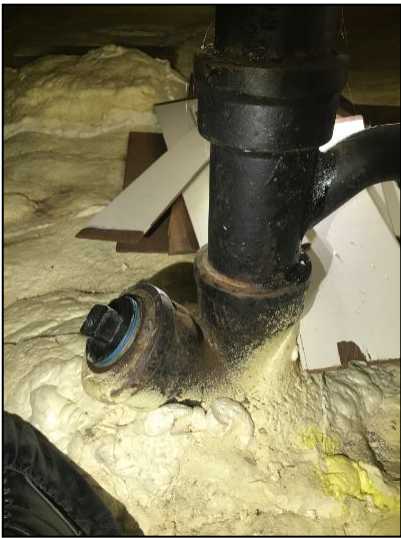
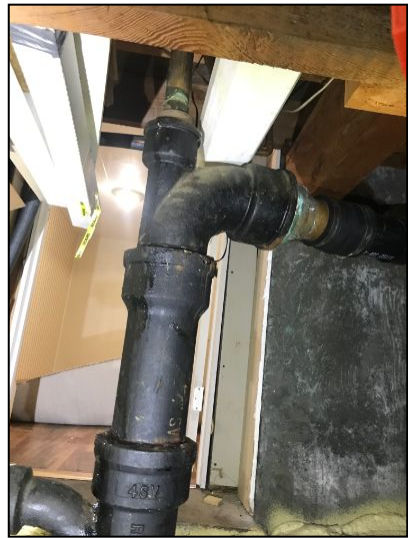
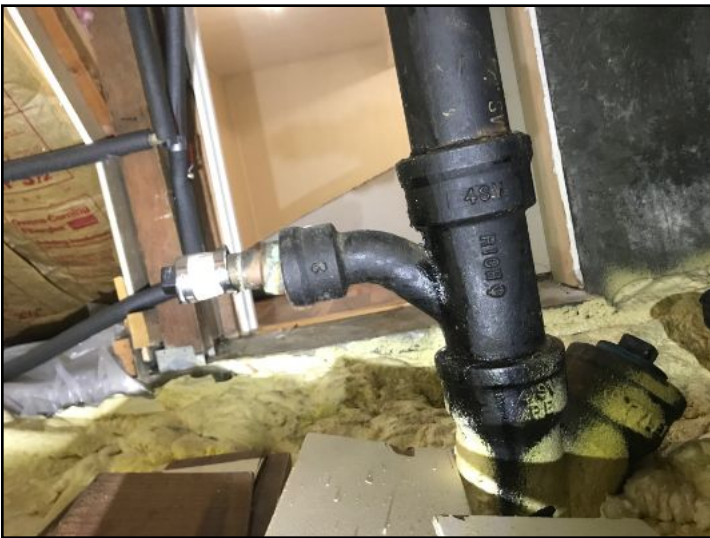
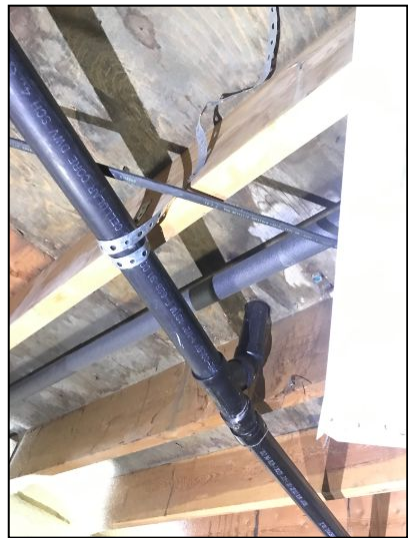
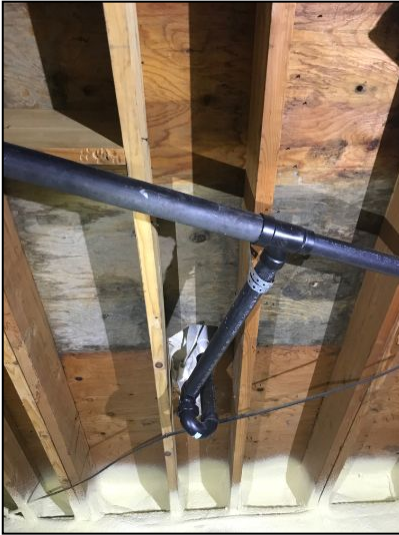
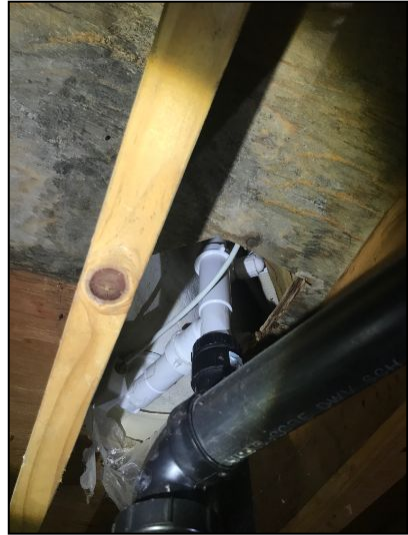
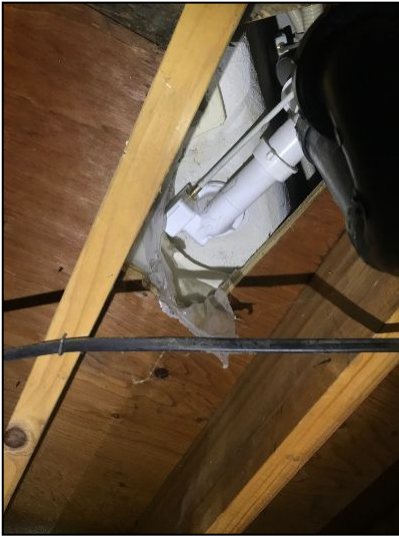
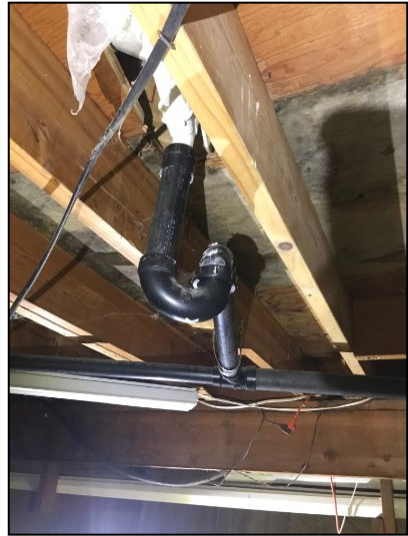
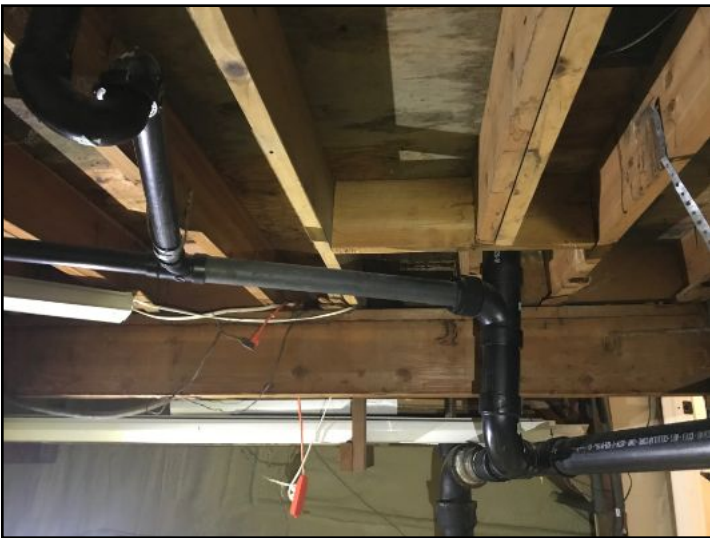
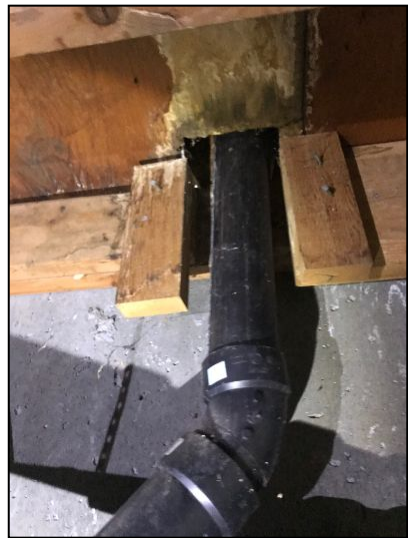
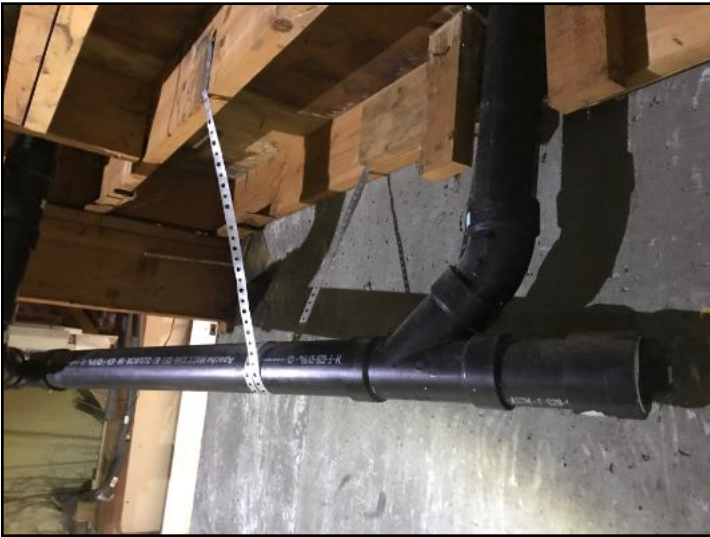
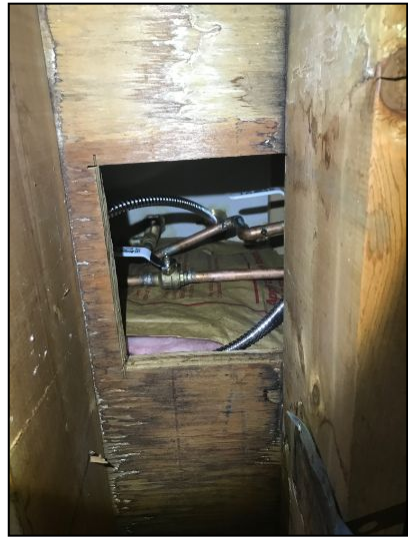
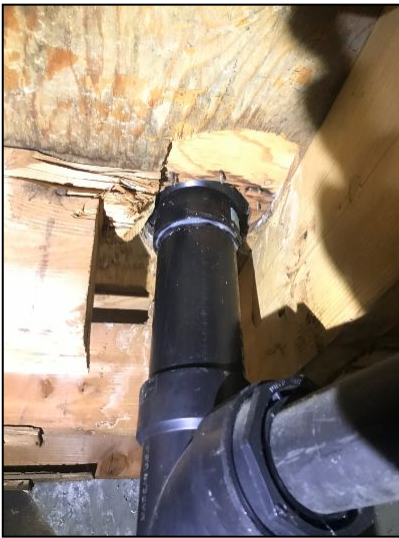
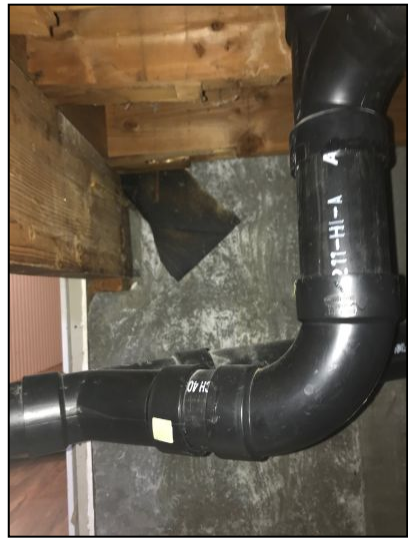
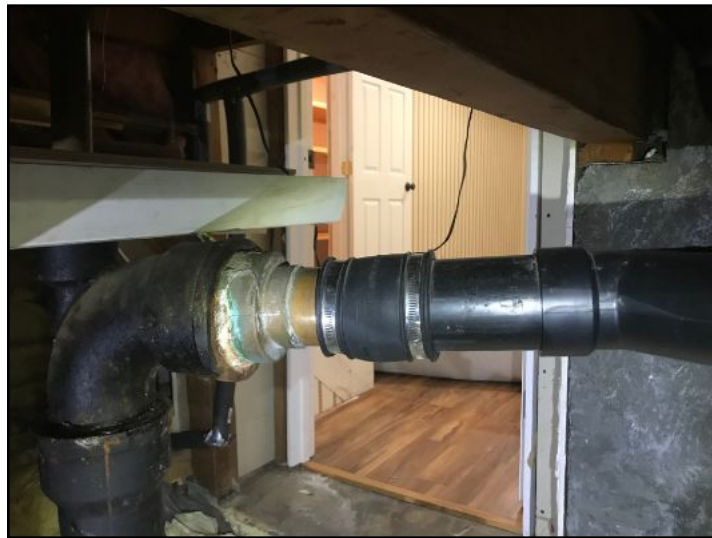
3. Plumbing Materials

Materials: Appears Functional. • Inspection of all areas of the drain pipes was not possible due to limited access/finished walls and ceilings to check for defects such as, but not limited too:leaks, corrosion, improper workmanship, and damage. • Plumbing pipes not fully visible for inspection due to finished ceilings and walls. • Recommended considering PEX (Cross Linked Polyethylene) as an economical means of repair to damage/deteriorated water lines. Please visit <http://pexinfo.com/> for more info on pex and installation practices. • Pipe insulation is recommended to eliminate condensation from forming on cold water supply lines causing stains on floors/ceiling coverings and excess moisture in dwelling as well.

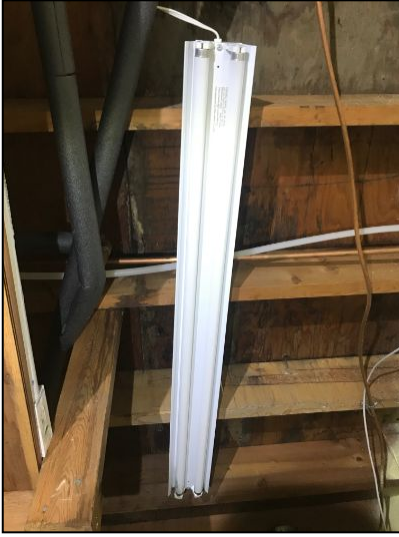
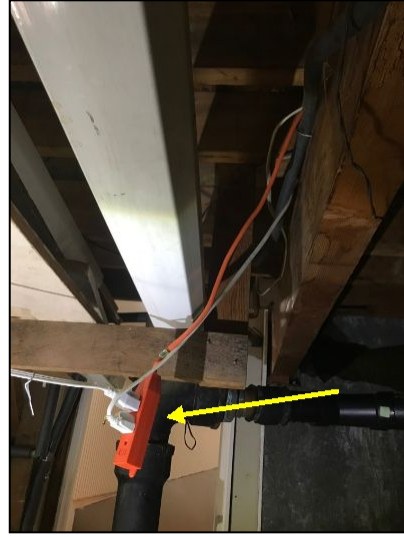
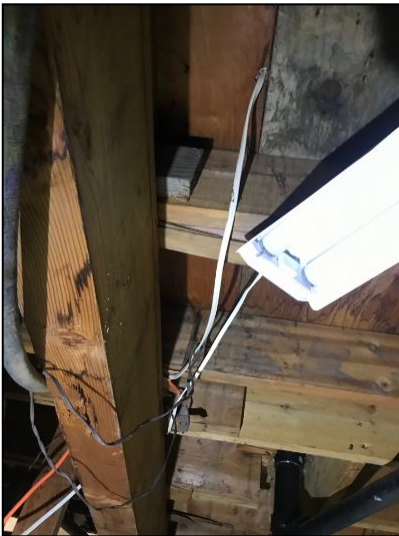
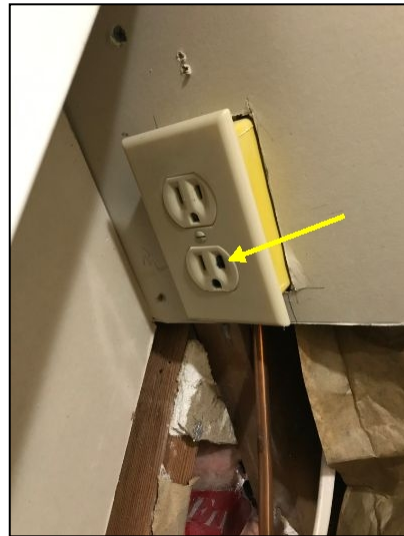
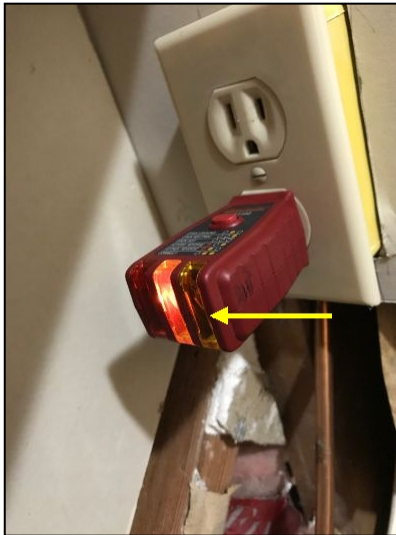
- Recommend full review by qualified electrical contractor for quotes on upgrades/repair to ensure safe and adequate service.
- Since ungrounded receptacles were noted in the home, buyer is cautioned that proper grounding is strongly urged where sensitive electronic equipment is used. Ungrounded receptacles do not offer protection for computers etc. Consultation with a qualified electrical contractor is recommended.
- Open ground- receptacle in crawlspace.
- Improper use of extension cord observed. Extension cords should not be permanently installed or be routed through walls, floors or partitions.

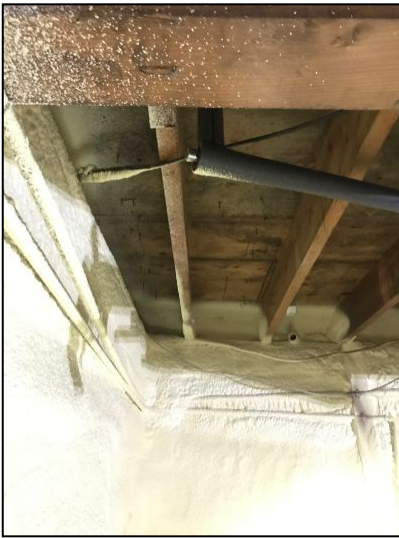
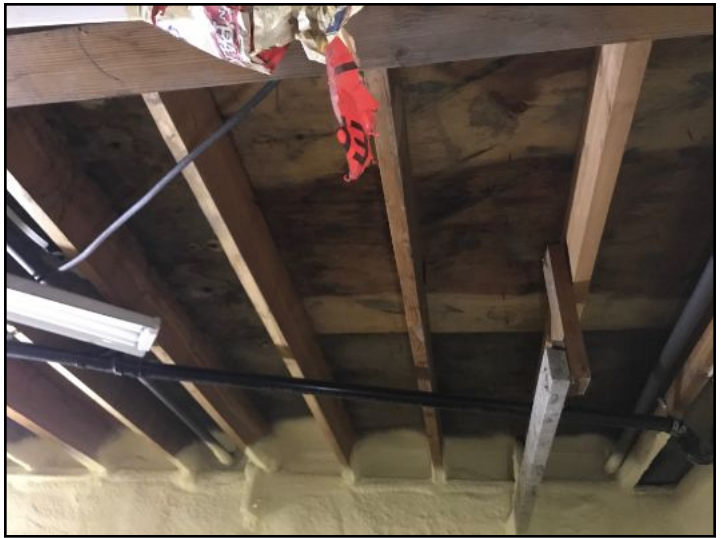
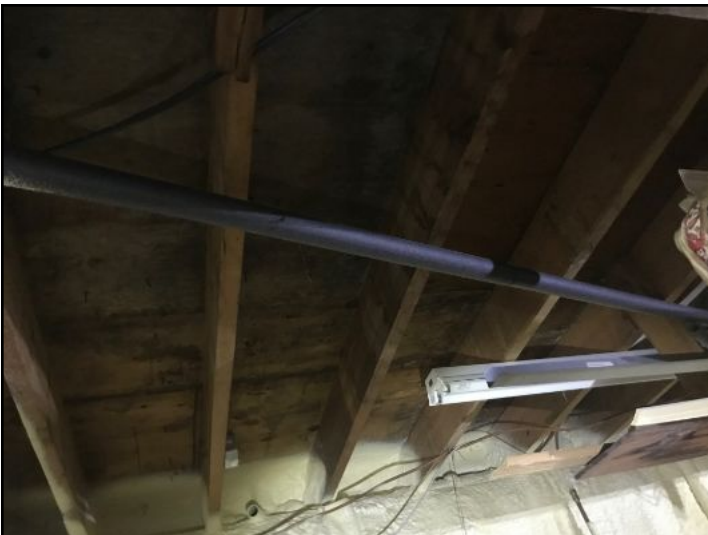
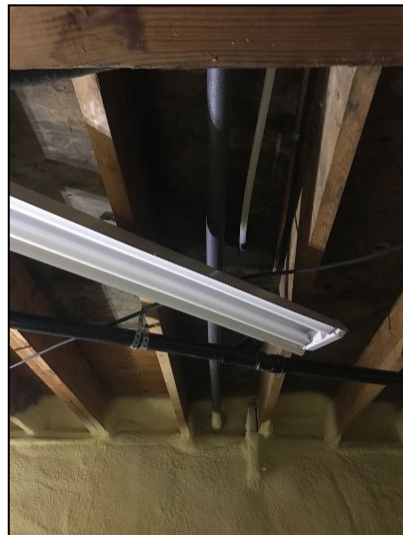
5. Subfloor

- Not fully visible for inspection due to lack of access.
- Sub flooring is partially visible from crawlspace.
- Sub flooring in crawlspace was in working order at time of inspection.

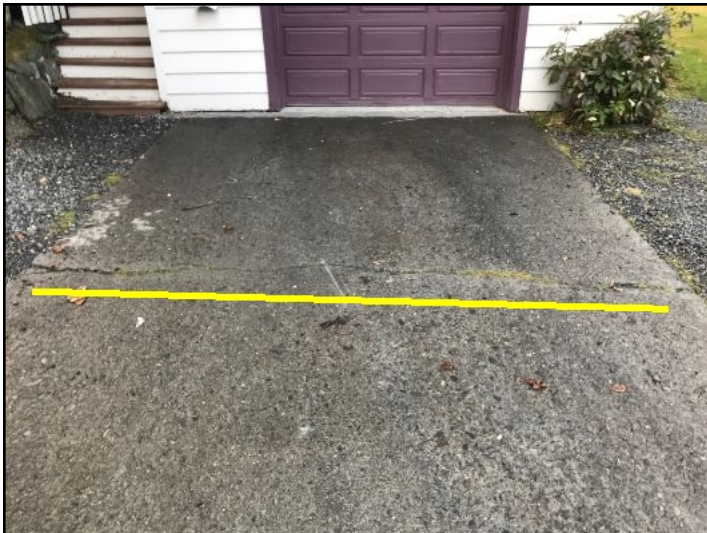
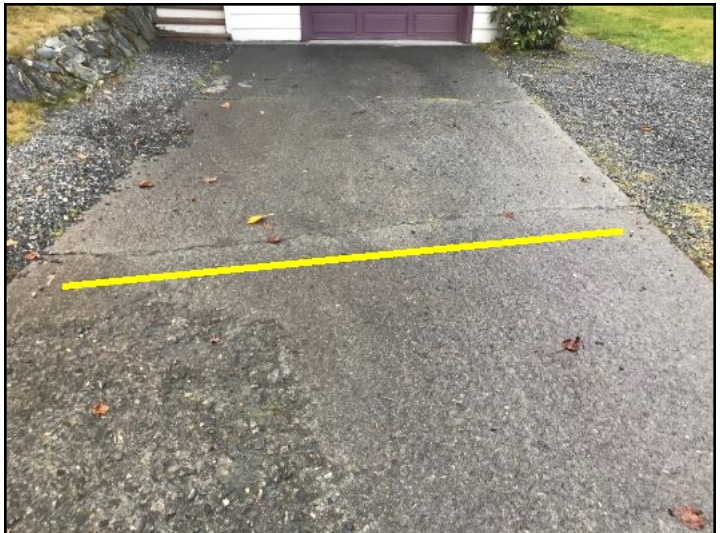
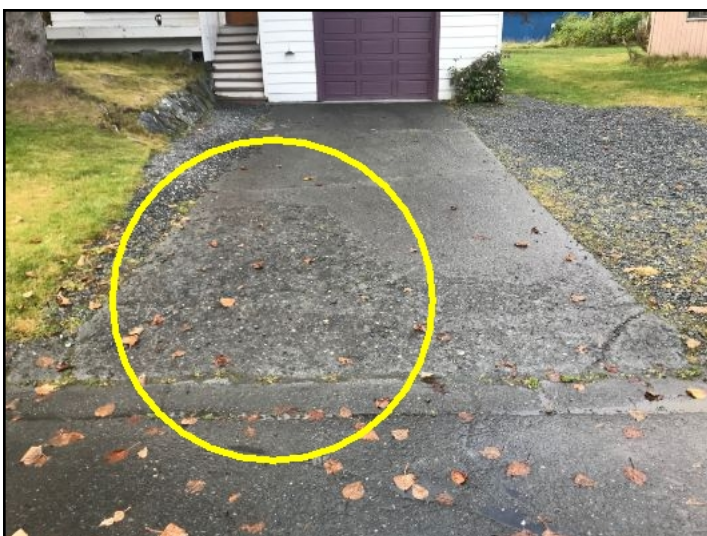
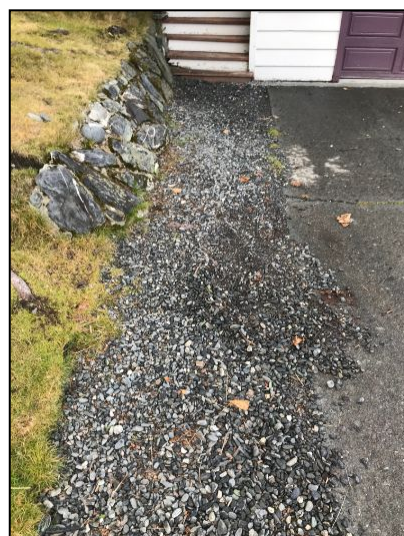
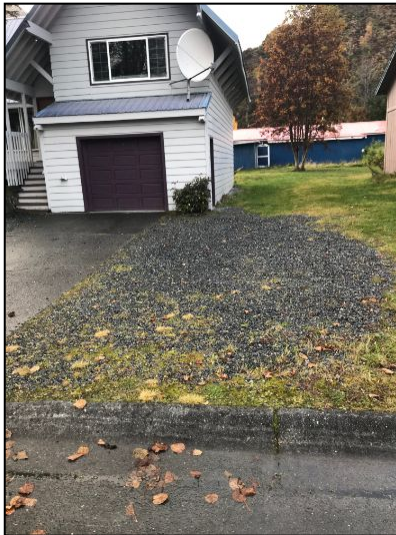
1. Driveway and Walkway Condition

- Driveway in good shape for age and wear. No deficiencies noted.
- **IMPROVE:** Typical cracking was observed at the concrete surfaces. Further deterioration will occur as water expands and contracts from freeze and thaw cycles. Recommend sealing the cracks to prolong the life of the concrete.
- **Monitor:** Surface deterioration observed at the concrete surface.
- Driveway in good shape. Recommend sealing to extend life.
- Concrete spalling noted at driveway. This loosening of the top, smooth layer of the cement is a common occurrence, possibly due to an improper curing process, age, or use of snow-melting materials.

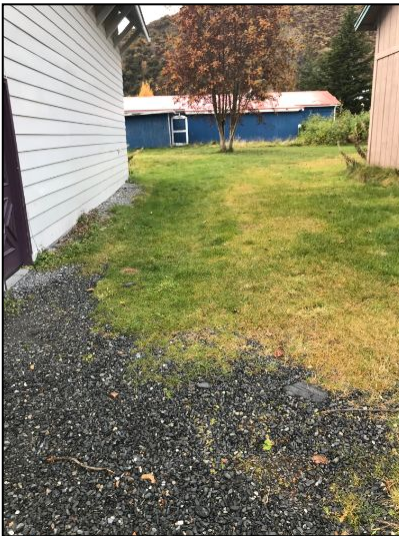
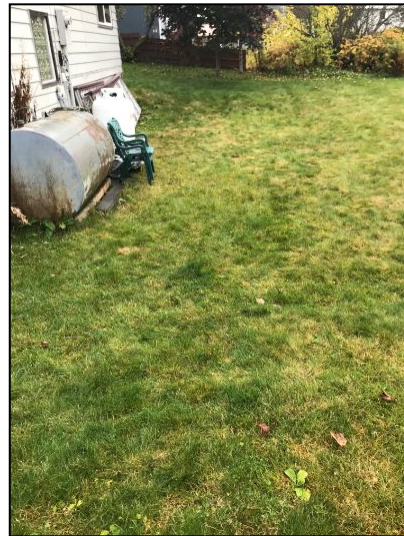
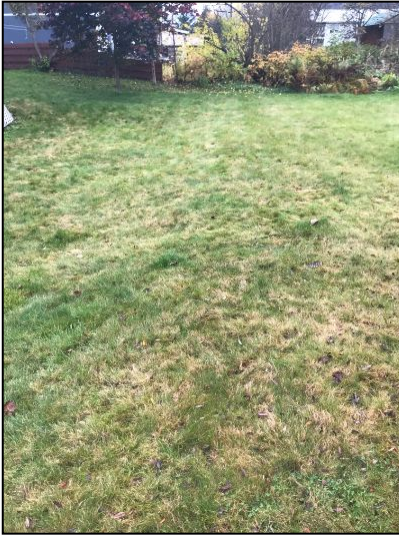
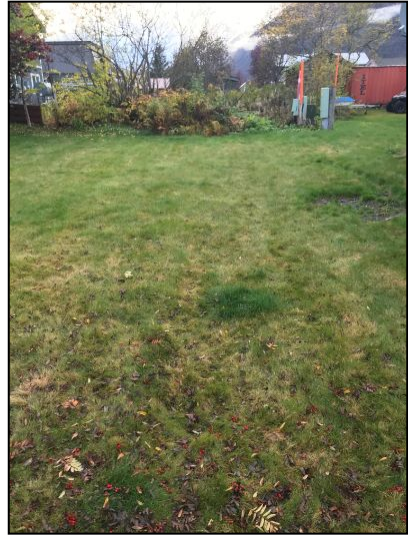
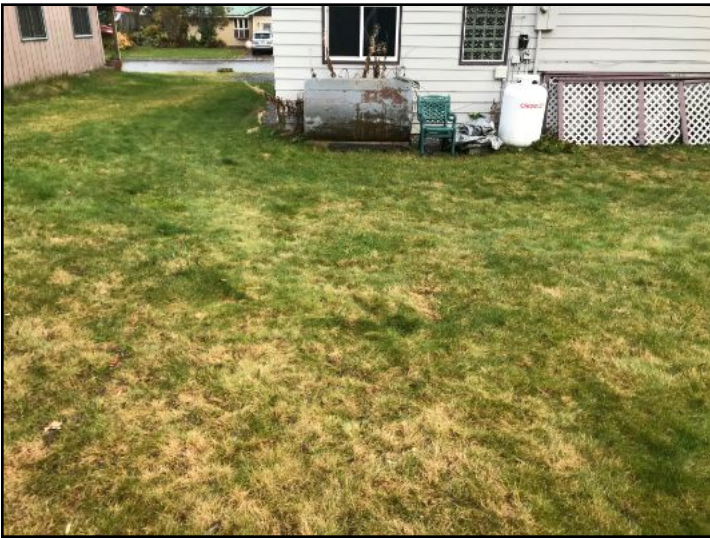
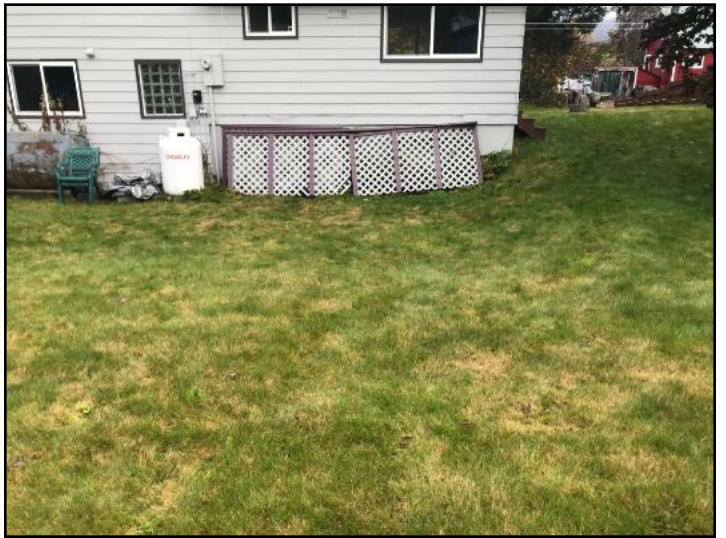
2. Grading

- No major system safety or function concerns noted at time of inspection.
- Lot grading and drainage have a significant impact on the building, simply because of the direct and indirect damage that moisture can have on the foundation. It is very important, therefore, that surface runoff water be adequately diverted away from the home.
- The exterior drainage is generally away from foundation -- except where noted below.

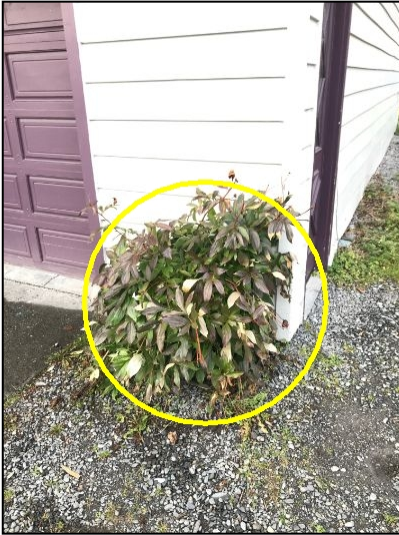
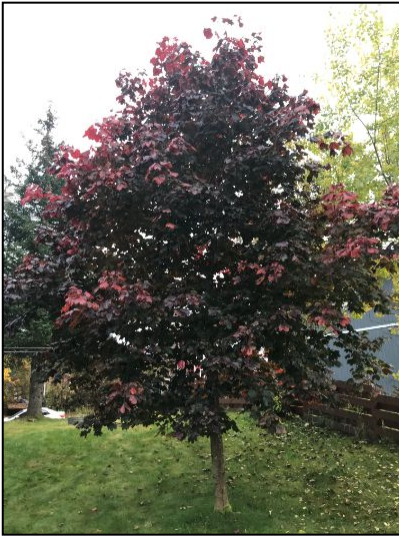
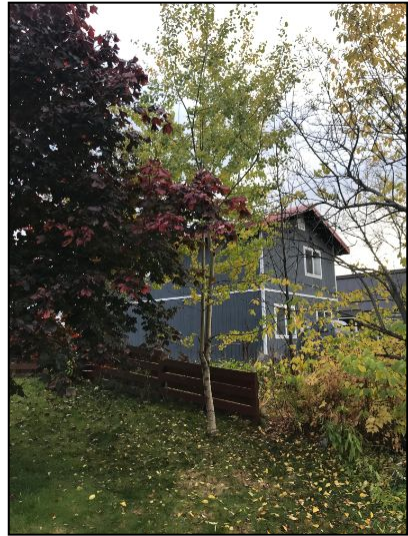
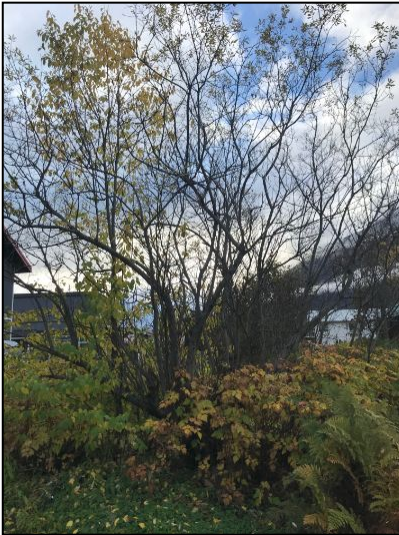
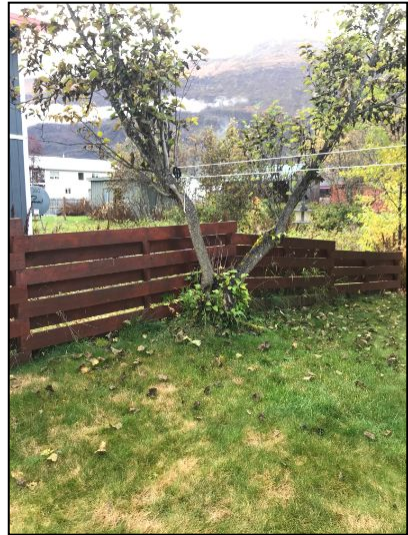
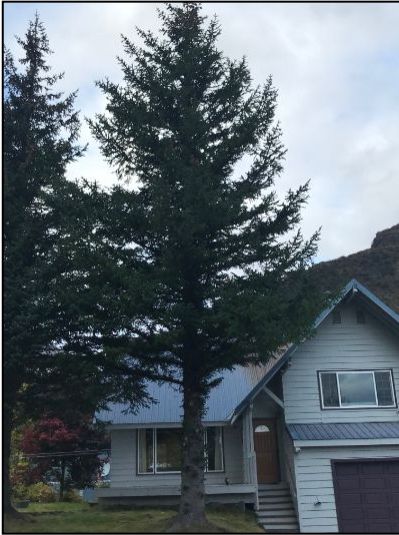
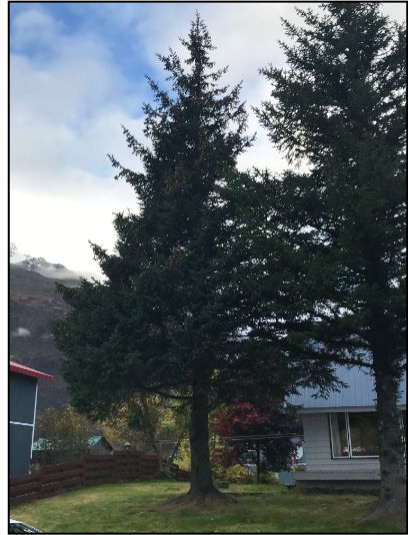
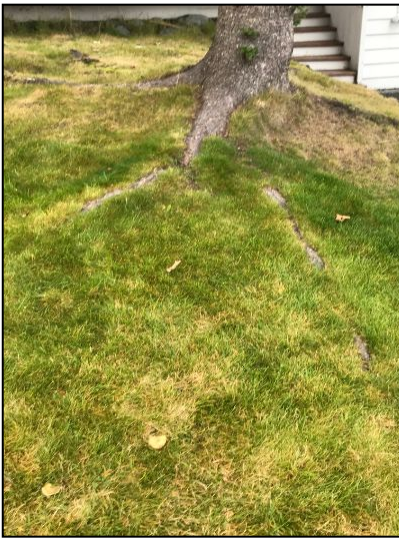
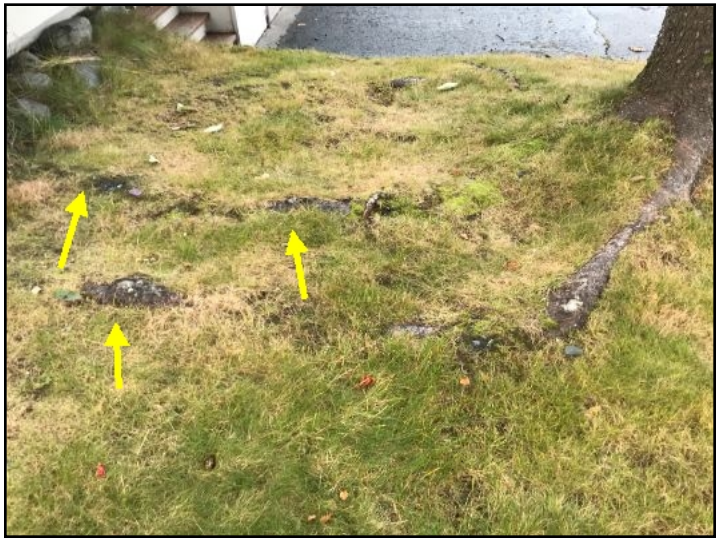
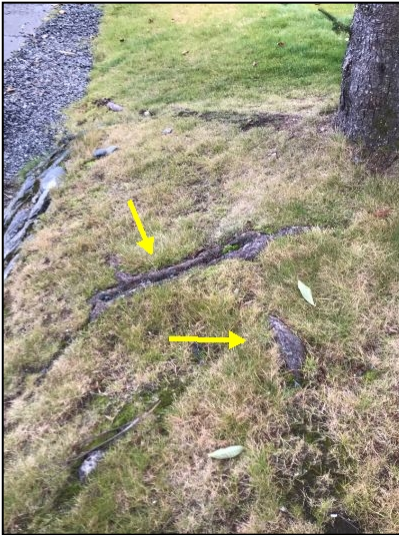
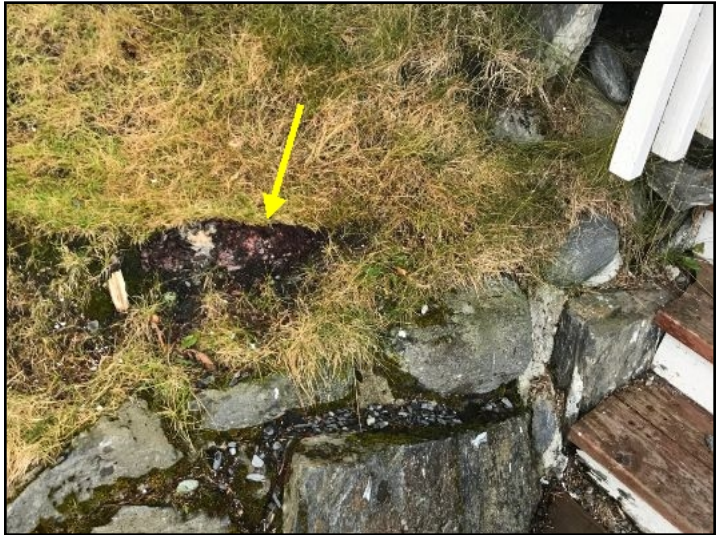
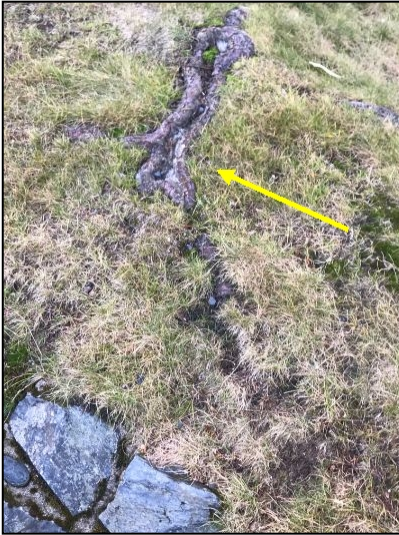
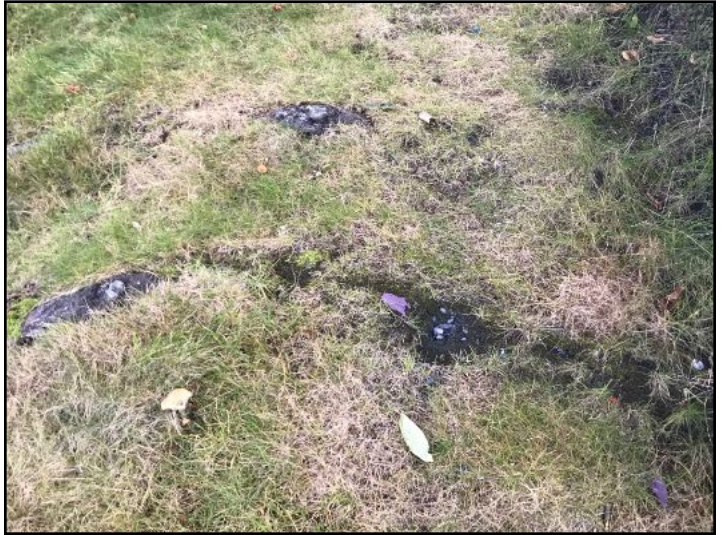
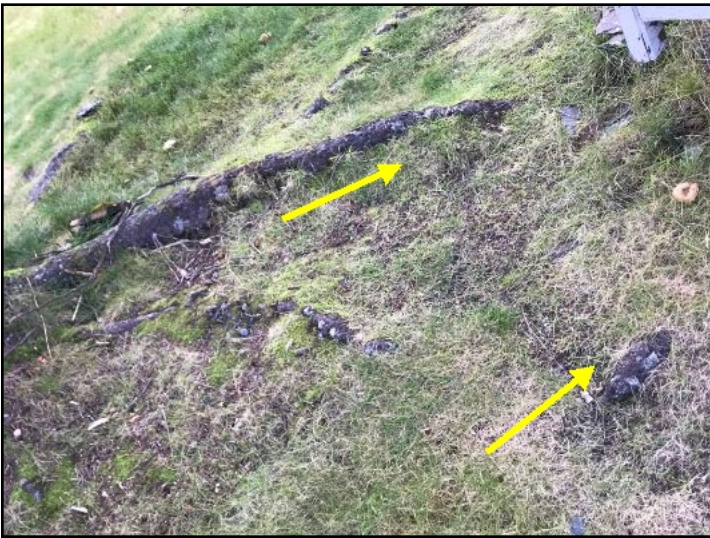
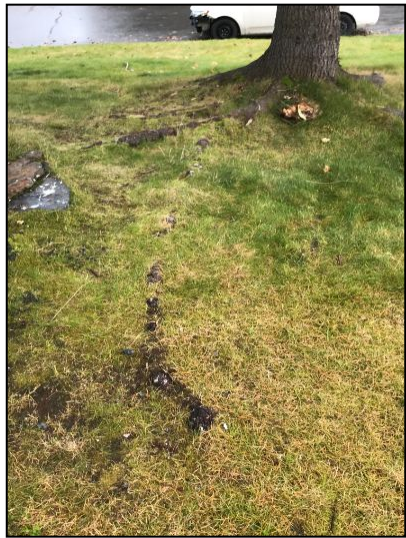
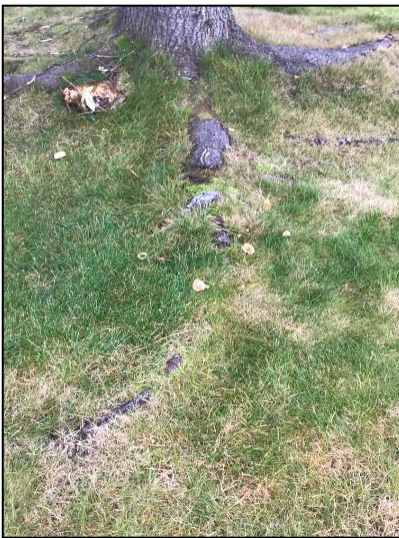
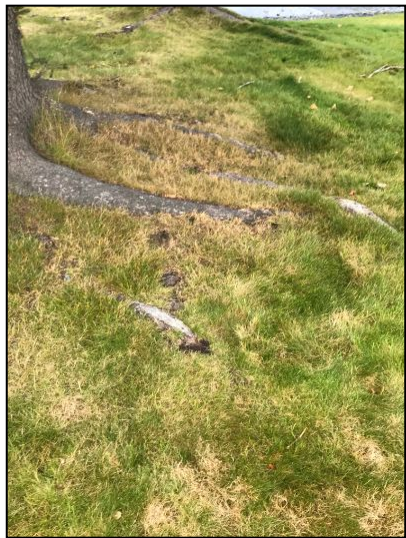
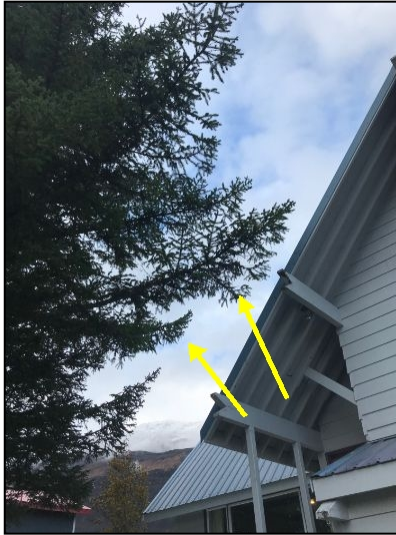
- Shrub in the front of the garage can be trimmed and pruned to not be so close to the siding of the house.
- There is two large trees in close proximity to the house. The roots may cause problems with any underground plumbing and the roots reach out to the foundation of the house. They pose a trip hazard in the yard.

- Trees also covers a good part of the house during the day. No sunlight can help dry anything that is covered by the shadow of the trees.

- Tree limbs within 10 feet of roof should be trimmed away to provide air and sunlight to roof, while minimizing debris & dampness.
- Maintenance Tip: When landscaping, keep plants, even at full growth, at least a foot (preferably 18 inches) from house siding and windows. Keep trees away from foundation and roof. Plants in contact or proximity to home can provide pathways for wood destroying insects, as well as abrade and damage siding, screens and roofs.
