Arctic Home Inspections

Property Inspection Report

Inspection prepared for:
Date of Inspection: 2/22/2022

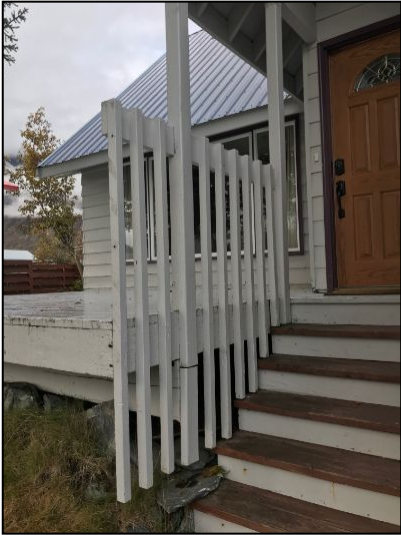
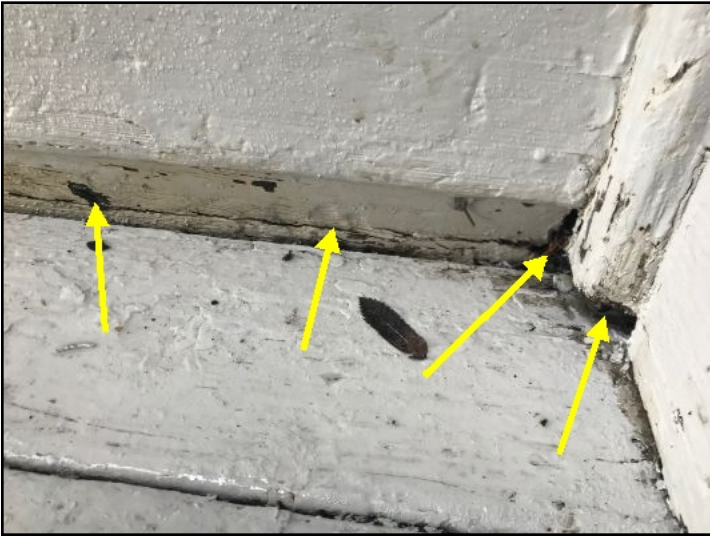
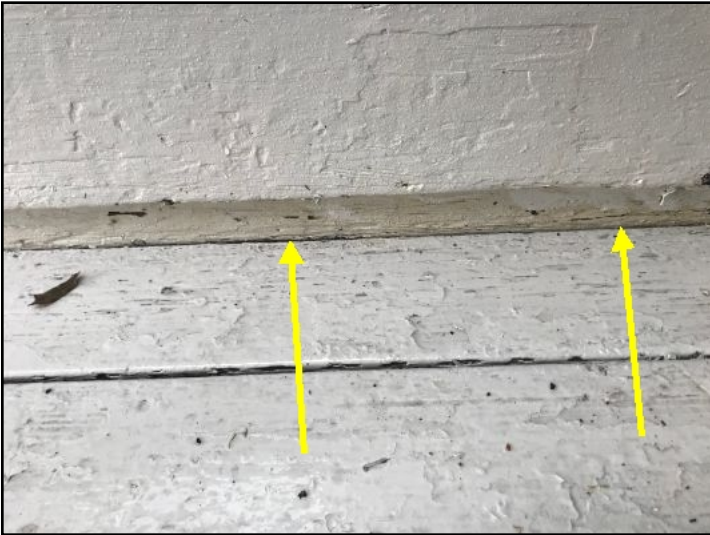
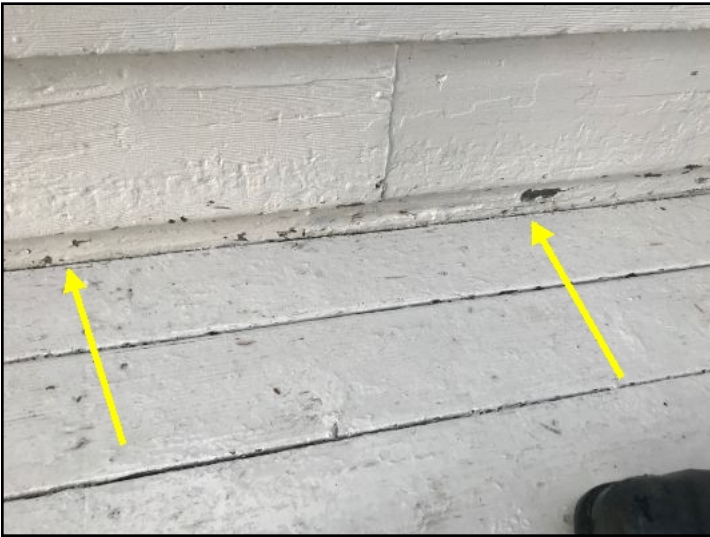
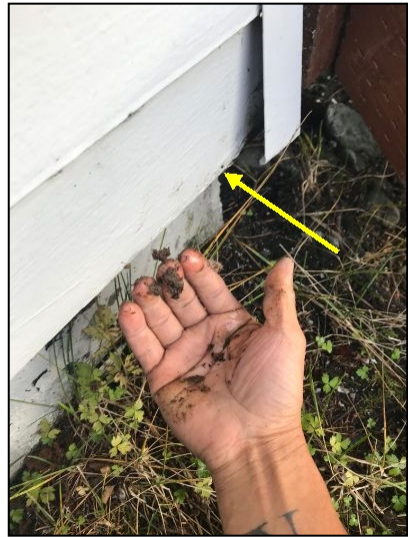
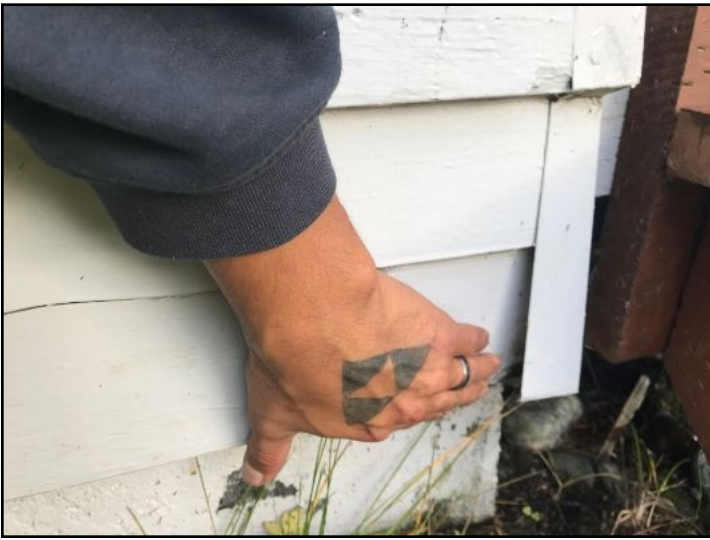
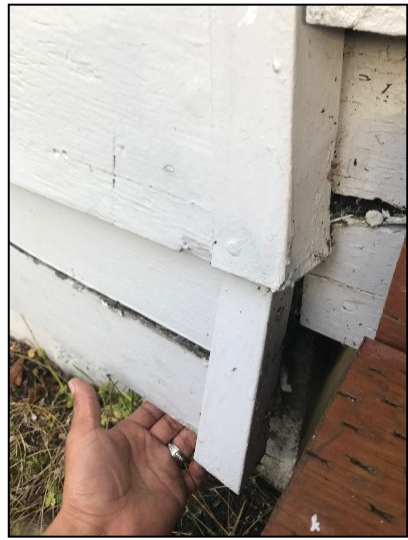
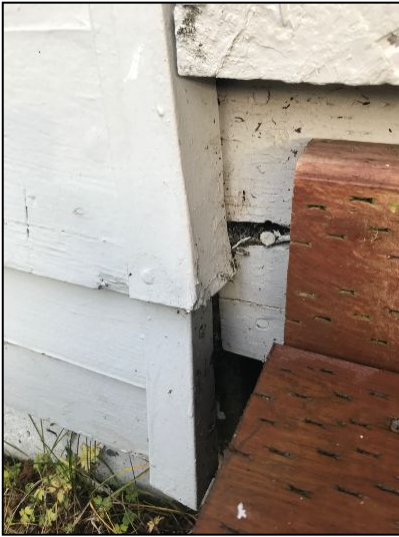
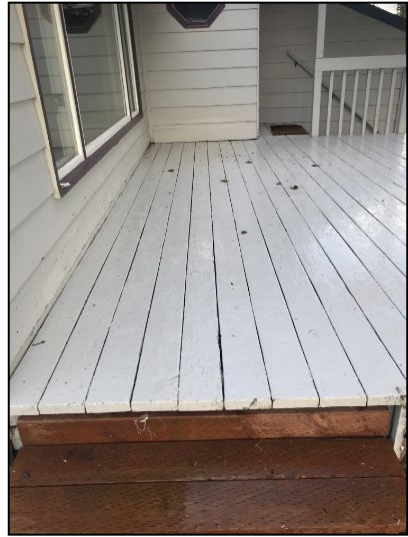
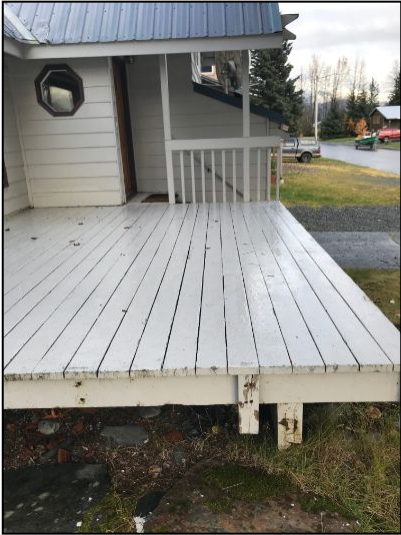
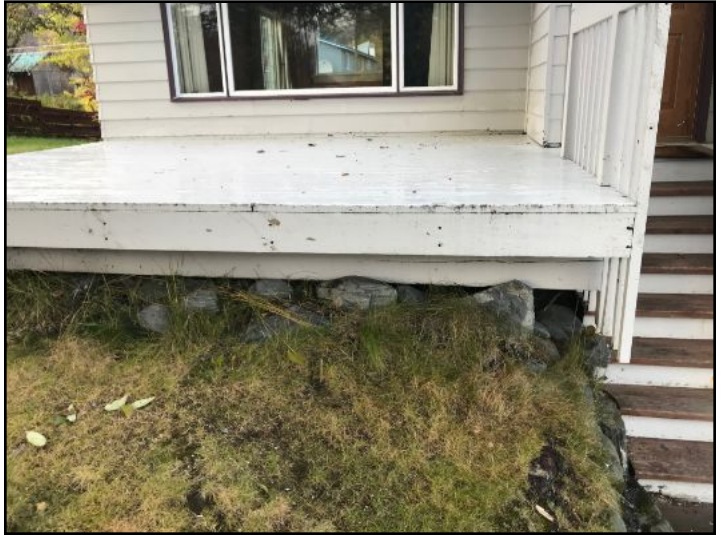
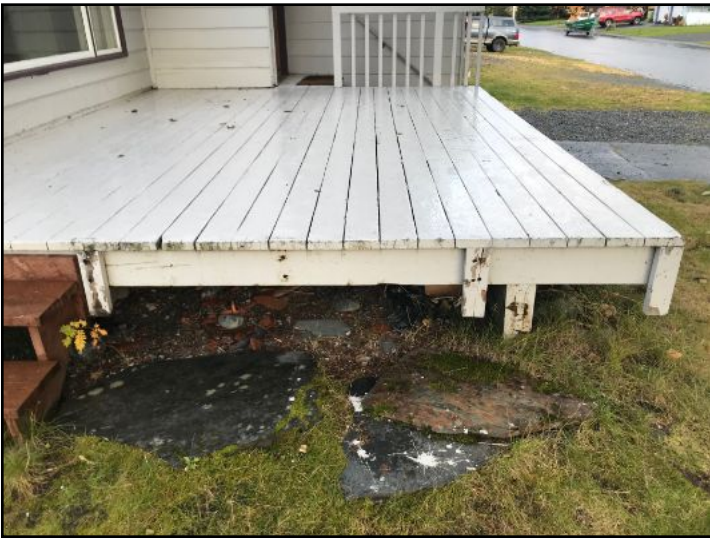
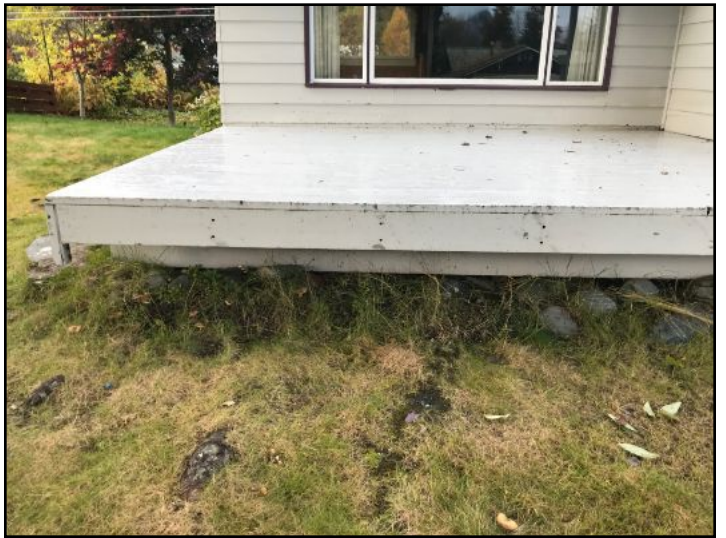
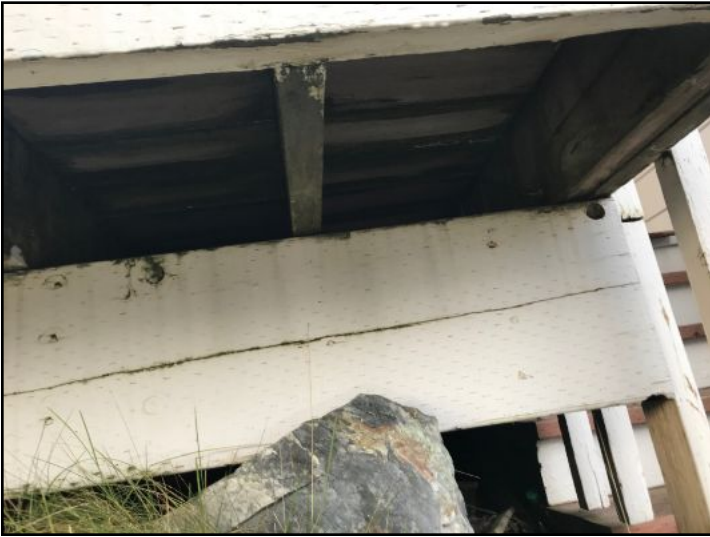
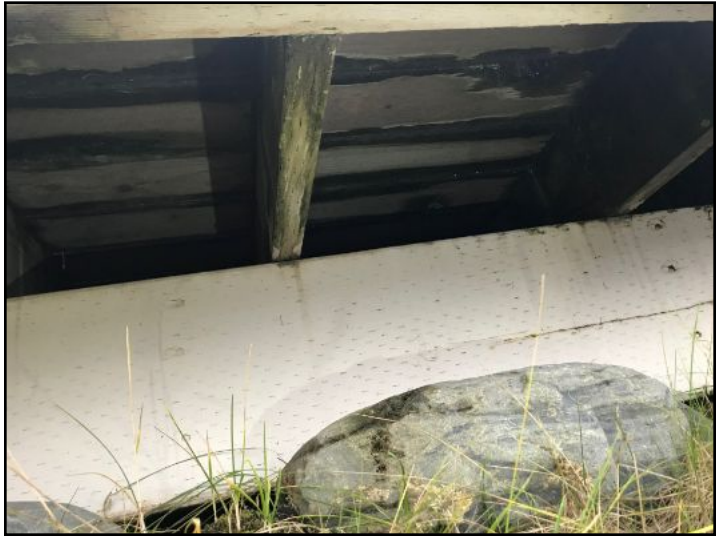
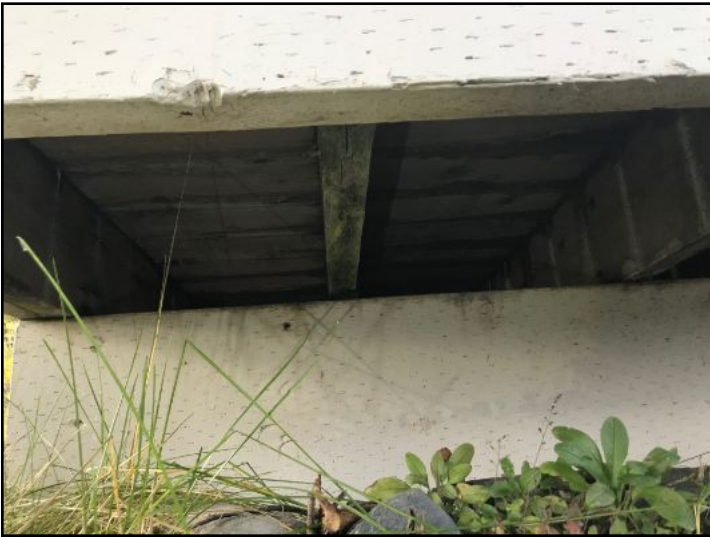
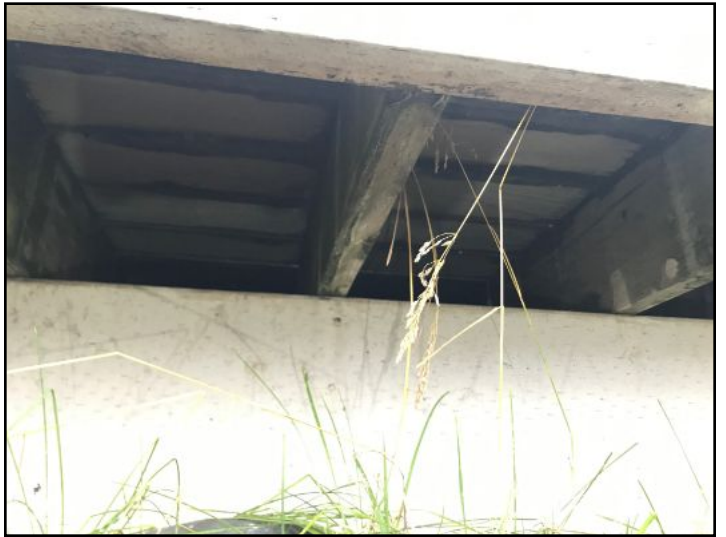
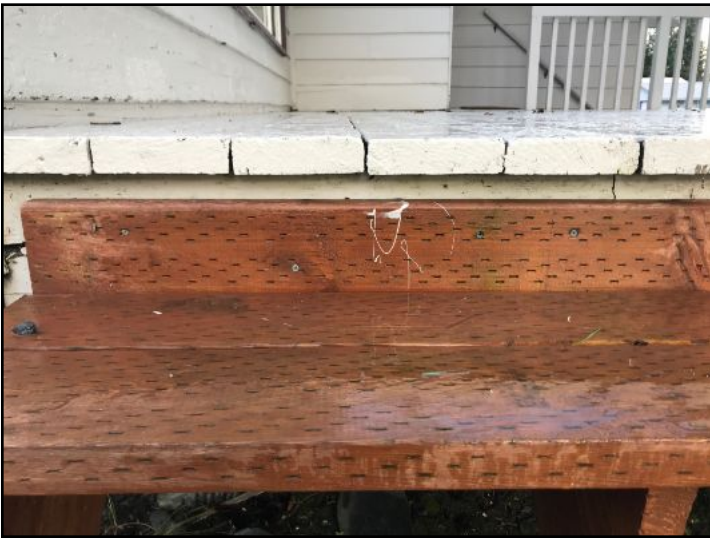
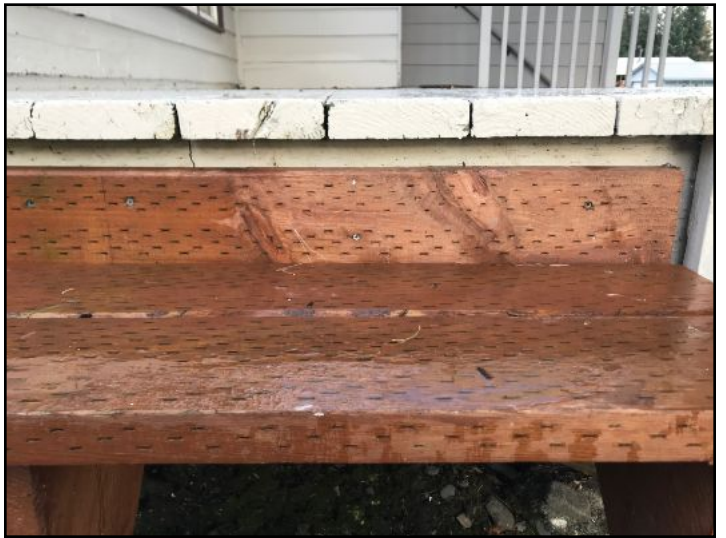
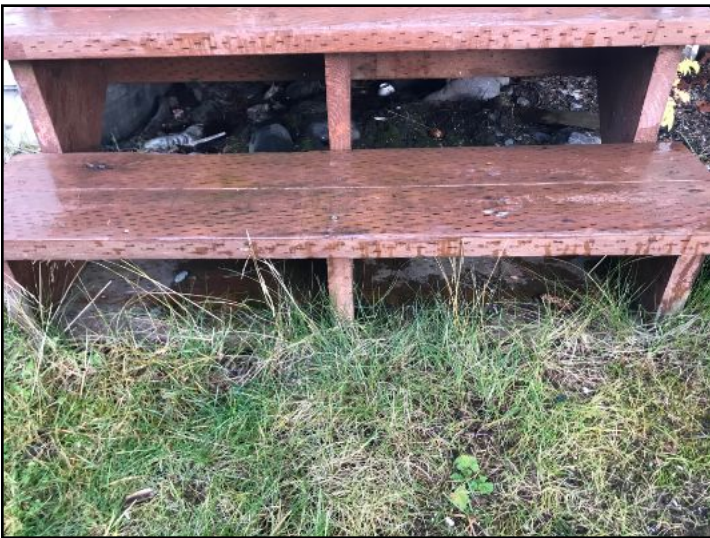
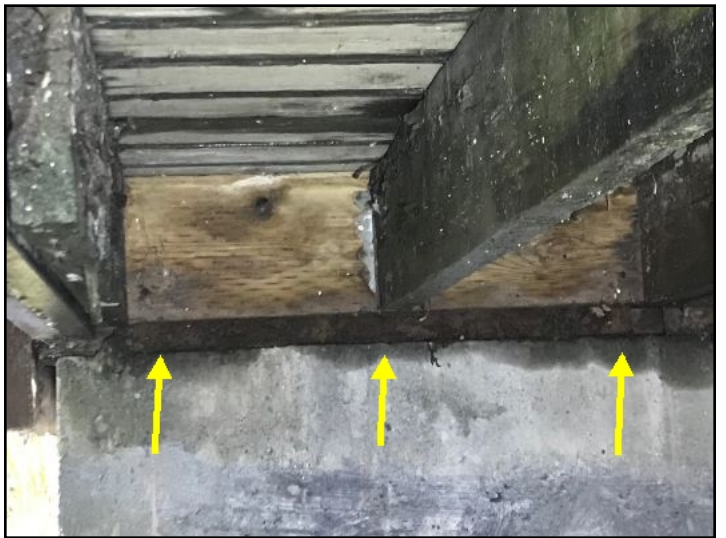
4. Patio and Porch Deck

- There is moisture intrusion in the house siding where the deck meets the home from rain not being directed away from the home. Seasonal rain gutters will help with directing any rain from the deck and home. Flashing will also help to divert any rain from the house and deck.

- Guard rails were stored away for the coming winter, and I was not able to inspect them at time of inspection.
- **No flashing present.**
- **There is moisture intrusion in the house siding where the deck meets the home from rain not being directed away from the home. Seasonal rain gutters will help with directing any rain from the deck and home. Flashing will also help to divert any rain from the house and deck.**

- **The trees in the front yard cover any sunlight during the day that would help to dry the deck.**

- **Clean and Seal Deck:** Recommend cleaning deck and treating with a waterproof sealant claiming to waterproof, block ultraviolet light, and stop mildew.

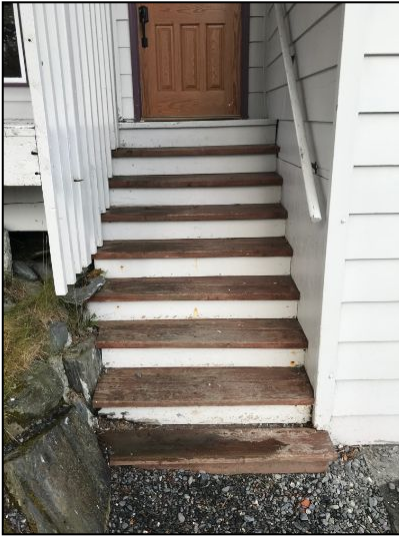
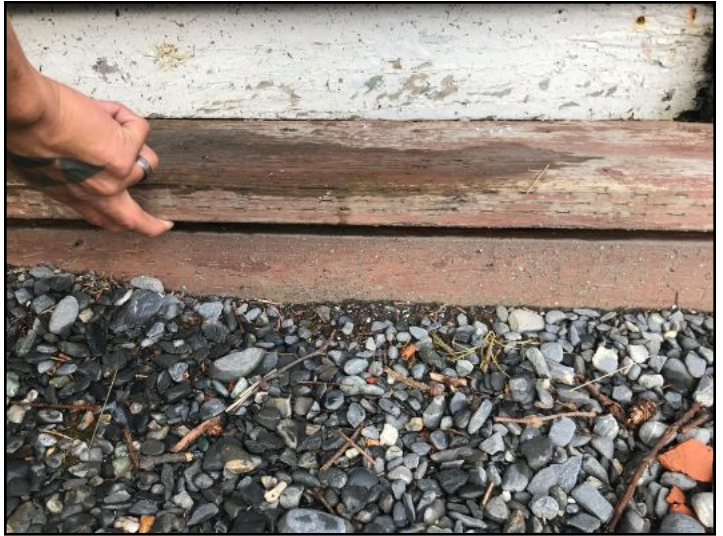
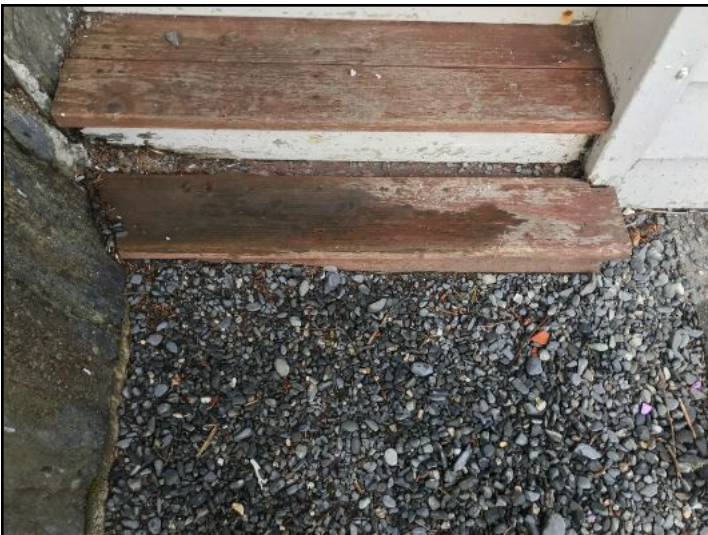
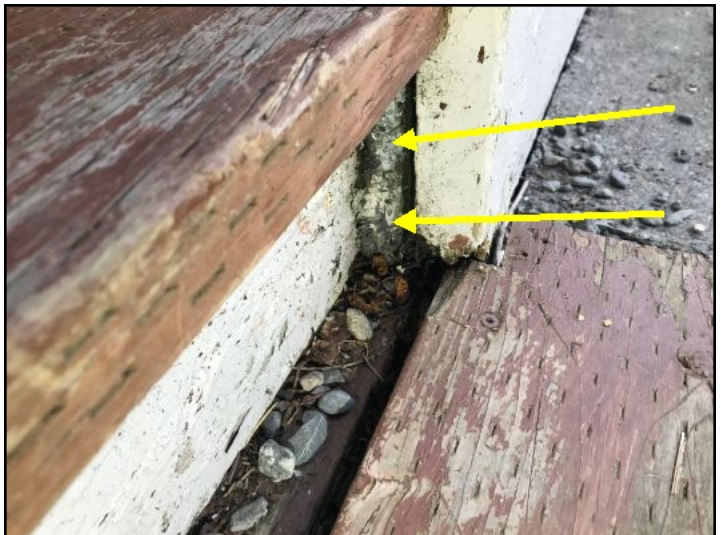
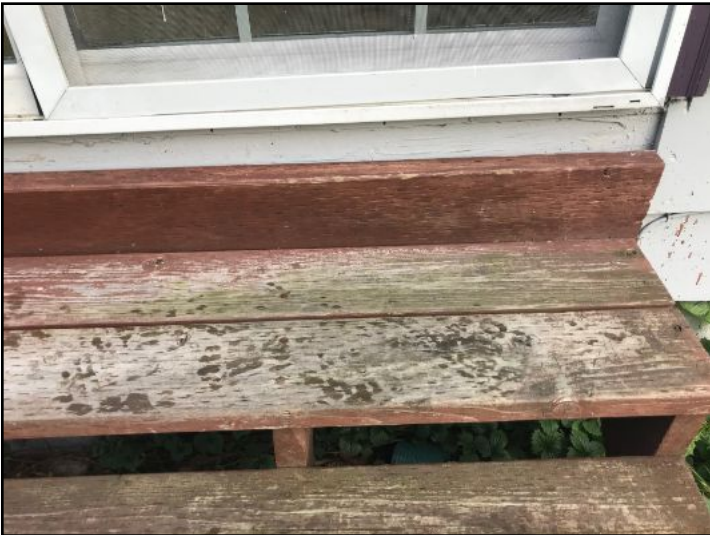
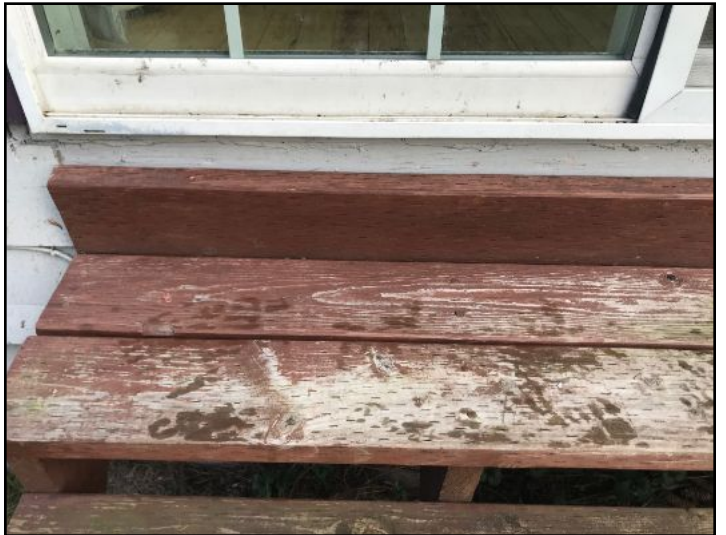
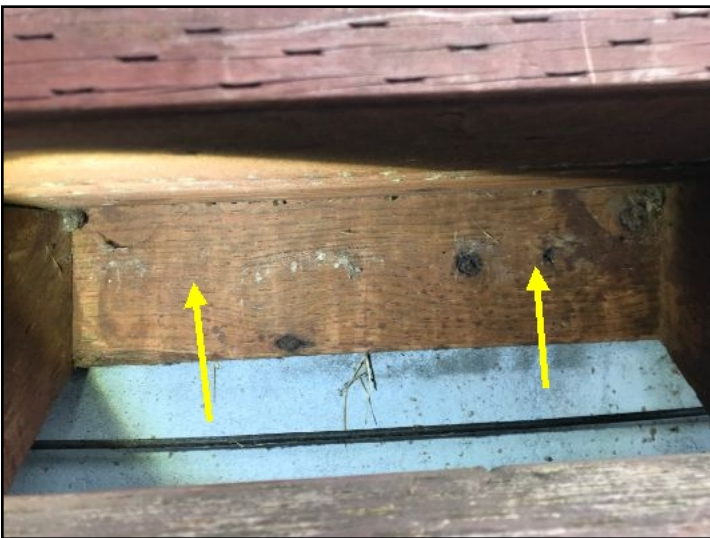
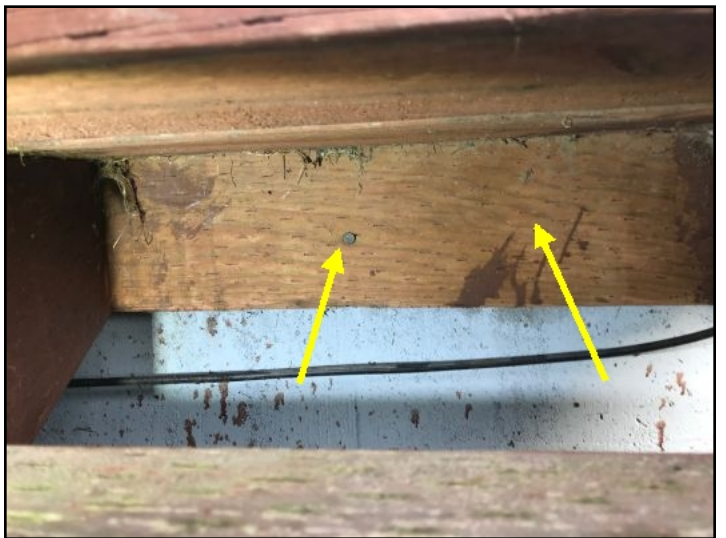
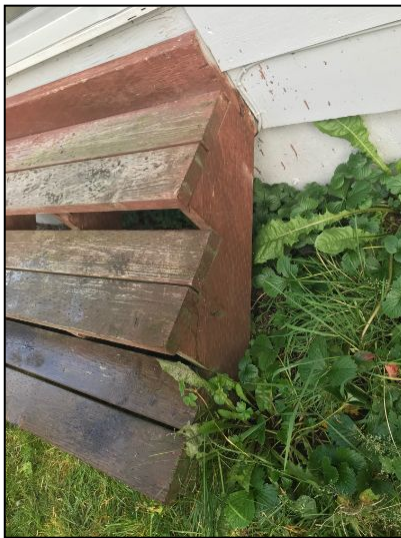
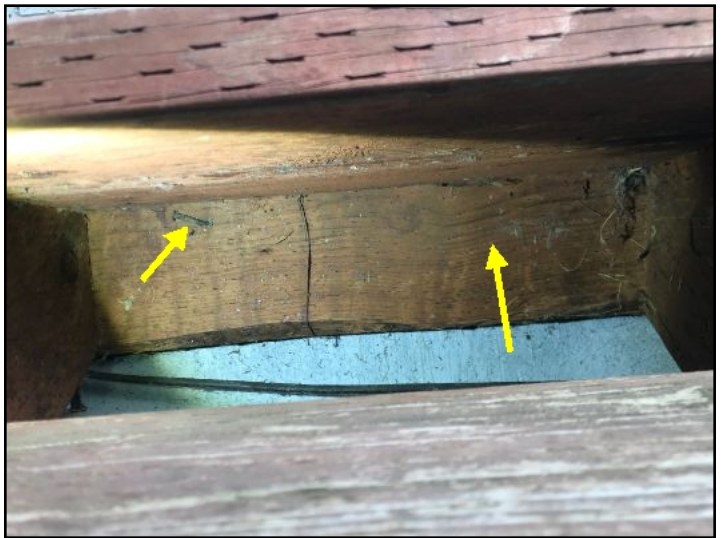
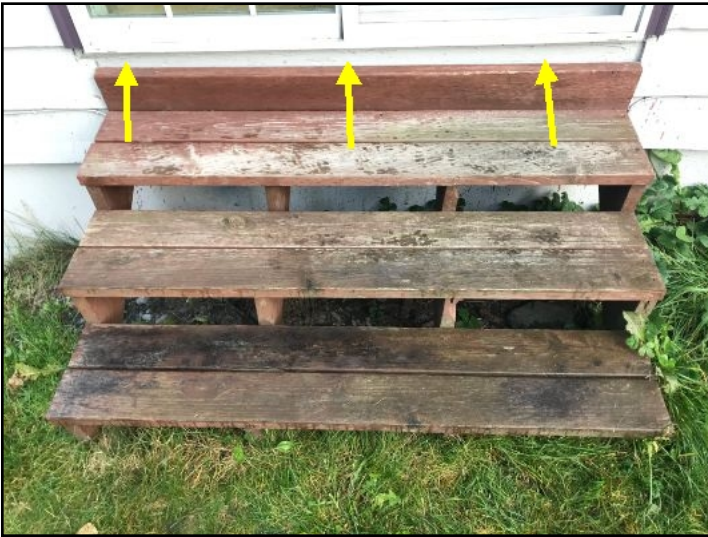
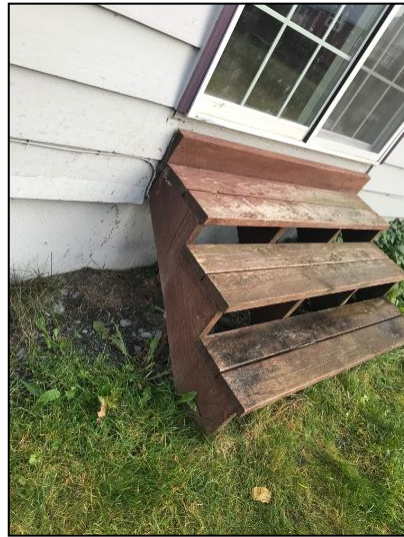
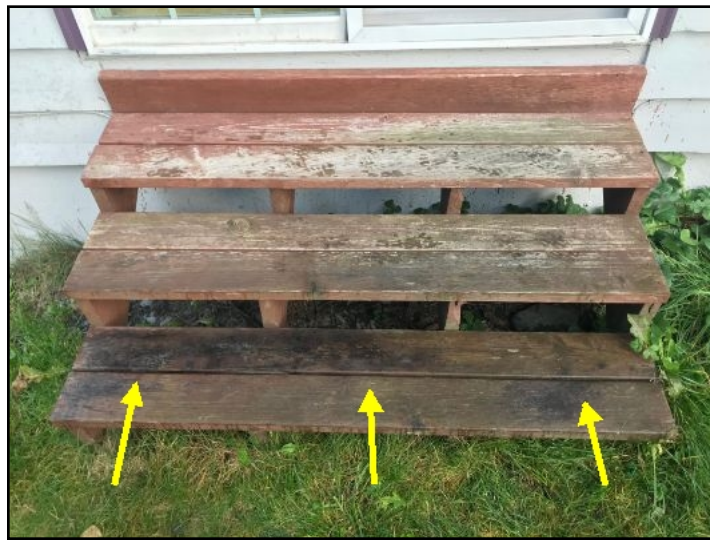
5. Stairs & Handrail

- Appeared functional at time of inspection.
 - Although railings are not required with drop-offs less than 30" above grade - consider your own personal needs and those of your family and guests. By today's standards, balusters (spindles) at decks and steps should be spaced no more than 4" apart for the safety of small children,
 - First step in the staircase to the house is in need of repair or replace.
 - There appears to be water intrusion where the staircase meets the garage.
 - Stairs for the patio door is only secured to the house with nails.
- Recommend better anchoring of the stairs to the house and flashing to divert any rain away from the house.
- The last step on the patio door stairs is in need of cleaning to prevent any slipping hazards.

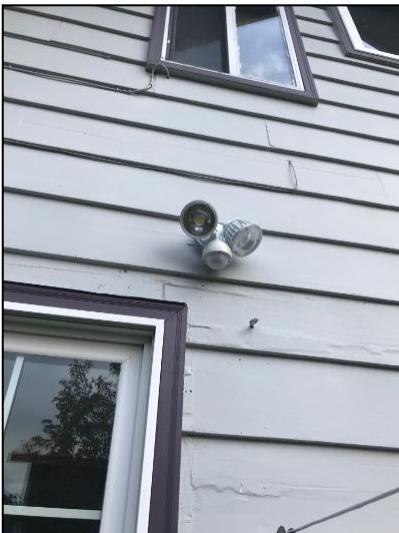
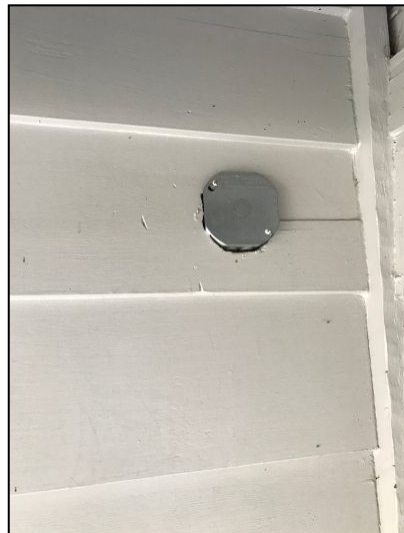
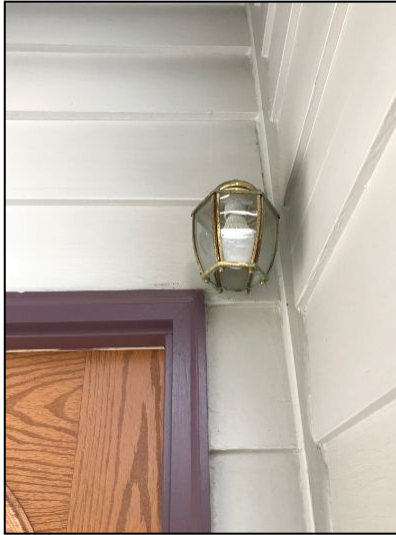
6. Grounds Electrical

- No major system safety or function concerns noted at time of inspection.

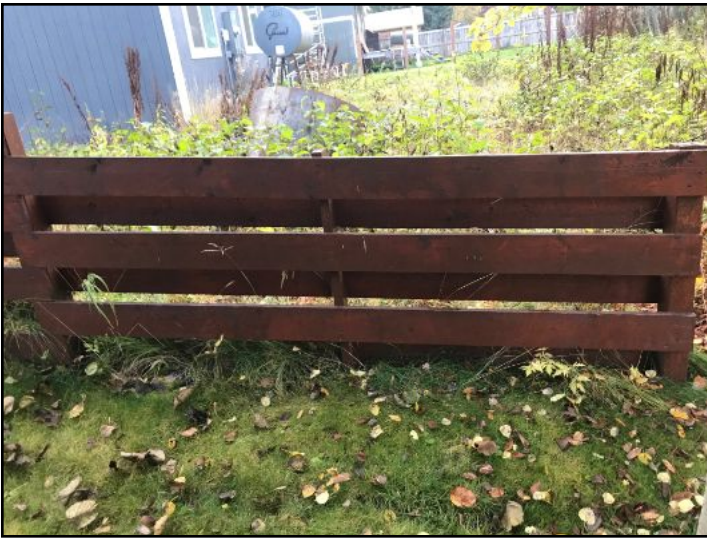
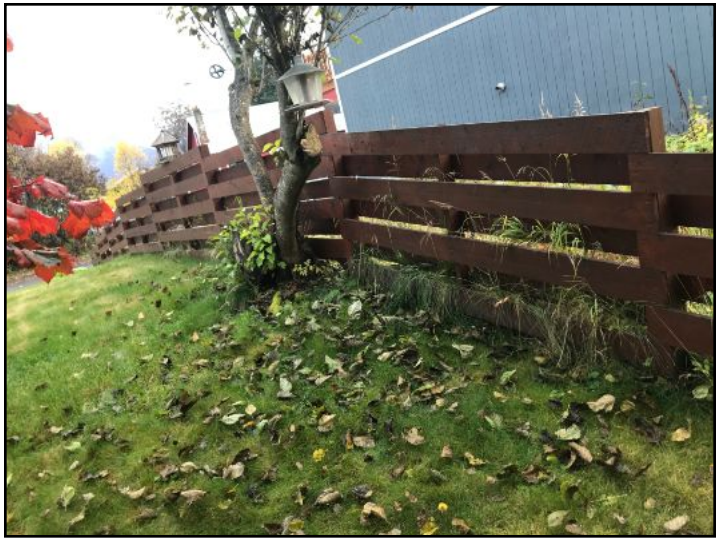
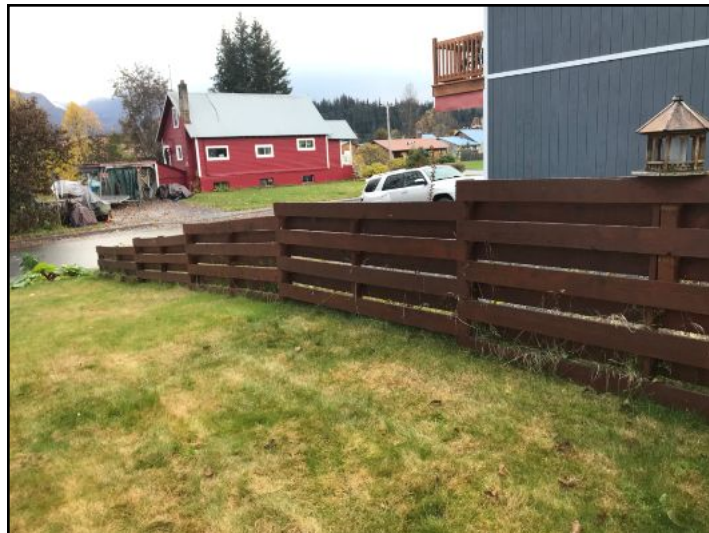
7. Fence Condition

- Appeared serviceable at time of inspection. Structural assembly inaccessible.

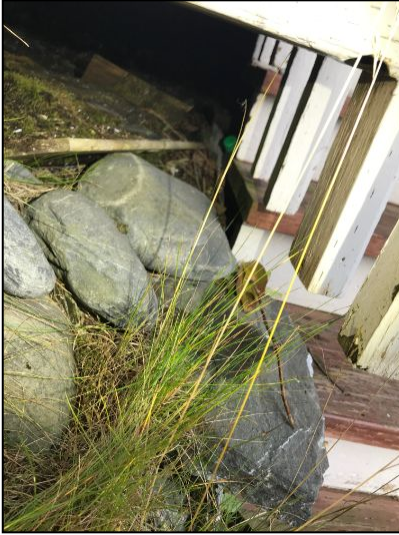
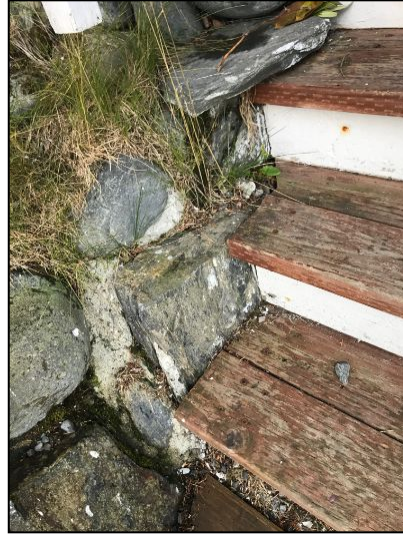
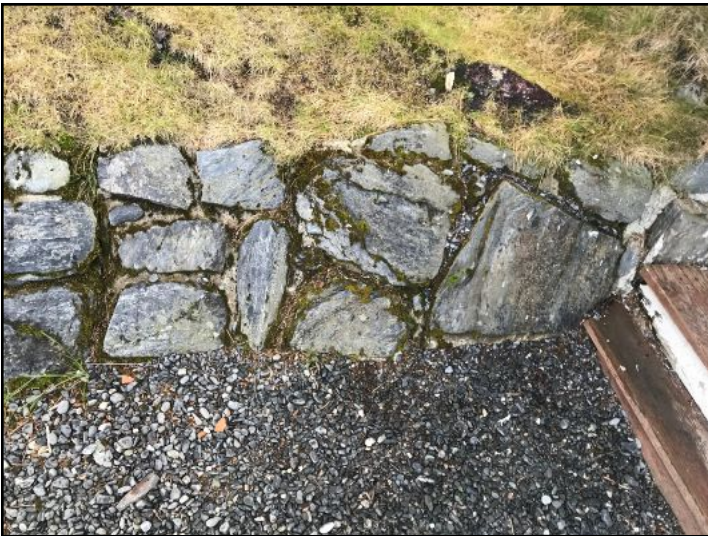
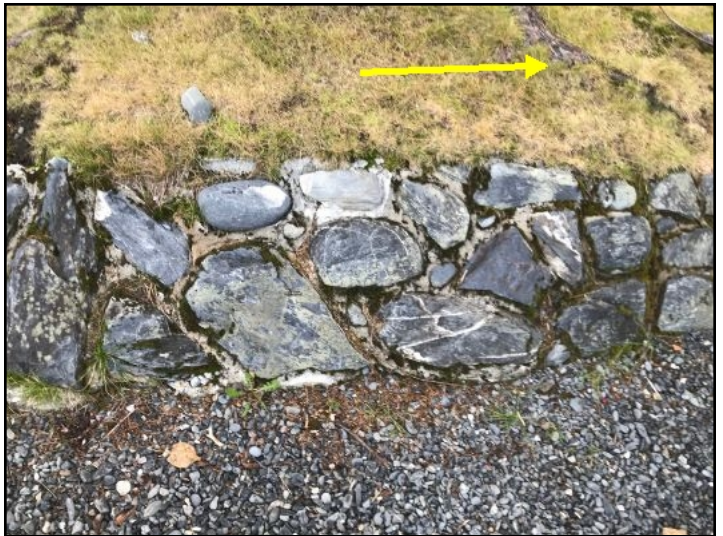
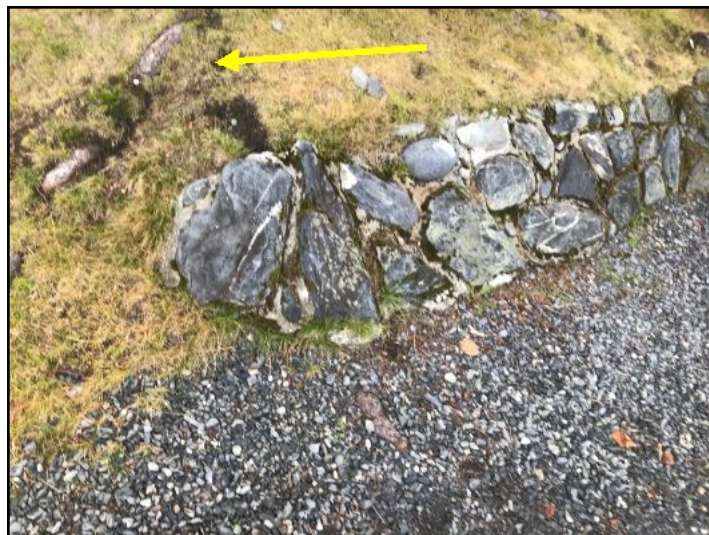
8. Stone Retaining Wall

- Retaining wall next to gravel side walk was in serviceable condition and no defects were found at time of inspection.
- Tree roots may impact the mortar of the retaining wall and weaken the wall.

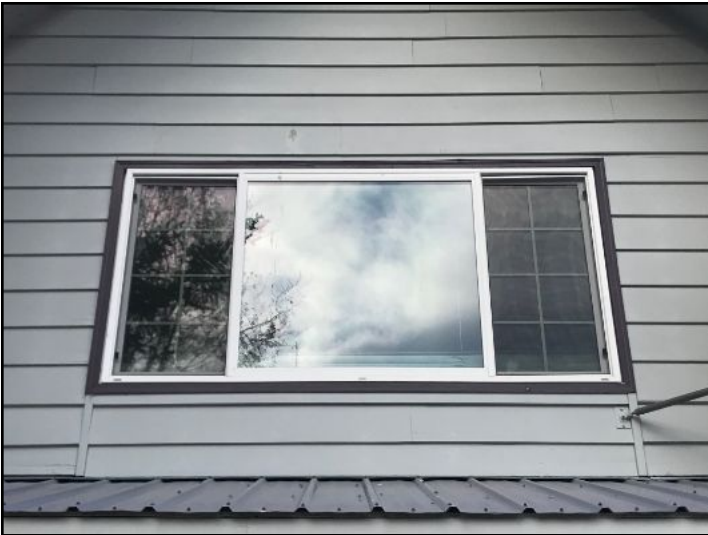
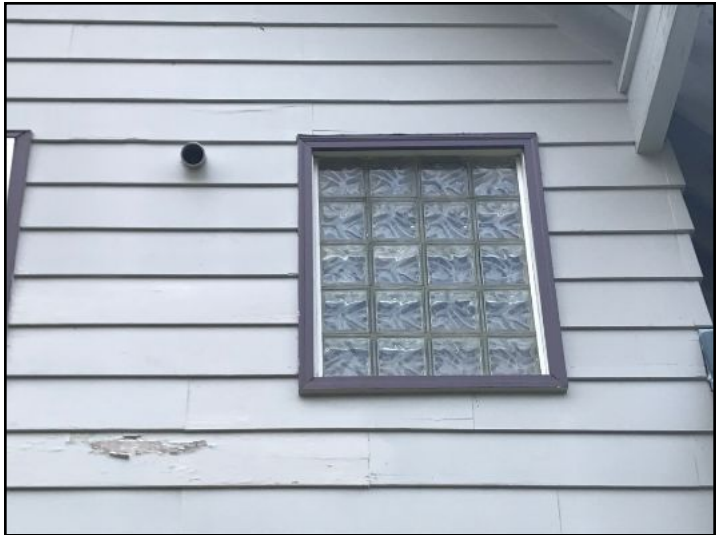
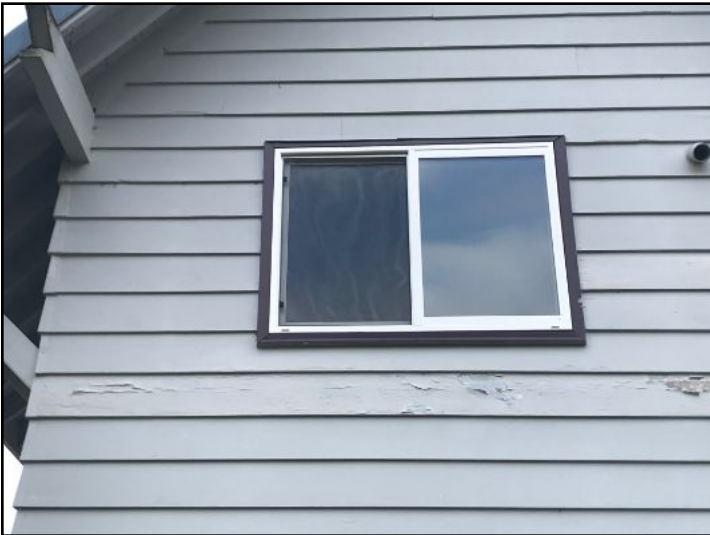
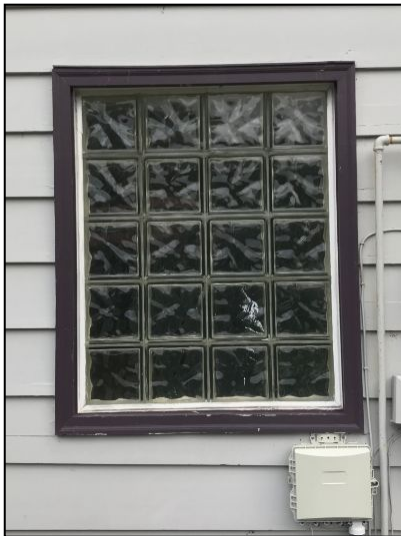
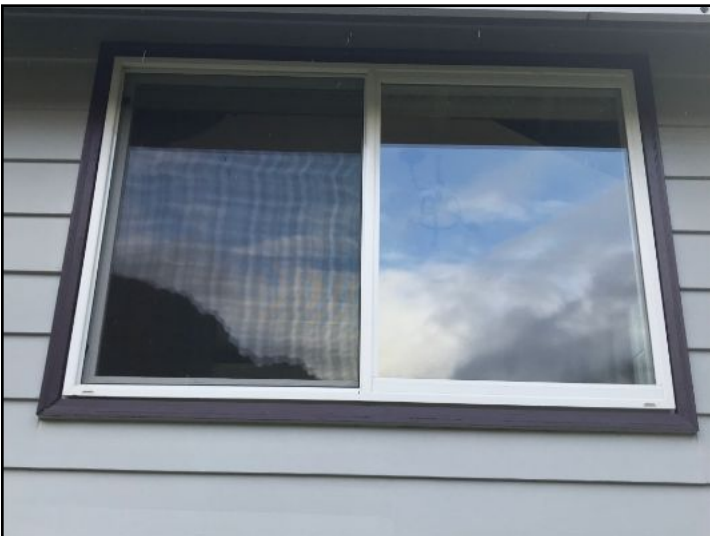
2. Window Condition

- Components appeared in satisfactory condition at time of inspection.
- No major system safety or function concerns noted at time of inspection.
- Some window screens missing. Check with seller to determine if they are on the property.
- Basement windows are overgrown with vegetation. This is not letting the window sill to dry properly and causing damage to the window sill.
- South facing window on the patio deck is showing signs of water damage shown in the pictures.

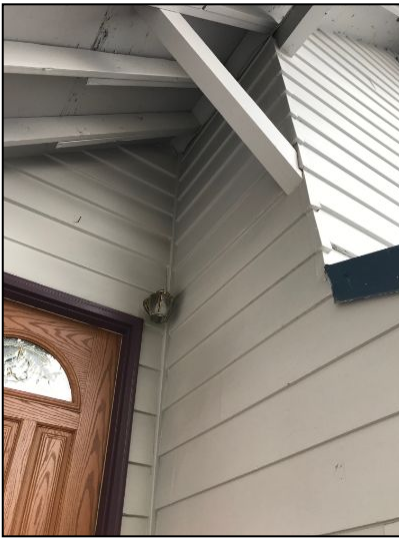
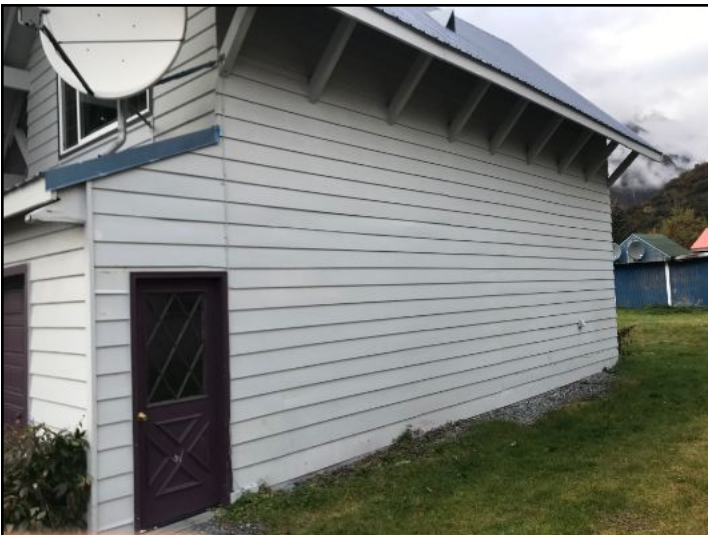
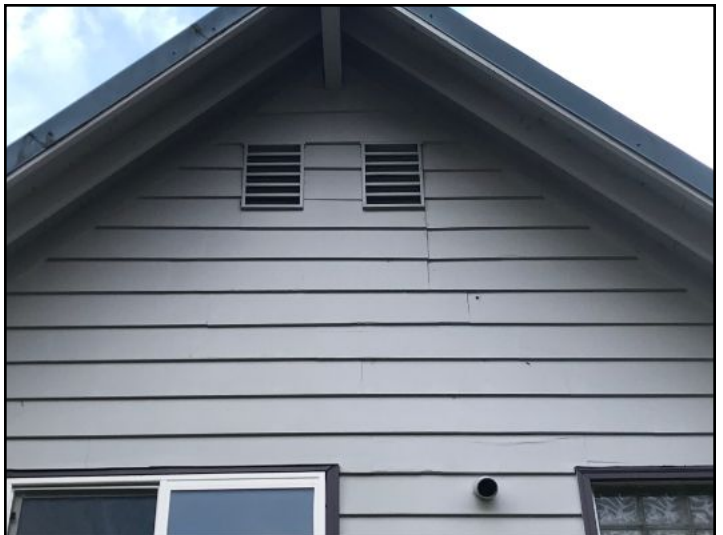
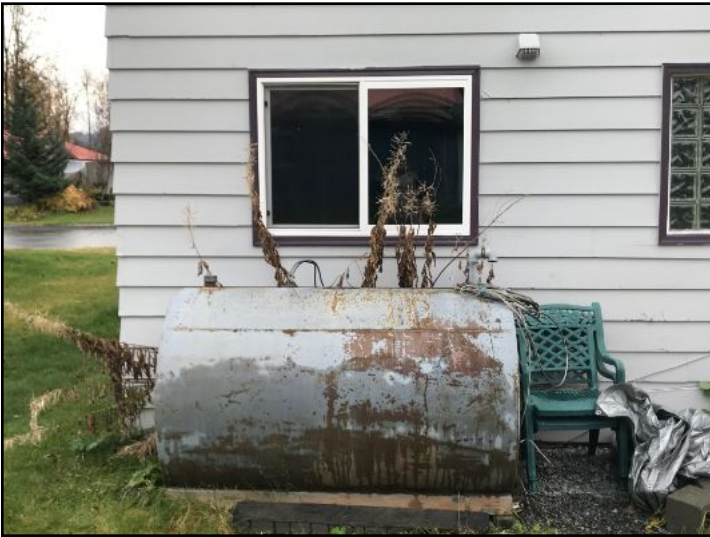
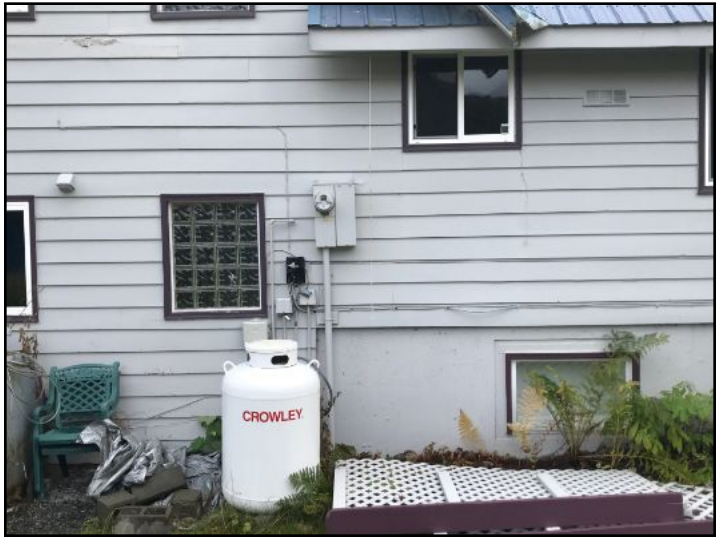
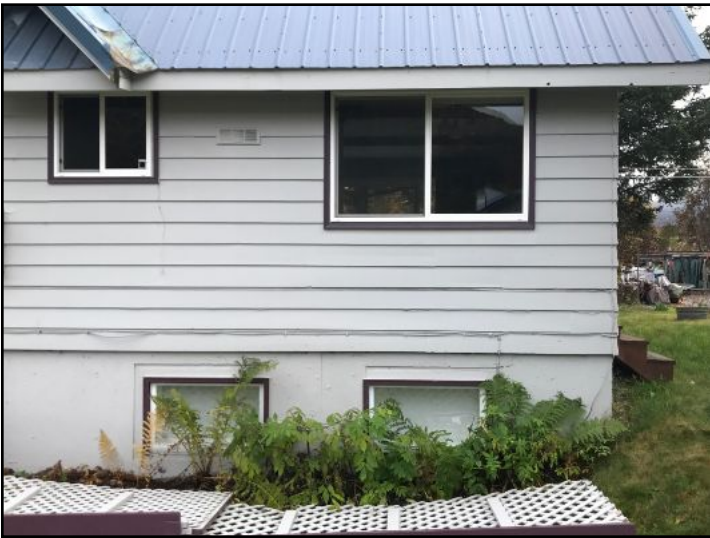
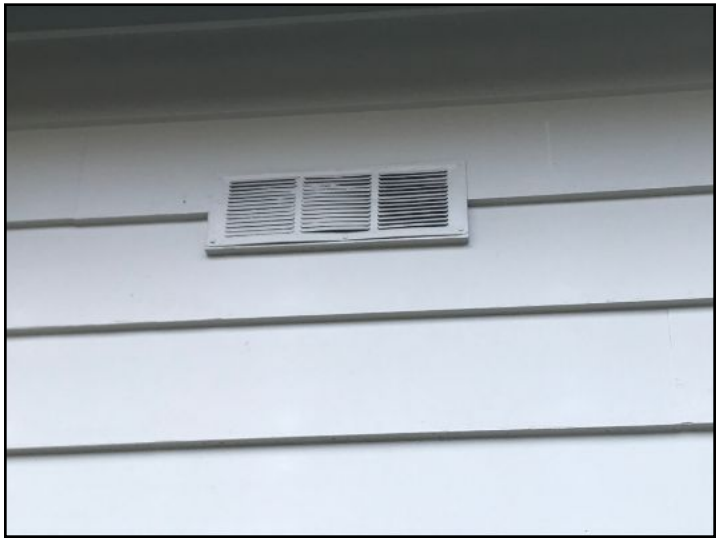
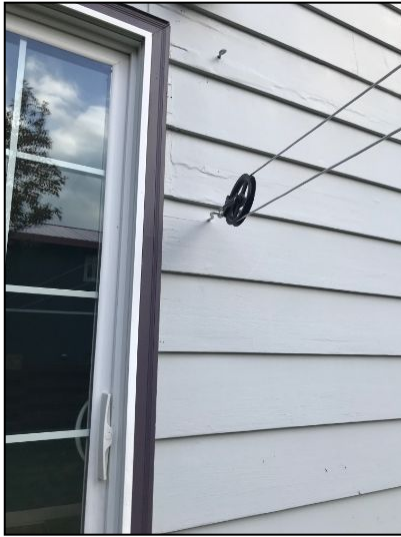
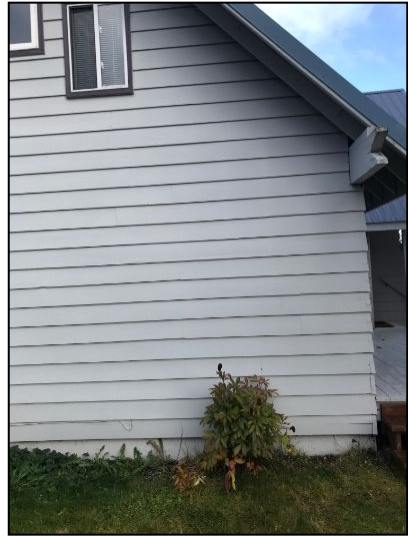
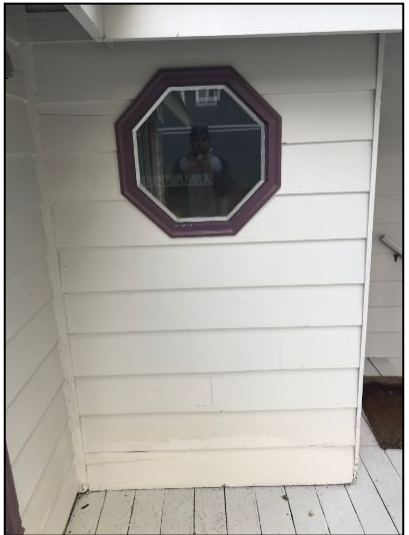
3. Siding Condition

- No major system safety or function concerns noted at time of inspection.
- Some areas need priming and repainting.

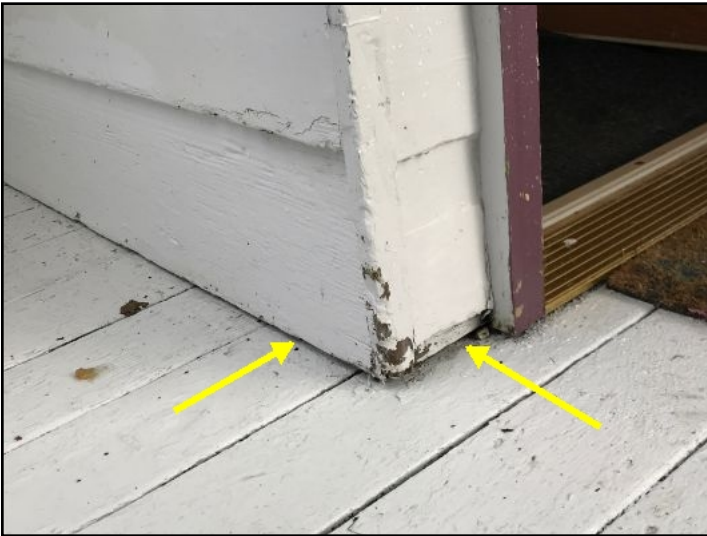
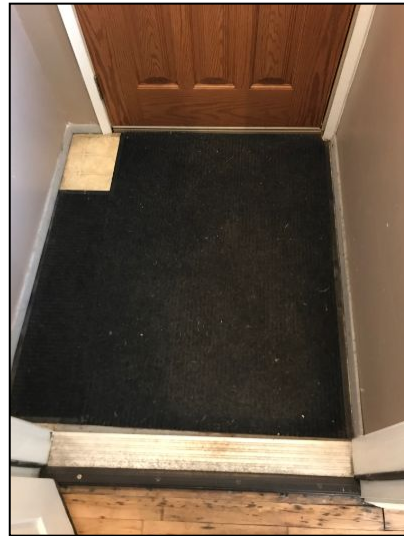
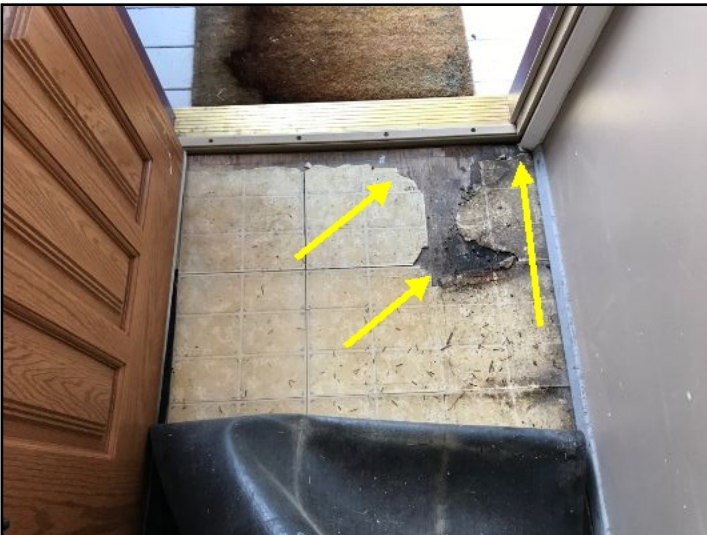
1. Floor Condition

- Flooring appears to have damaged sub floor due to water leak from the outside. Recommend a licensed contractor to repair or replace flooring in the arctic entryway.

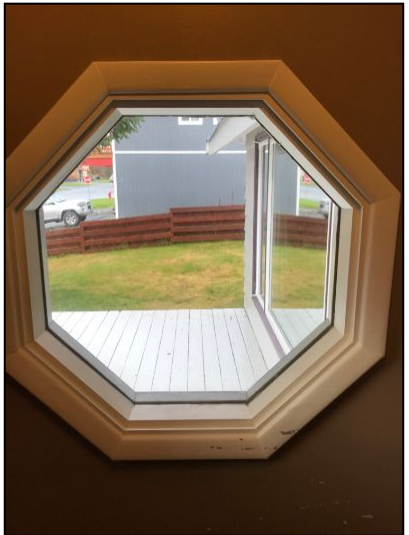
2. Window Condition

- Window in arctic entryway was in good working order at time of inspection.

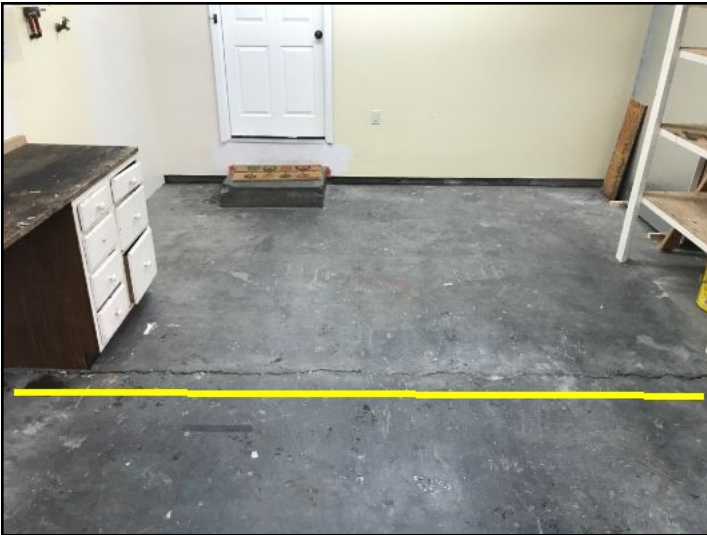
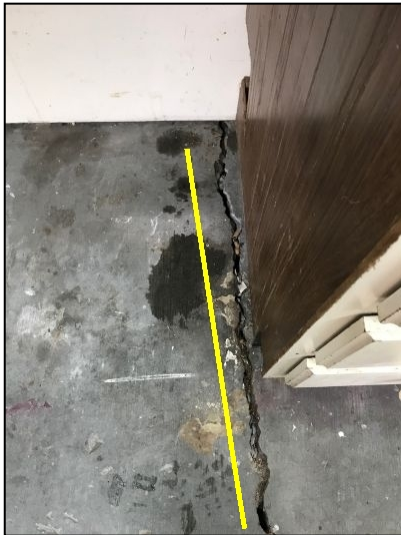
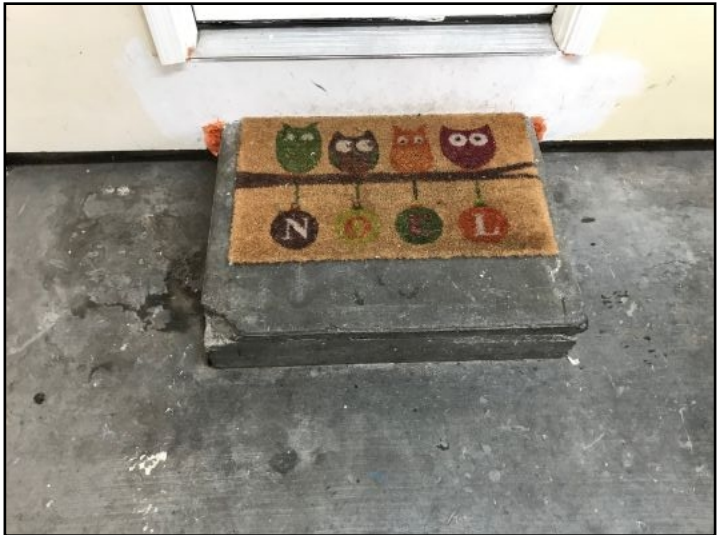
2. Floor Condition

- Common cracks noted.
- Recommend review by a qualified professional for repair or replacement, as necessary, prior to close.
- Recommend sealing cracks/voids.
