Arctic Home Inspections

Property Inspection Report

Inspection prepared for:
Date of Inspection: 2/22/2022

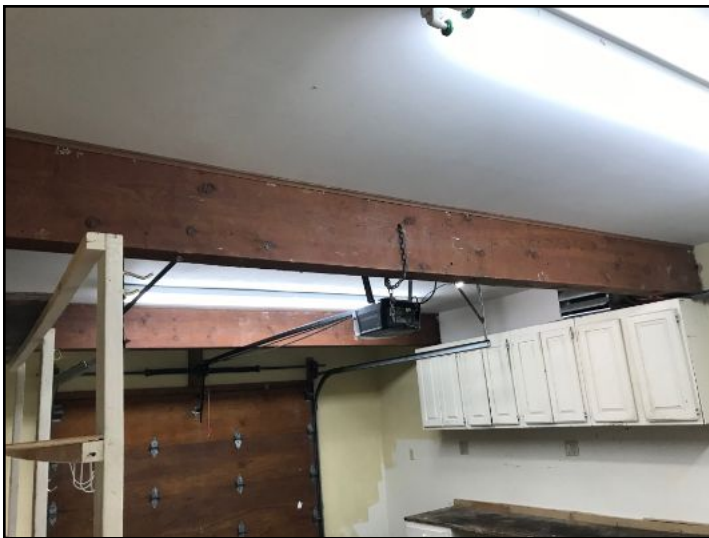
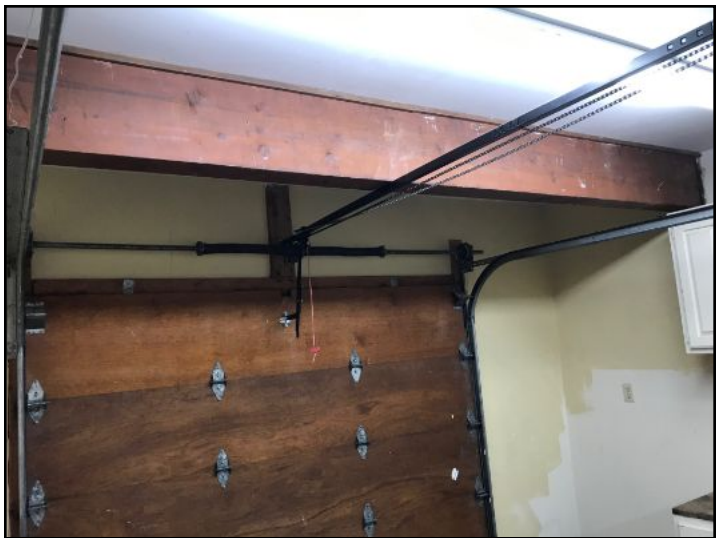
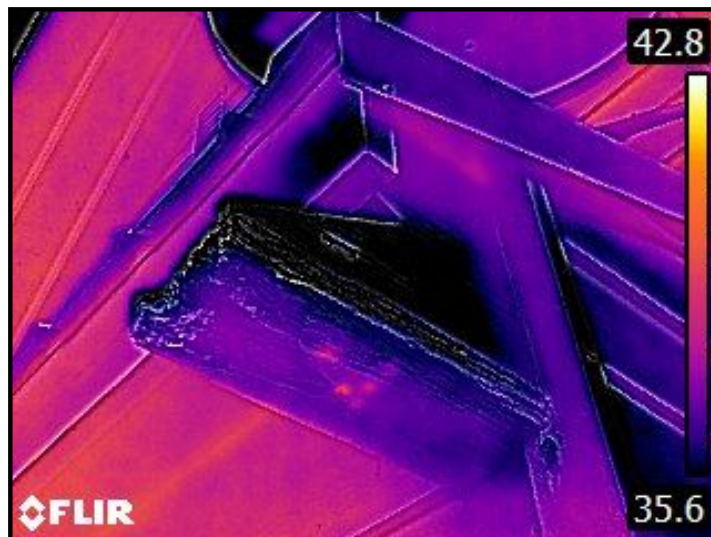
3. Rafters & Ceiling

- Dimensional lumber wood ceiling joists.
- Limited review due to finished ceilings.
- Visible areas appear satisfactory, at time of inspection.

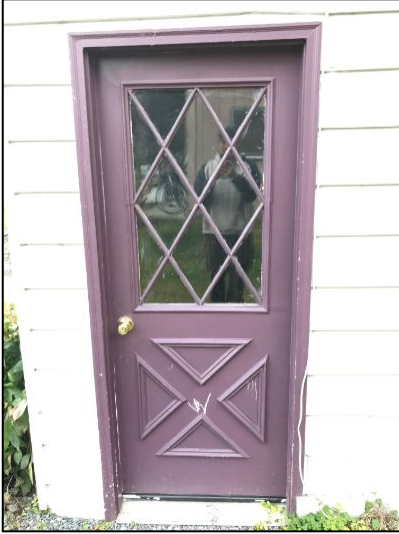
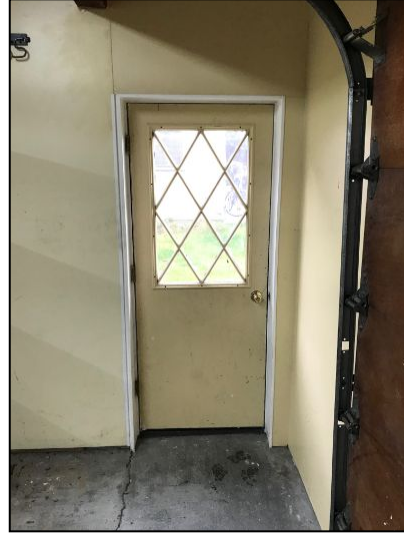
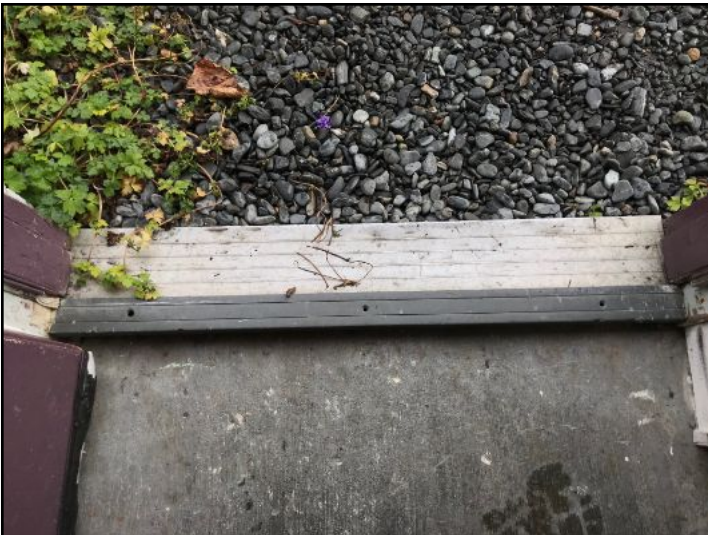
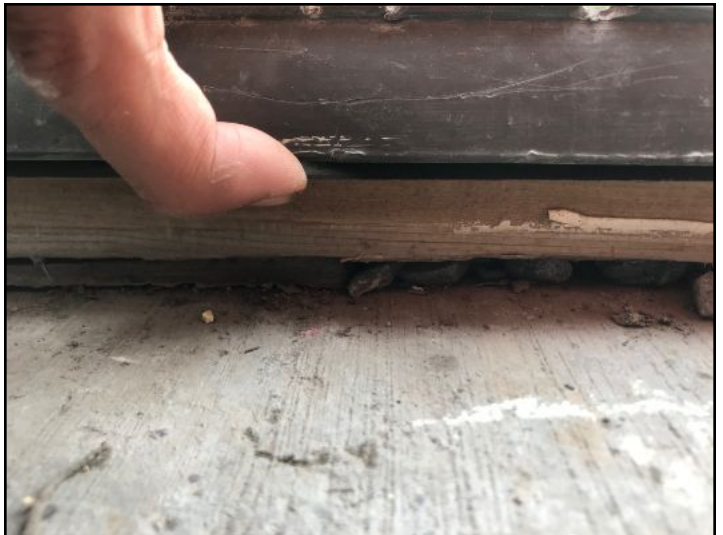
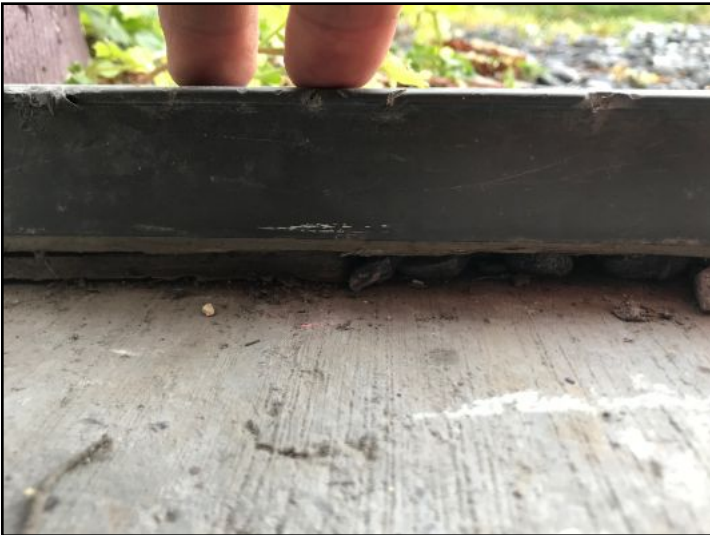
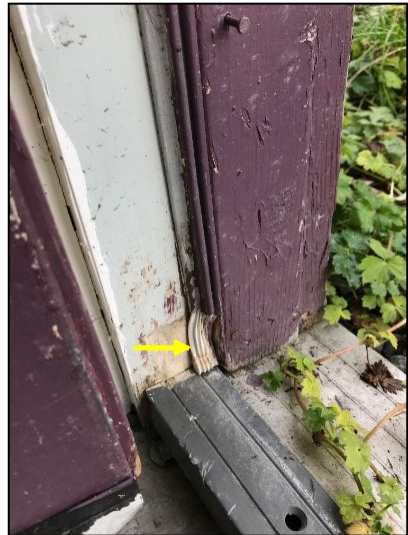
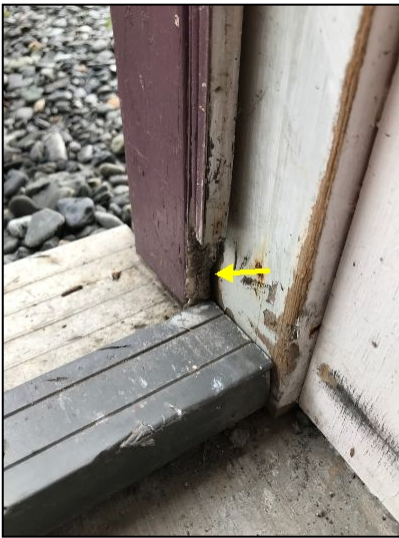
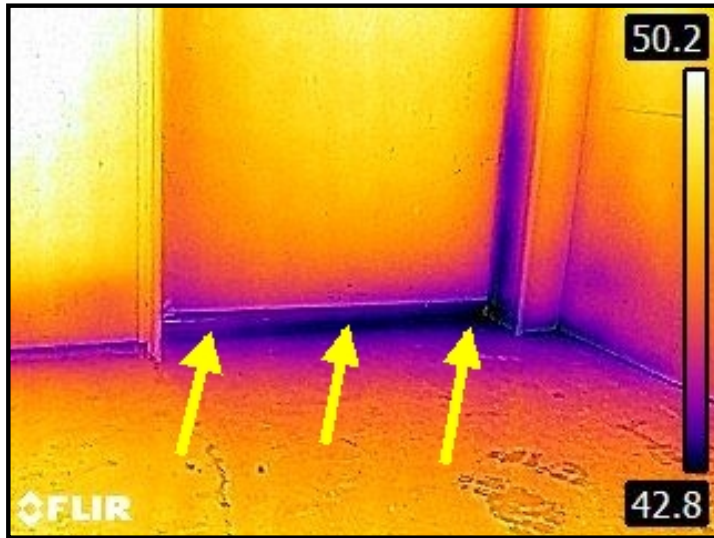
- Appeared functional, at time of inspection.
- Door sill looks to be showing its age. Recommend replacing to help seal garage better.
- Recommend replacing door seals to help keep cold whether out.

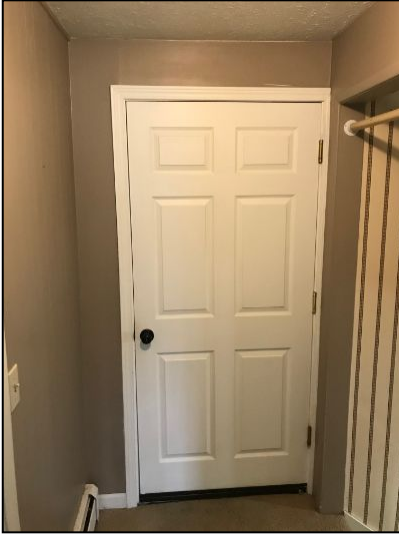
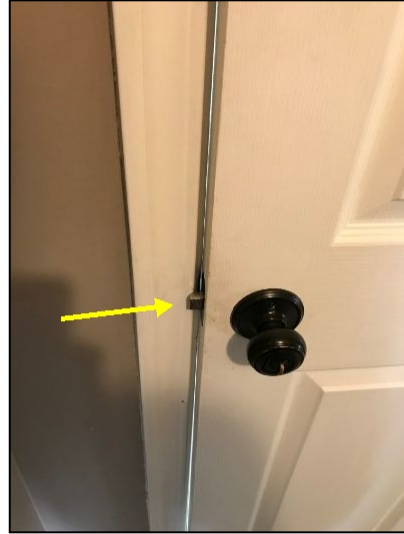
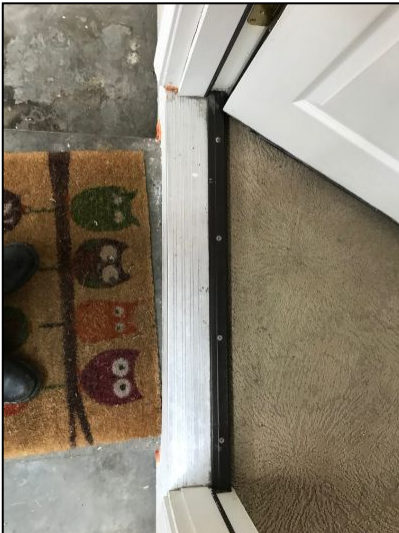
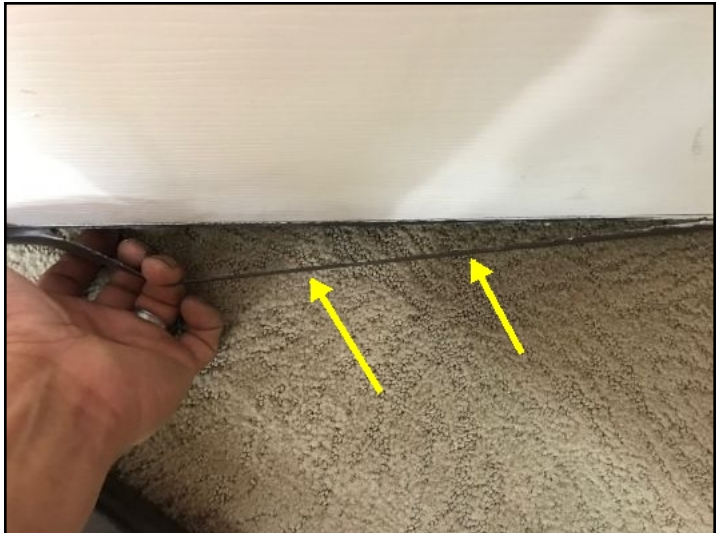
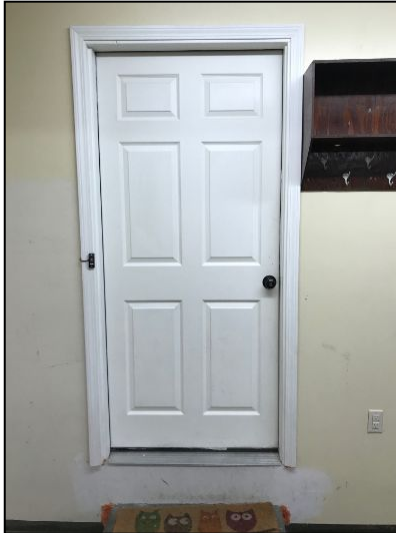
6. Fire Door

- Appeared satisfactory and functional, at time of inspection.
- The automatic closure device does not close the door properly. This could allow a fire to enter the home. Recommend adjusting or replacing the hinges to allow for proper closure of the door.
- Door sweep is coming apart on bottom of door. Recommend replacing to seal the house from the garage properly.

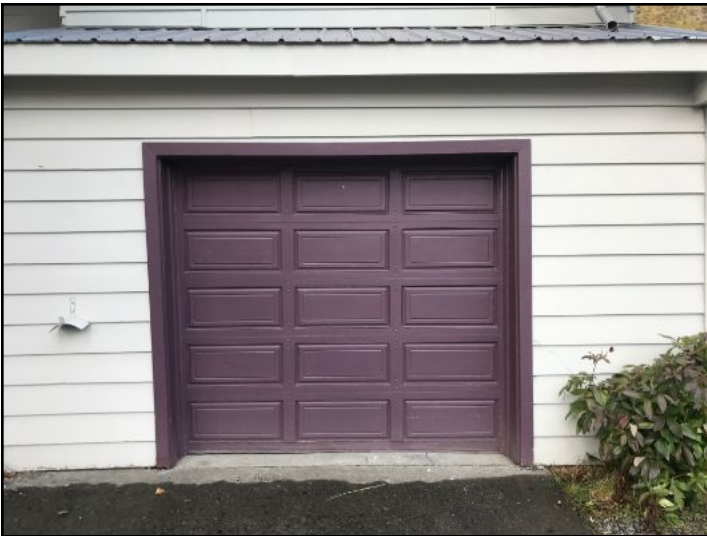
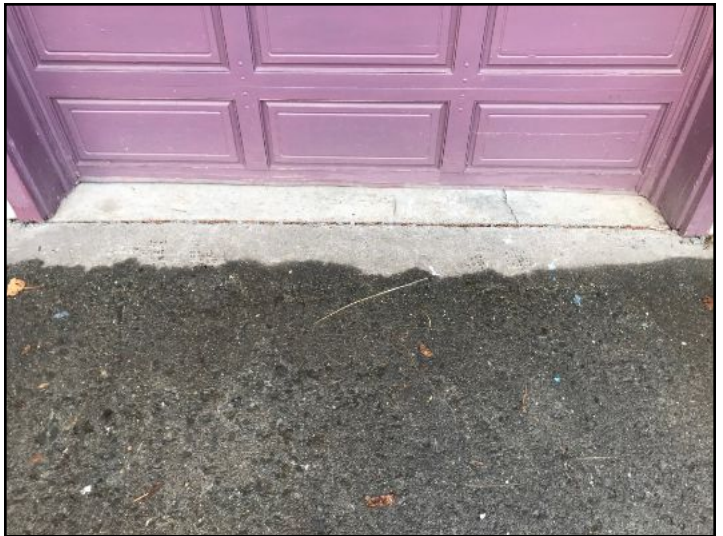
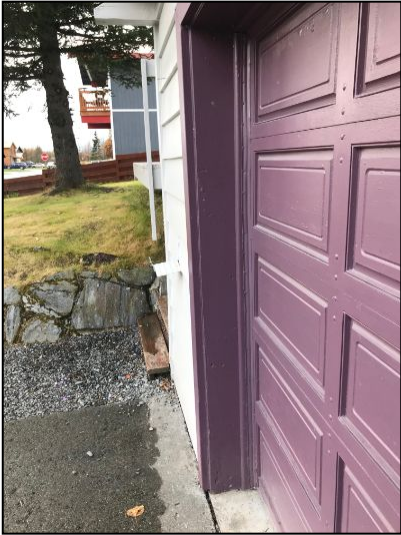
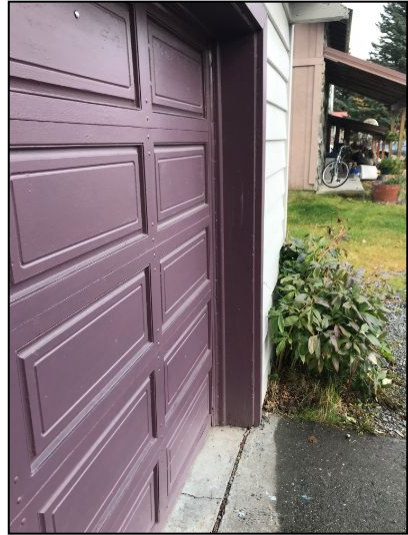
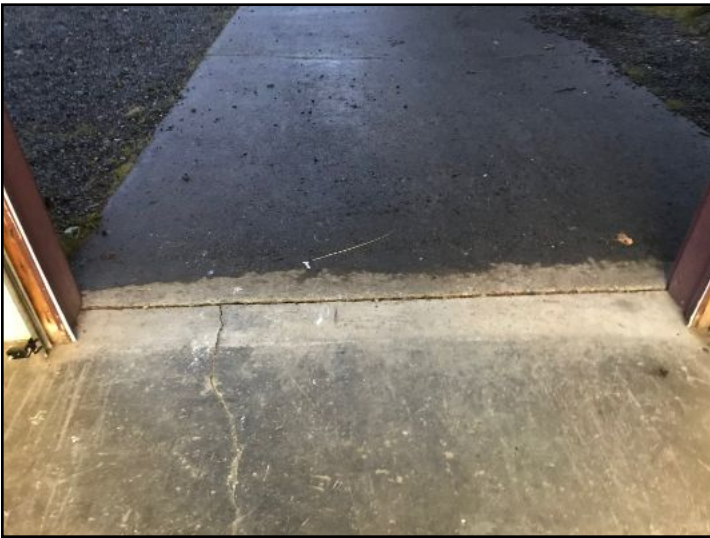
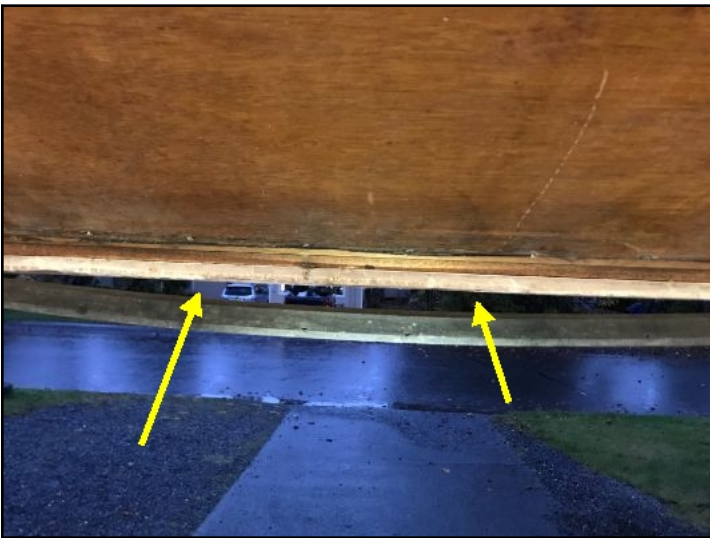
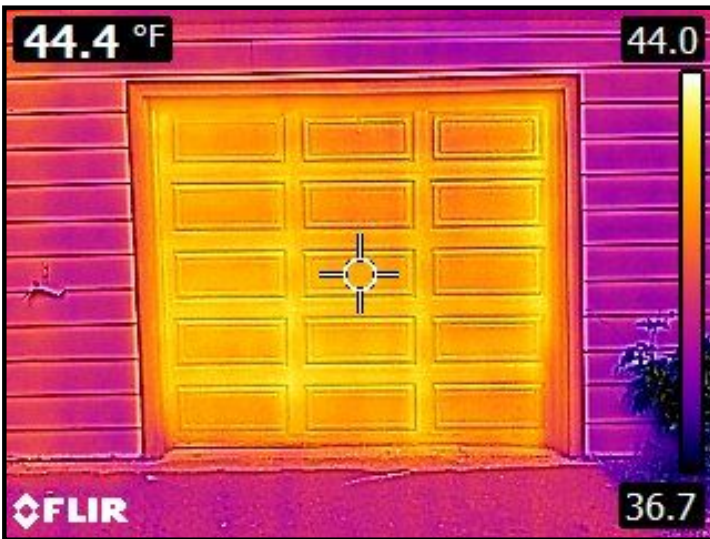
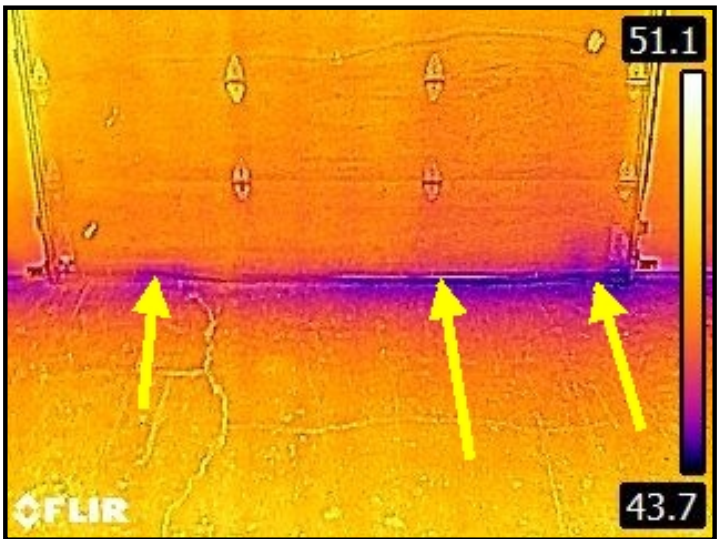
7. Garage Door Condition

- Maintenance repairs needed.
- IMPROVE: Consider future replacement with new steel triple-layer insulated type doors.
- Garage Vehicle door weatherstripping is damaged.
- weathered
- missing handle

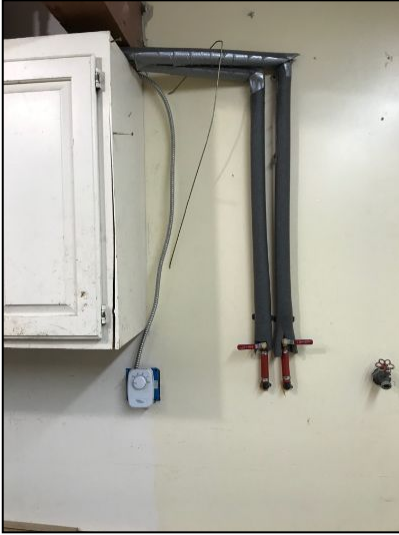
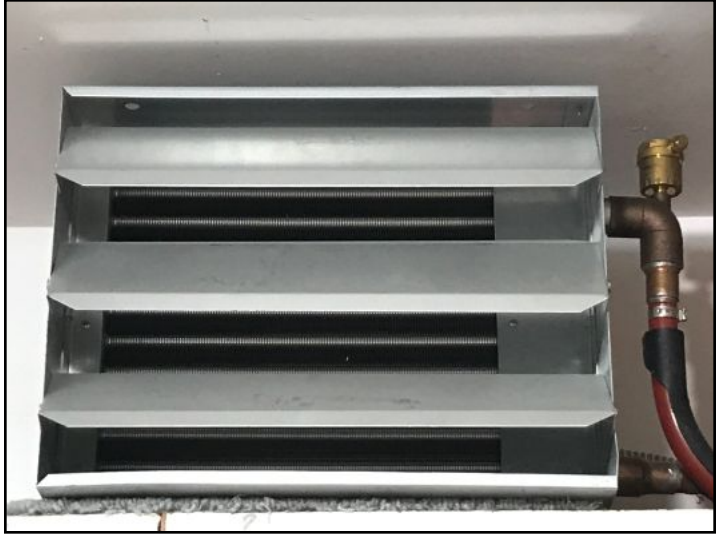
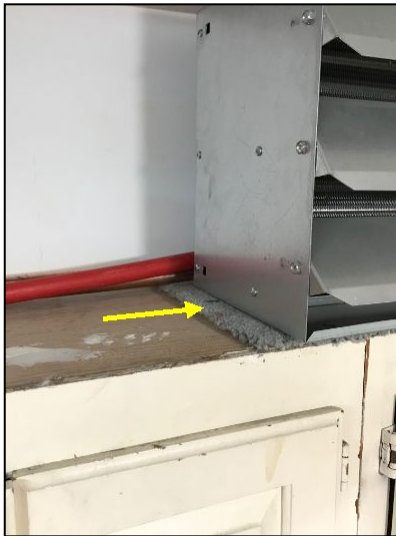
11. Heating

- Heating for garage appears functional.
- Switch out the carpet under the heater and use blocks of wood. This will be safer.

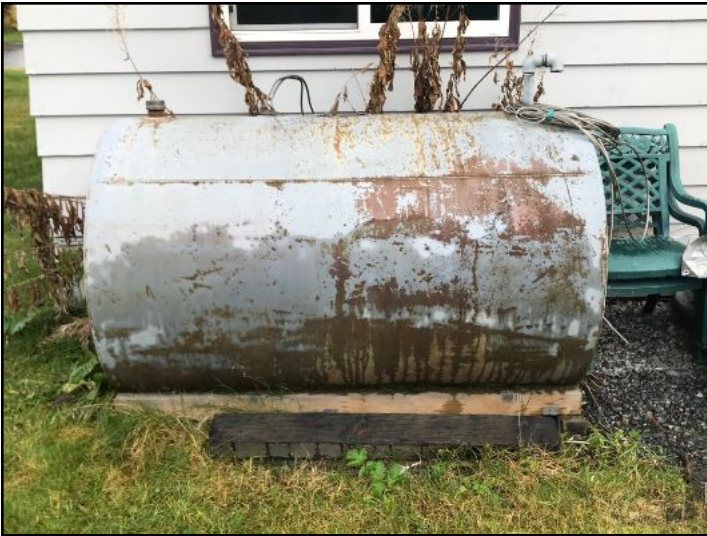
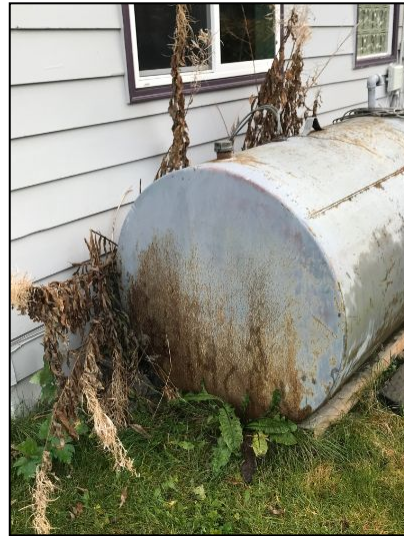
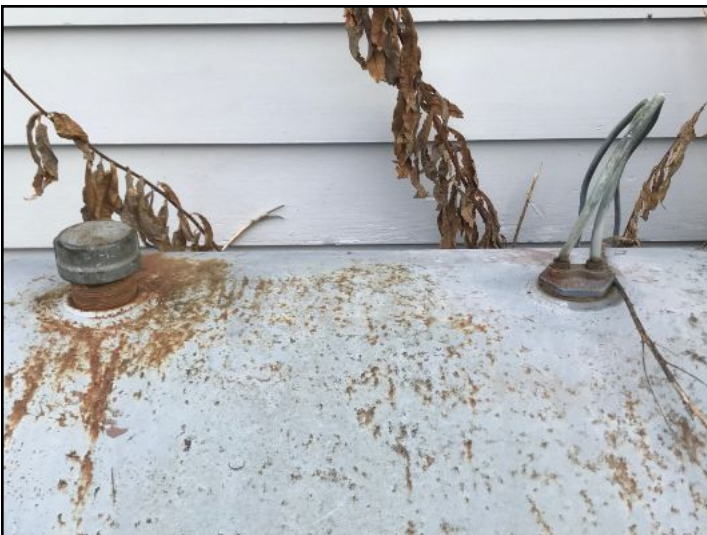
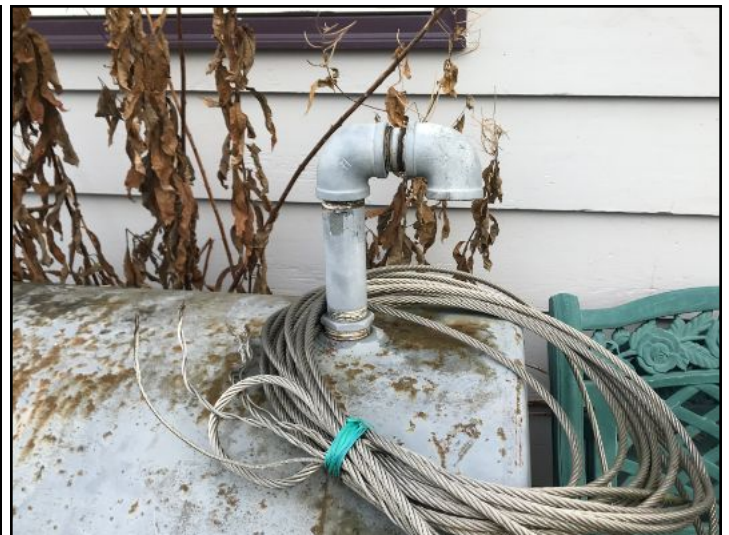
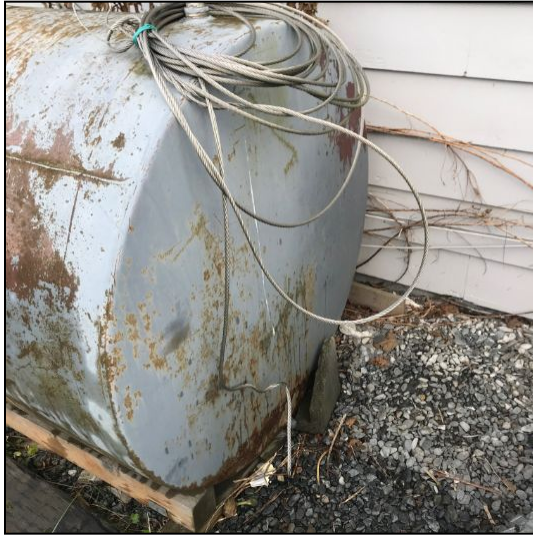
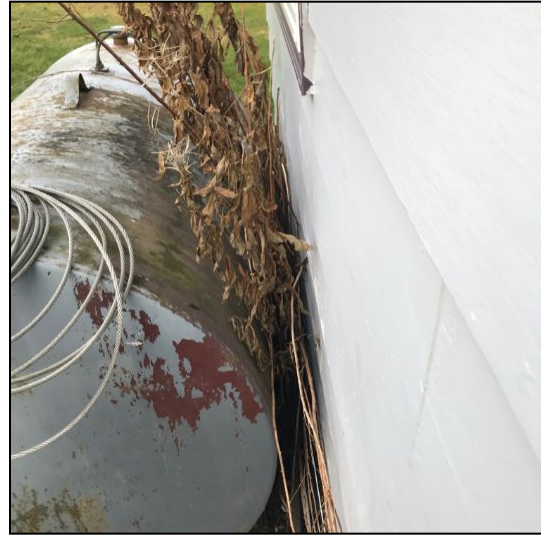
- Heating oil tank was in working service at time of inspection.
- No leaks or damage was apparent at time of inspection.
- Typical rust stains for an older storage tank observed.

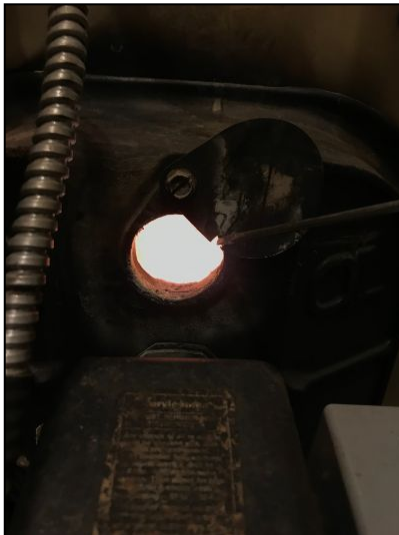
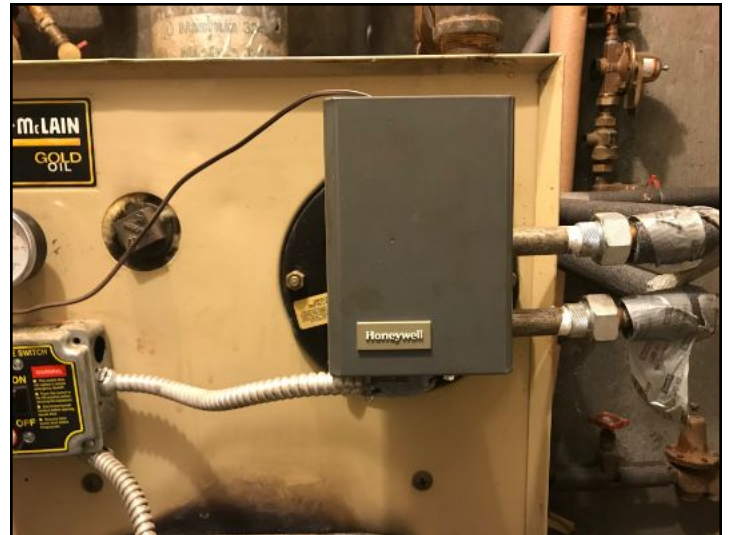
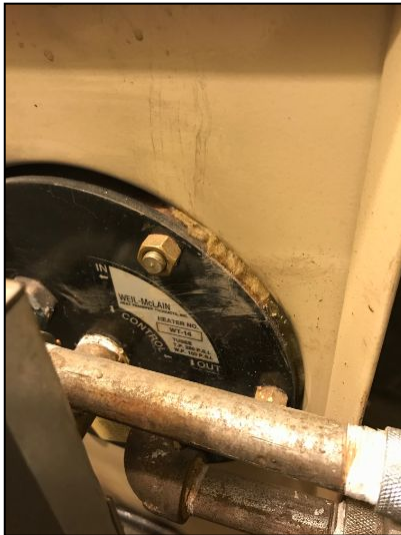
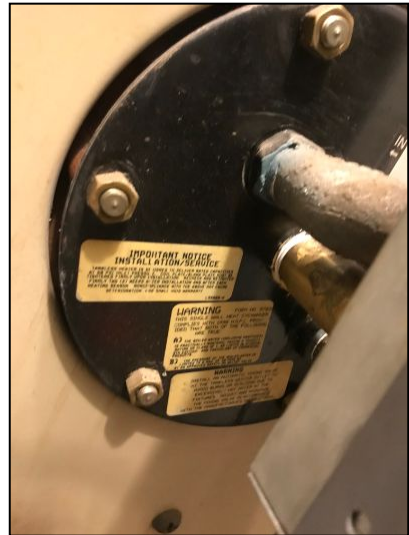
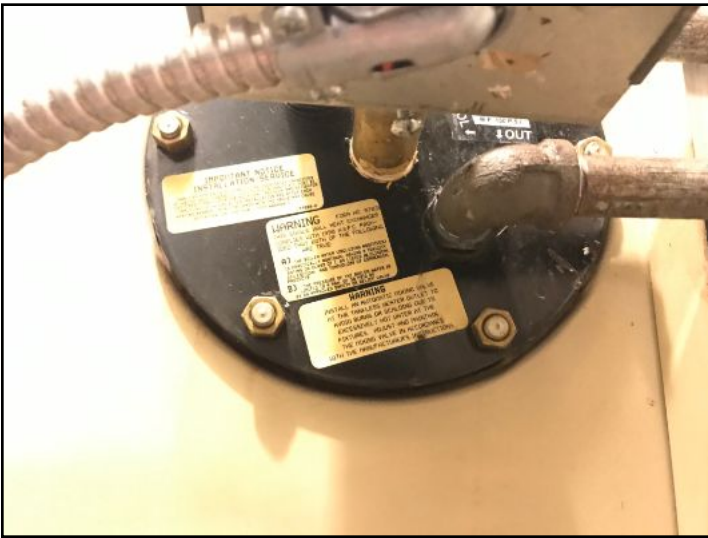
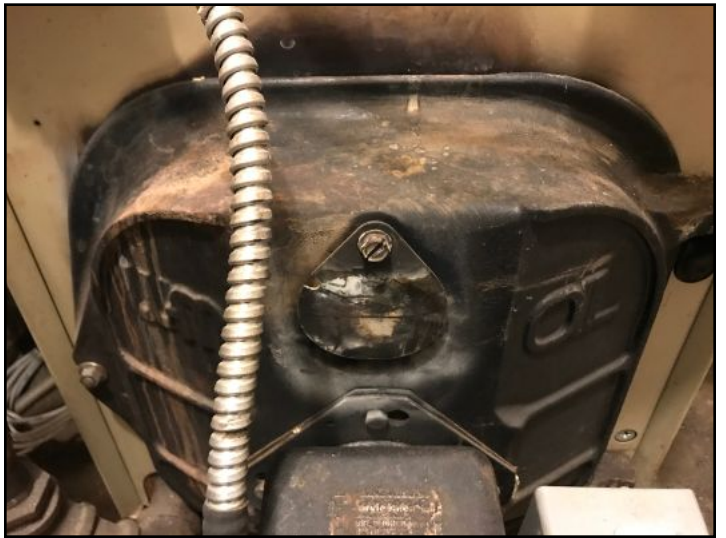
2. Heater Condition

- Fuel Furnace: Last service date is over one year ago, or is unable to be determined. Although this unit appears to be operating properly from controls, there are areas which cannot be seen without specialized equipment and training. One such area is the combustion chamber / heat exchanger where cold air blows across the "fire box", becoming the hot air that circulates throughout your home. During the life span of any furnace, this metal wall may develop a crack or a broken weld, allowing carbon monoxide to circulate throughout the home. This is why furnace specialists recommend a complete inspection annually; consider having unit inspected by certified HVAC technician.

- The heating unit is approaching its designed life expectancy. We make no warranty, guarantee or estimation as to the remaining useful life of this unit.

- Unable to inspect heat exchanger due to closed system.
- **Expansion tank** is covering boiler information on the side of the boiler. This makes it hard to figure the boiler manufacture date.

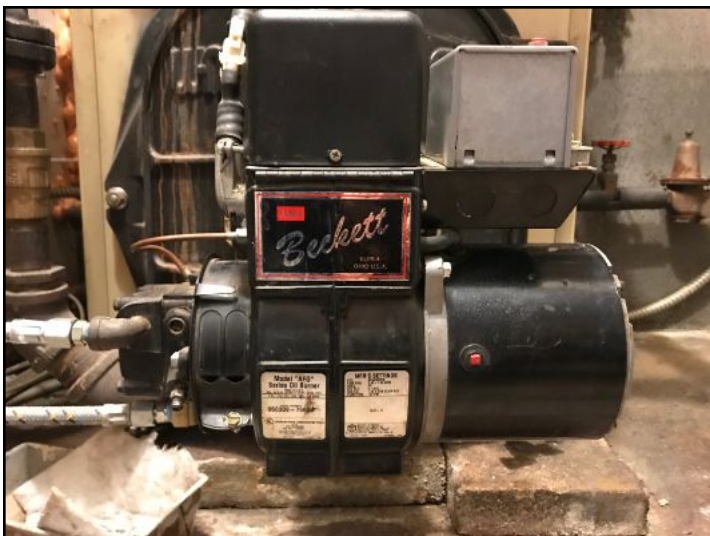
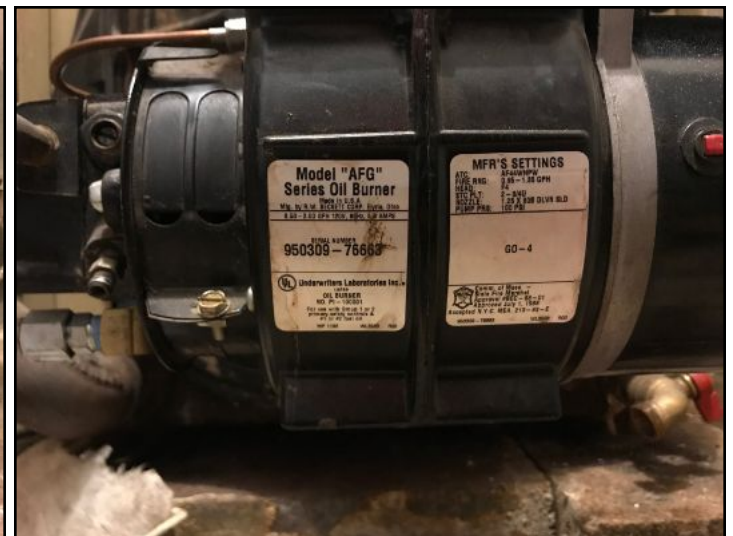
3. Oil Burner

- Oil burner is a Beckett.
- Oil burner was in good working condition at time of inspection.

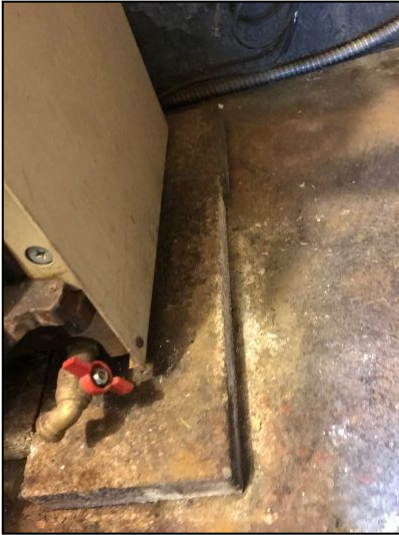
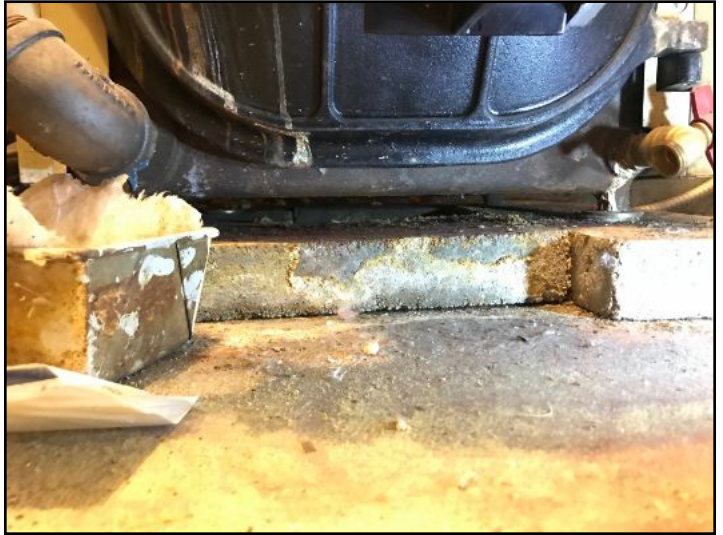
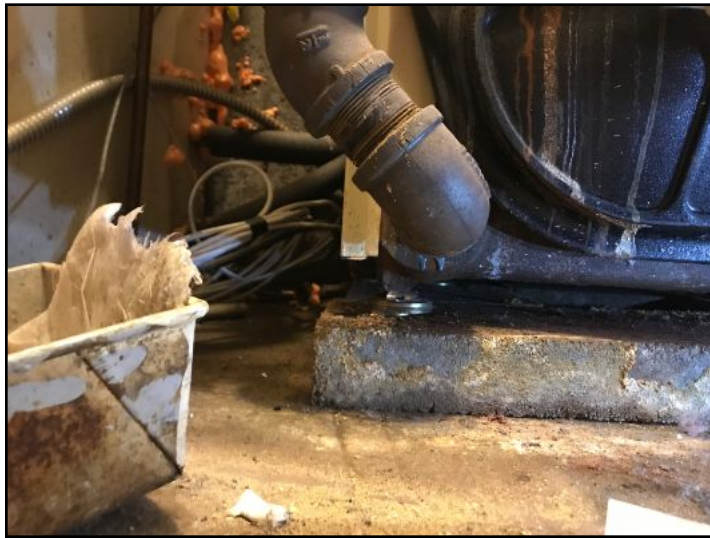
4. Heater Base

- The heater base appears to be functional.

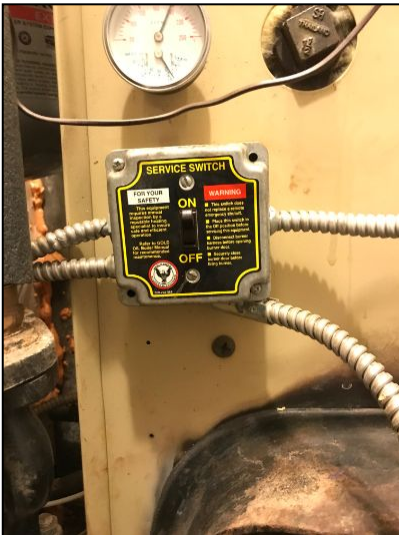
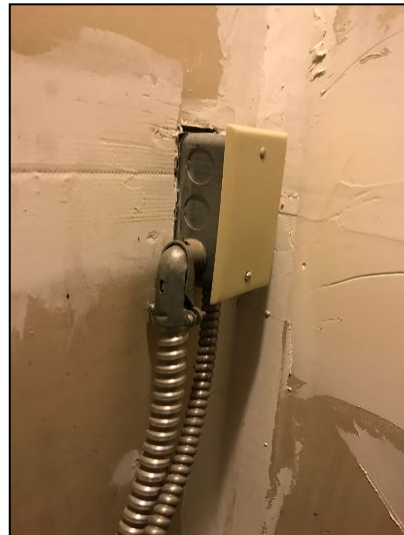
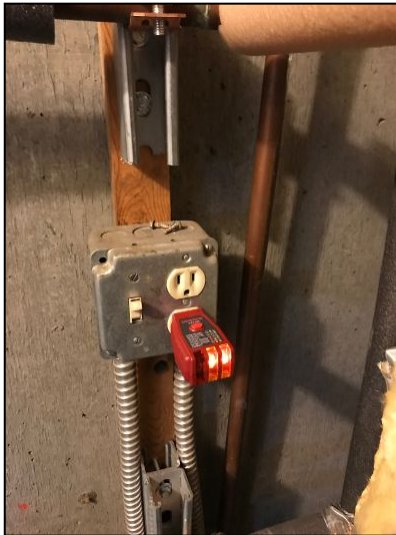
5. Heating Electrical

- Service switch appeared in working condition at time of inspection.
- Service switch was not tested.

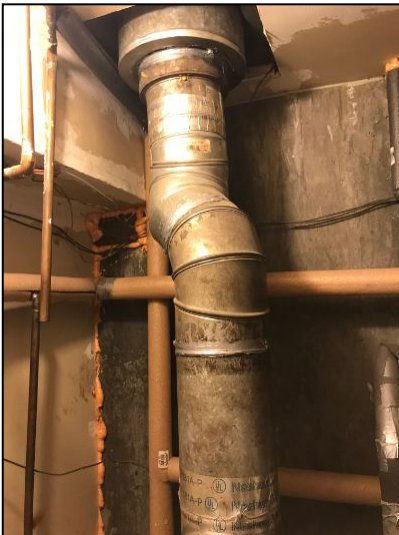
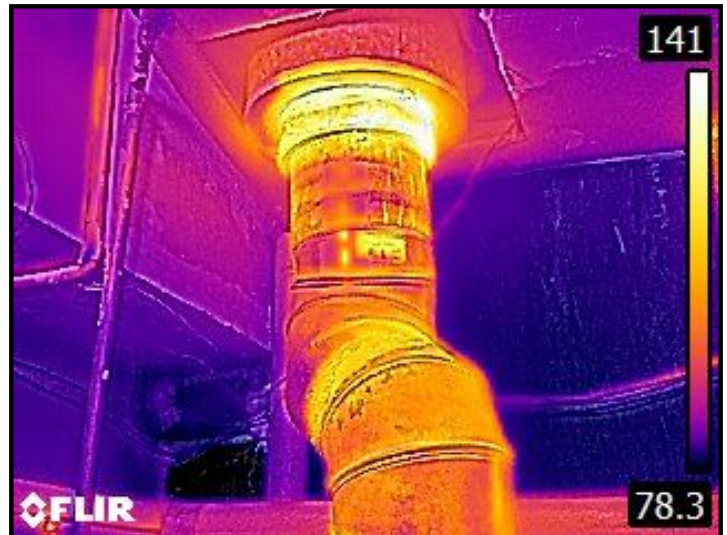
6. Venting

- Metal double wall chimney vent pipe noted.
- The metal chimney liner vent flue pipe was not inspected or visible from end to end. Recommend a certified chimney sweep inspect for your safety.
- The visible portions of the vent pipes appeared functional.

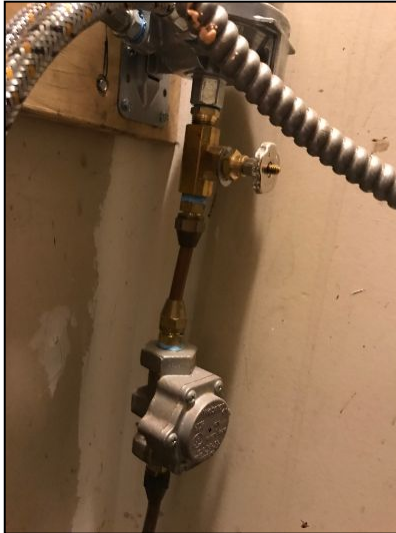
7. Gas Valves

- Oil gas shut off valves were present and seemed in working order.

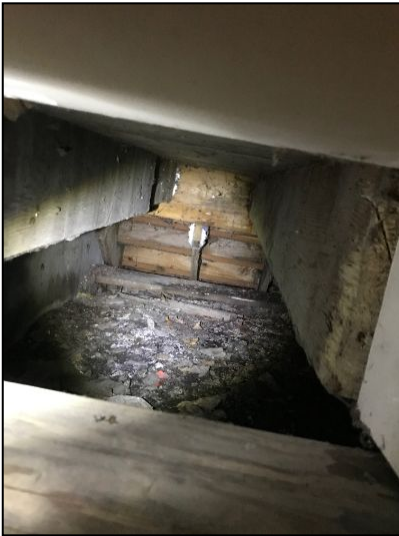
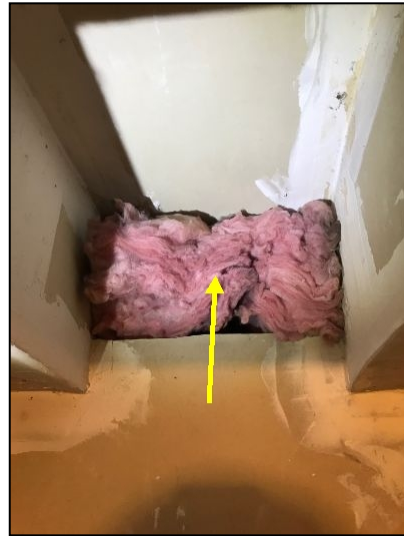
8. Air Supply

- Outside air supply come from under the deck of the house under the arctic entry.
- Air supply is blocked with insulation. Air supply is important for an oil fired boiler to run efficiently.

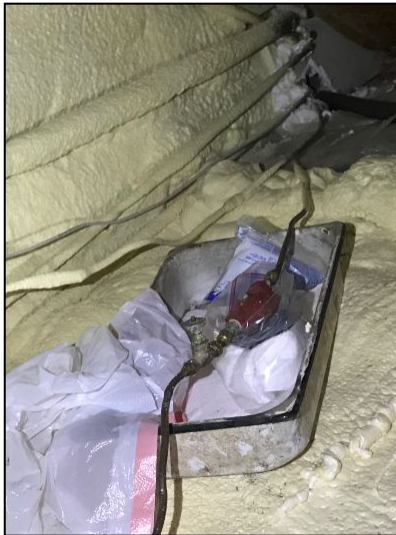
9. Filters

Location: Located inside crawlspace.

- Access is a bit difficult.
- Oil filters should be changed every year along with a boiler inspection.

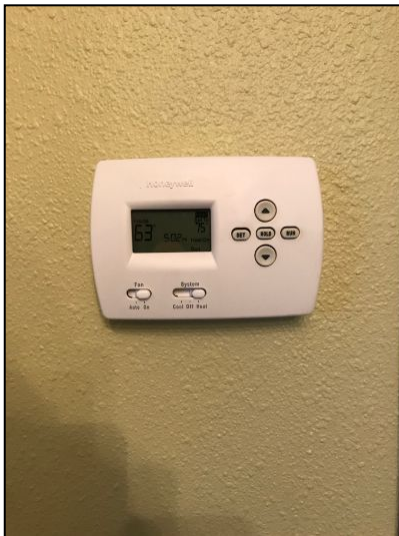
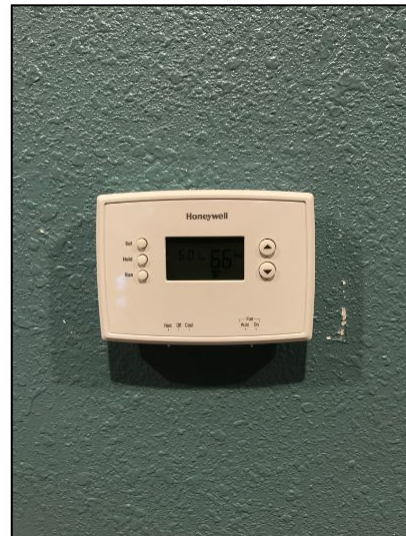
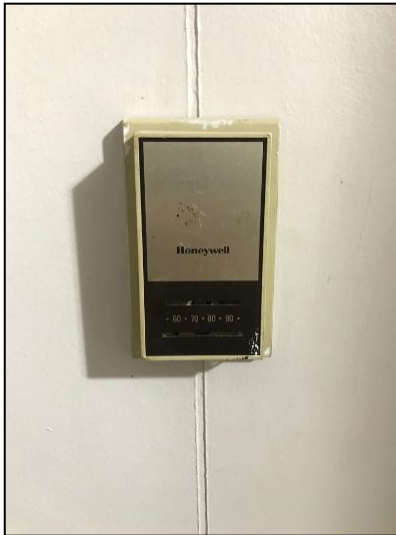
10. Thermostats

- Locations: Bedroom #1, Living room, and Office.
- Location(s): Zone#1: Bedroom#1 -- Zone#2: Living room -- Zone#3: Office
- Digital - programmable type.
- Analog, non-programmable type.
- Functional at the time of inspection.
- Thermostats are not checked for calibration or timed functions.
- IMPROVE: Non-programmable thermostats have no energy saving capabilities as do digital setback-type thermostats. Recommend an upgrade to a modern, digital programmable thermostat. This could yield a saving of up to \$180 per year in energy costs.

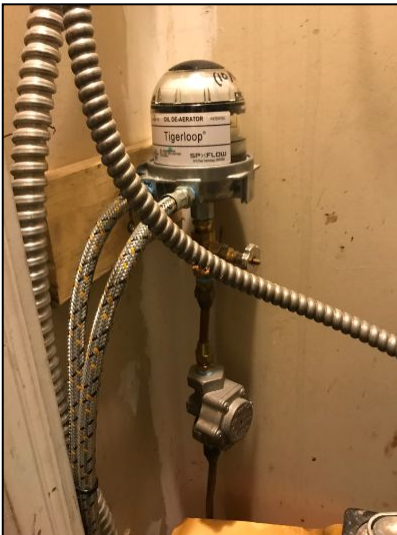
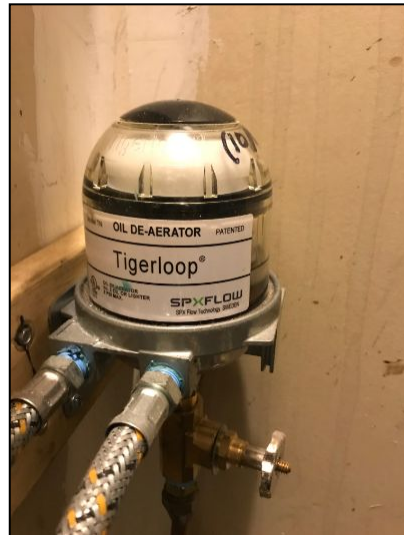
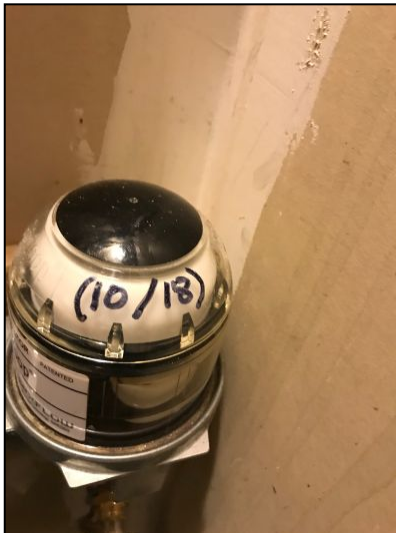
11. Oil De-Aerator

- Oil de-aerator appeared in serviceable condition at time of inspection.
- The de-aerator should be serviced every year same as an oil filter.

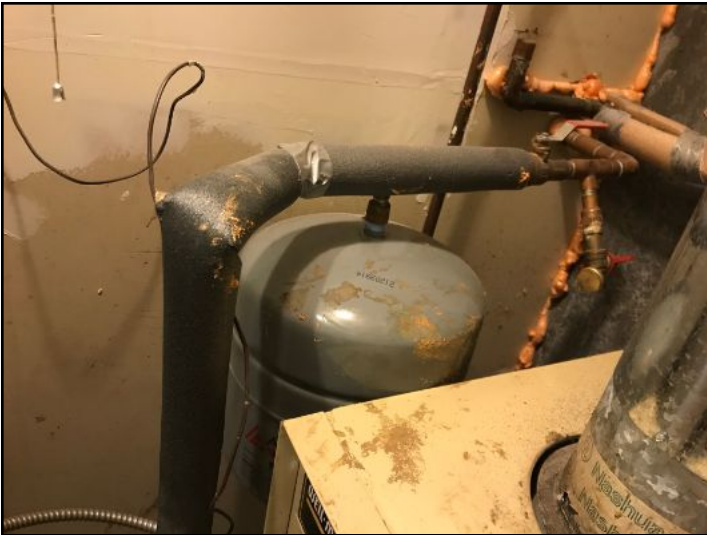
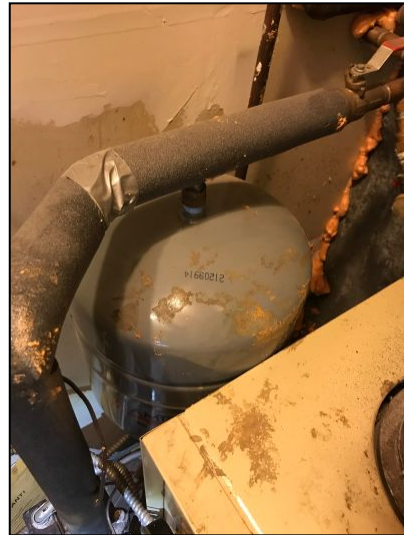
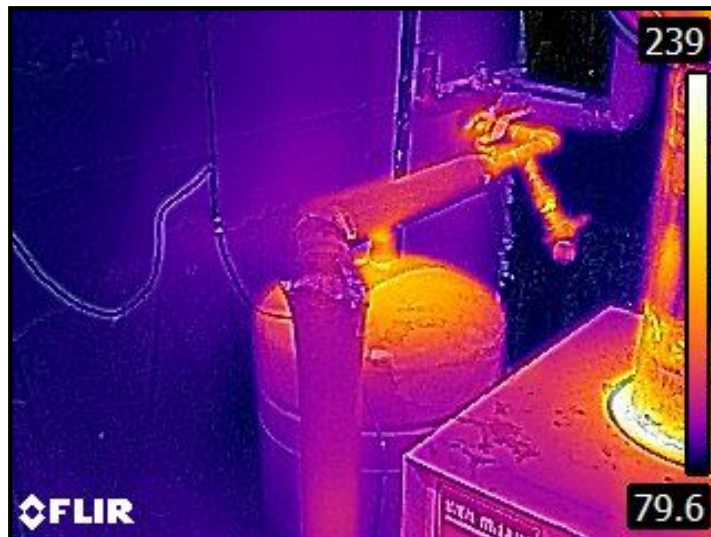
12. Expansion Tank

- Expansion tank was in working condition at time of inspection.
- No leaks apparent at time of inspection.

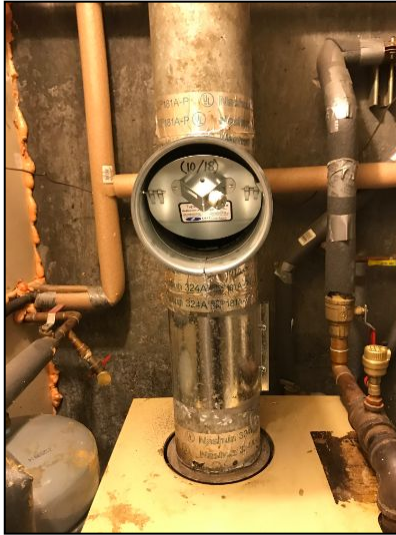
13. Draft Regulator

- Draft regulator was functioning properly at time of inspection.

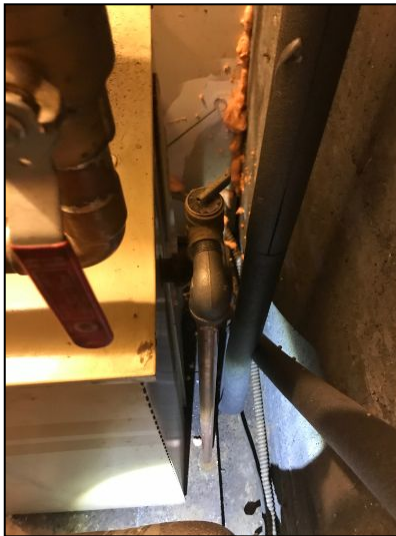
14. Heating TPRV

- TPRV had no apparent leaks and appeared functional at time of inspection.

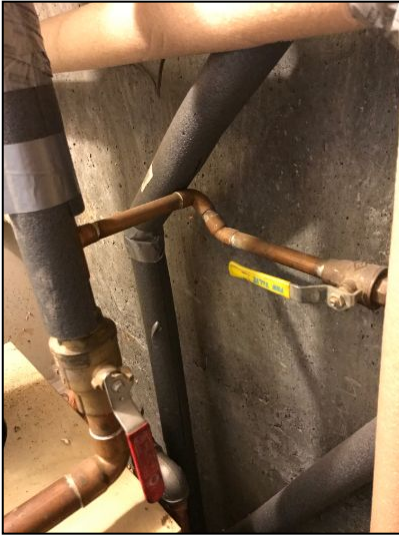
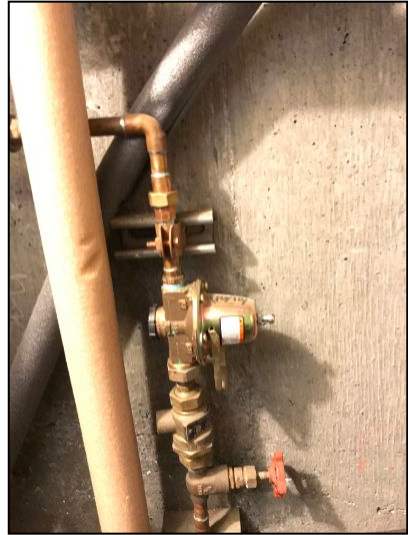
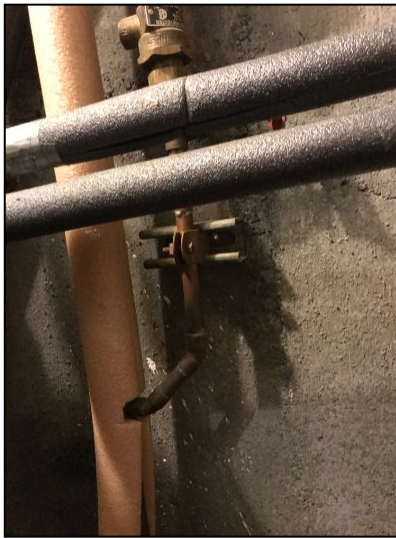
15. Hartford Loop

- Hartford loop was in working condition and no apparent leaks at time on inspection.

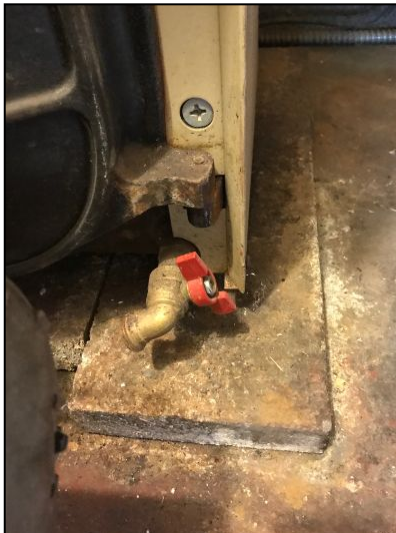
16. Heater Drain Valve

- Boiler drain valve appeared in good working condition and no apparent leaks at time on inspection.

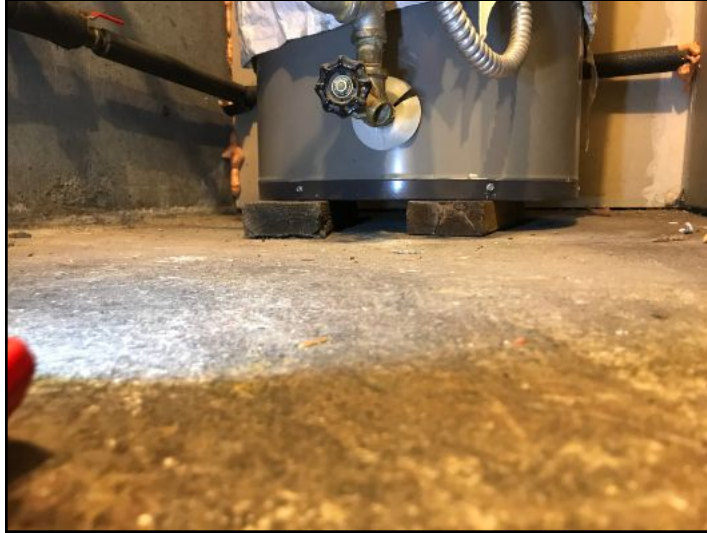
- The water heater base is functional.

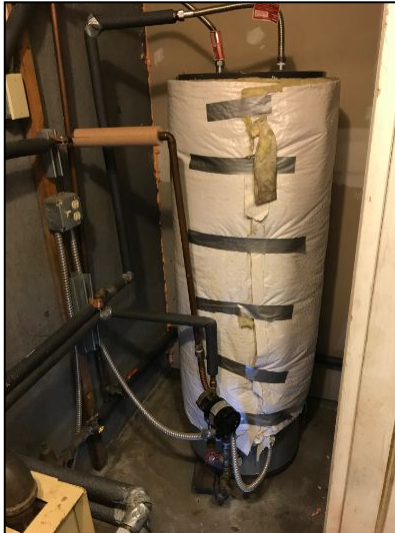
2. Heater Enclosure

- The water heater enclosure is functional.

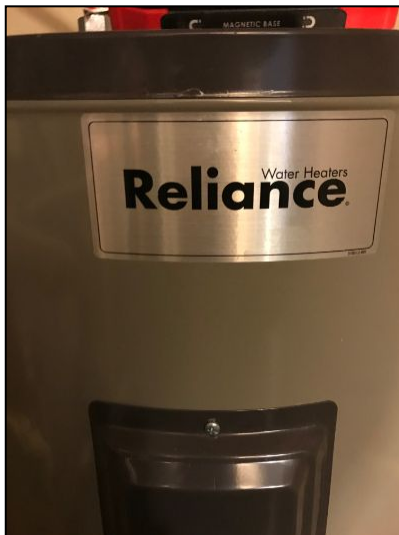
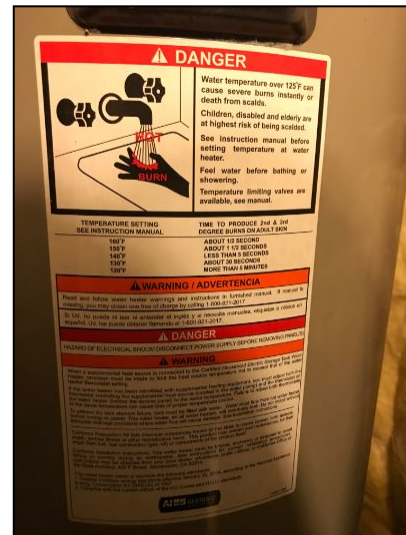
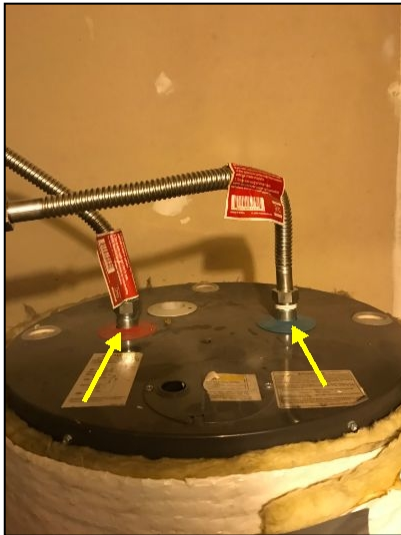
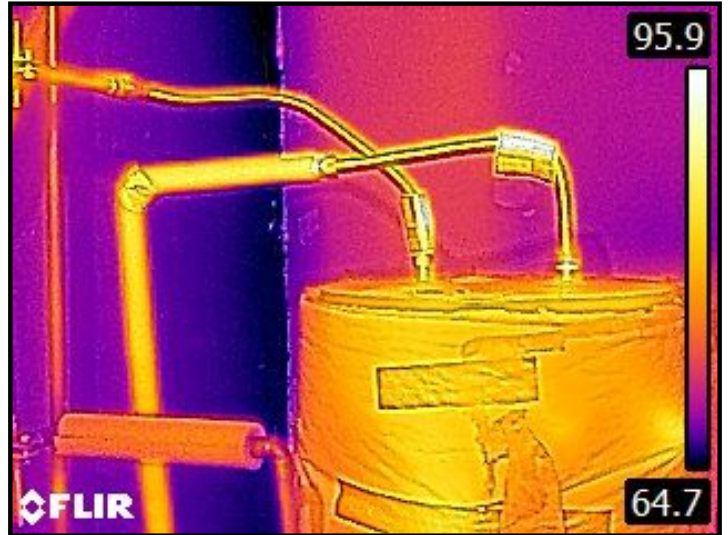
3. Water Heater Condition

- Tank appears to be in satisfactory condition -- no concerns.
- No major system safety or function concerns noted at time of inspection.
- A Temperature Pressure Relief (TPR) valve present. This safety valve releases water (and thus relieves pressure) if either the temp or pressure in the tank gets too high. The **TPR valve** discharge tube must be made of copper, iron, or CPVC (NOT regular **PVC**). It must terminate within 6" above the floor--the end cannot be threaded or have a fitting.

- The extension at the water heater relief valve is missing. This is a potential scalding concern as water can discharge improperly. Recommend installing the proper type of relief extension to discharge within 6" from the floor.

- Water Source: Public
- **The hot water and cold water on top of the water heater are backwards. With hot water coming out of the cold side.**

- Recommend extending TPR discharge tube with 3/4" copper pipe to within 6" off the floor.
- **IMPROVE:** A 40 gallon water heater is somewhat small for a home of this size. Recommend installing a larger tank or tankless system when a new water heater is needed.

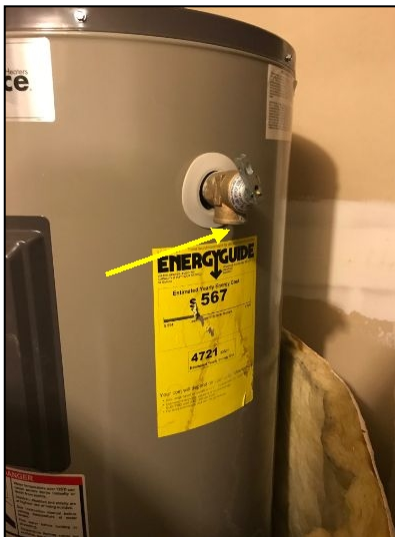
4. TPRV

- Appears to be in satisfactory condition -- no extension is present on the TPRV that extends to floor.

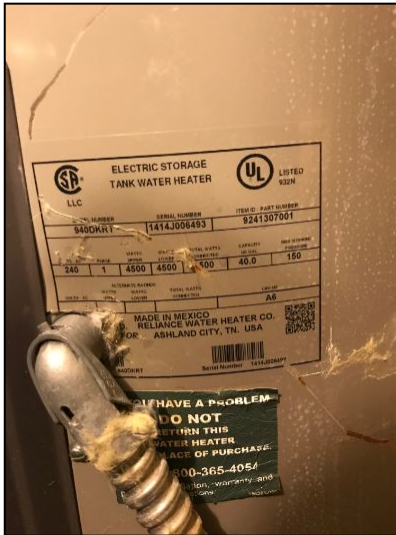
5. Number Of Gallons

- 40 gallons
- Boiler present.
