Arctic Home Inspections

Property Inspection Report

Inspection prepared for:
Date of Inspection: 2/22/2022

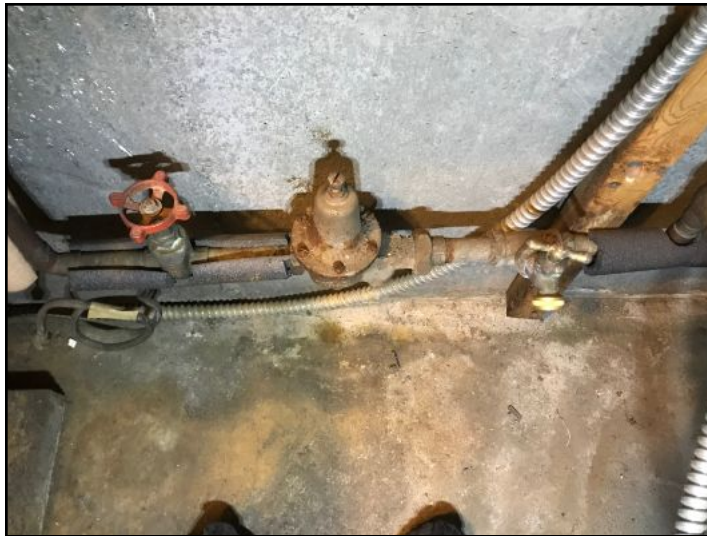
- Appears functional.

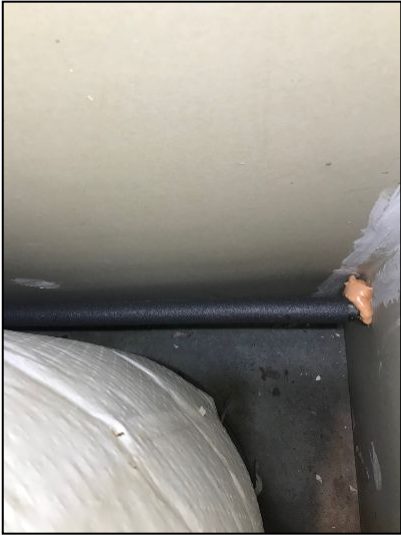
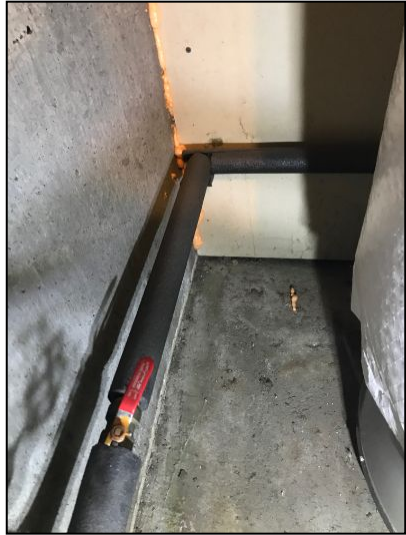
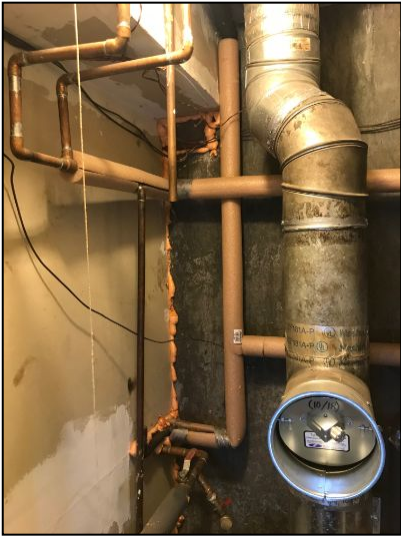
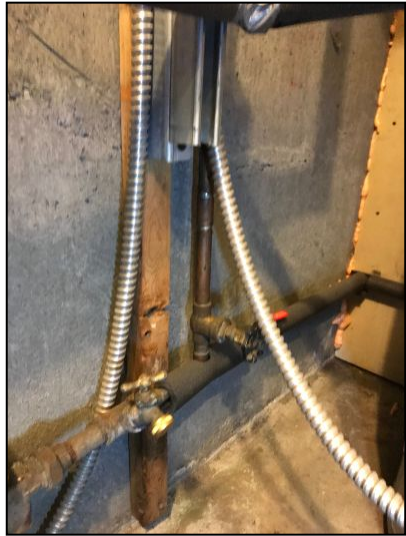
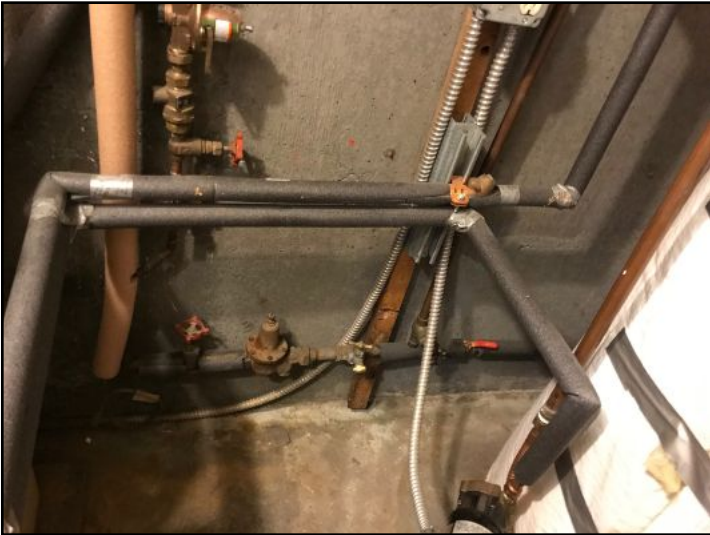
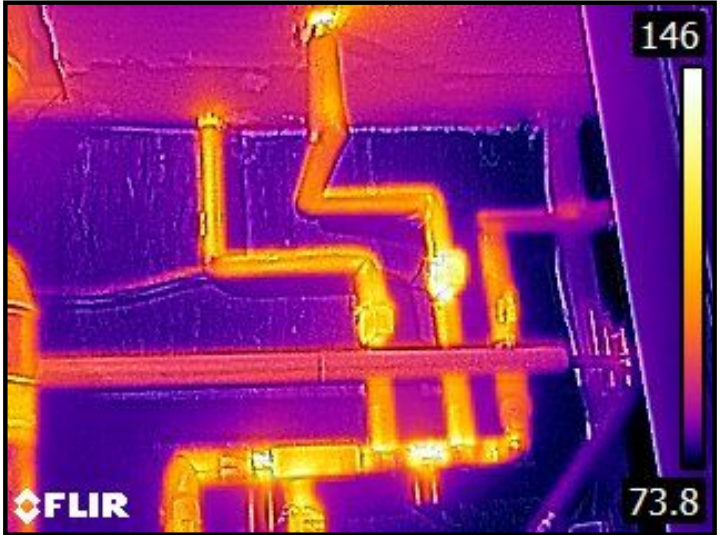
7. Plumbing

- No deficiencies observed at the visible portions of the supply piping.
- Most of the piping is concealed and cannot be identified.
- Have all supply piping in the crawlspace reviewed by a qualified specialist.
- All pipes in crawlspace should be insulated.

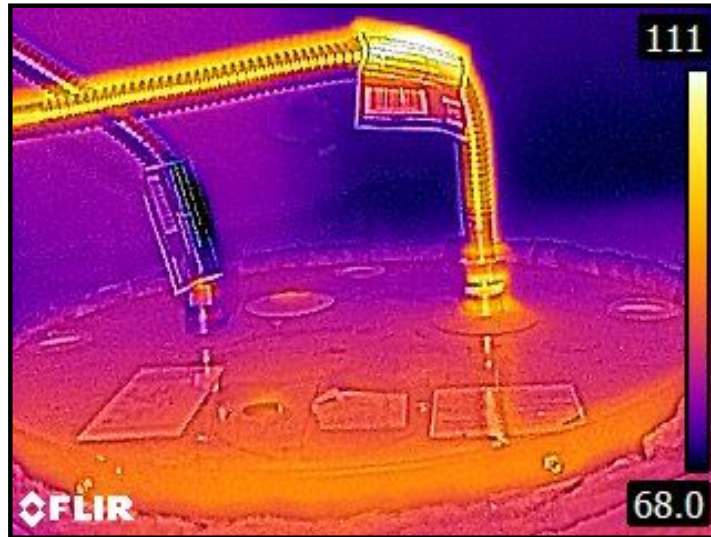
8. Strapping

Page 102 Item: 8	Strapping	<ul style="list-style-type: none"> • The water heater is not strapped.

- With no strapping. If there is an earthquake the water heater can fall over and flood the basement.
- **The water heater is not strapped.**

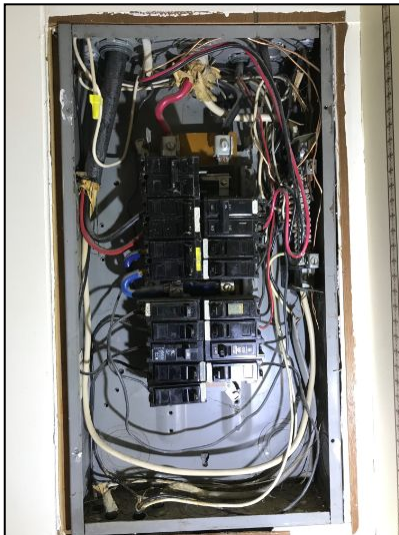
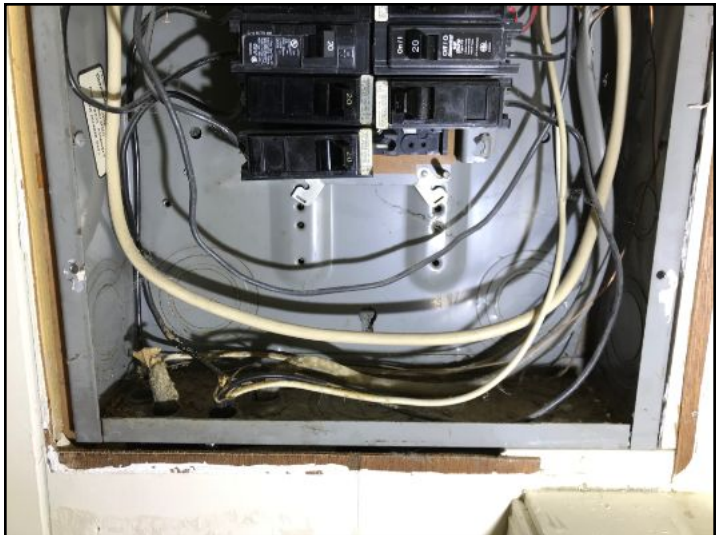
- Panel box appears to be older than the projected effective life (25 years) of panel buss bar and breakers; recommend electrician evaluation of panel box and associated wiring, including non-tripping **GFCI**s on property.
- Recommend upgrading service.
- **Open breaker panel slot(s) at panel box cover. Electrocutation hazard.**
- **Grounding / Bonding questionable at panel box.**
- **Have electrician ensure that ground is continuous, see photo.**
- **There appears to be grounding wire that has come loose or has broken off. This may be the cause of grounding issues in the home.**

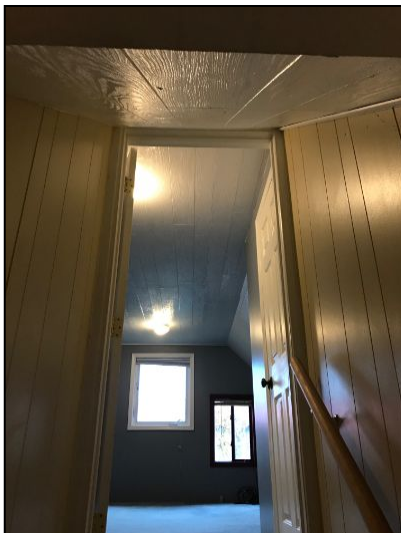
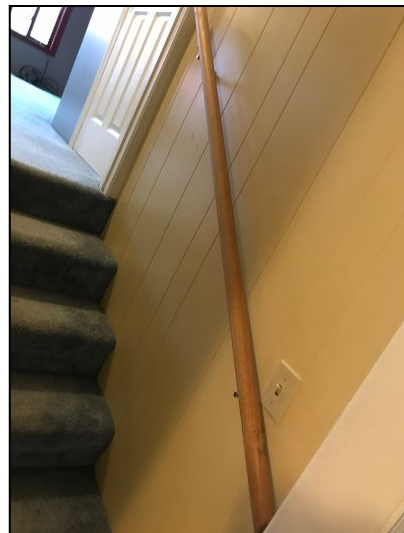
2. Stairs & Handrail

- Stairs in the house were in good working order during the inspection.
- Stairs are partially covered in carpeting.
- **A handrail is MISSING.**
- **Need guard rails installed at opening or stairs to basement.**

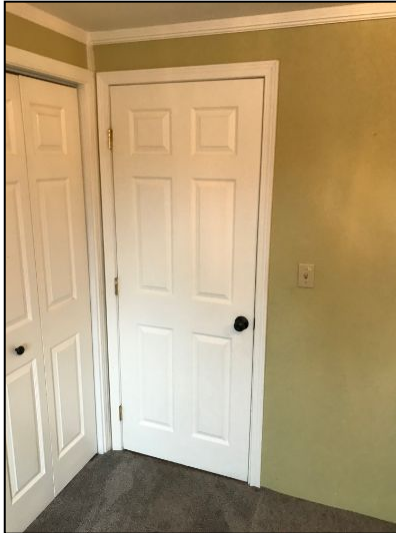
3. Electrical

- Bedroom #1 electrical is in servicable condition.

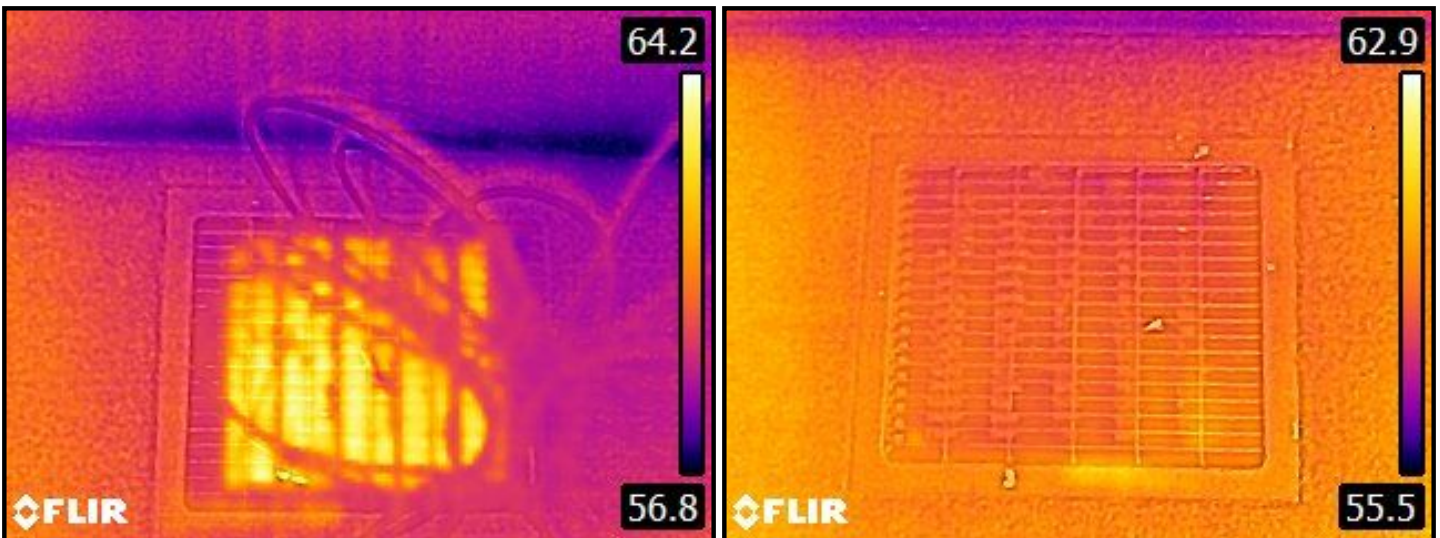
7. Old Return Ducting

- Old return ducting, can be blocked and sealed to help keep cold air out.

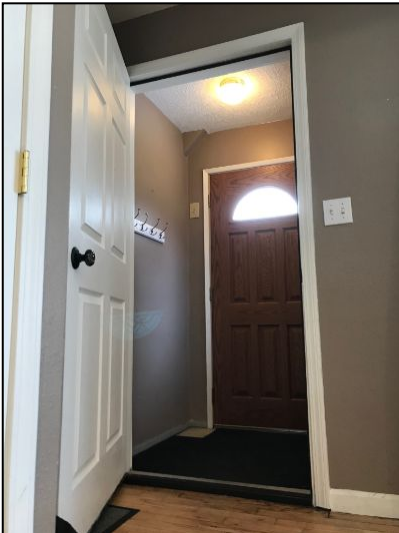
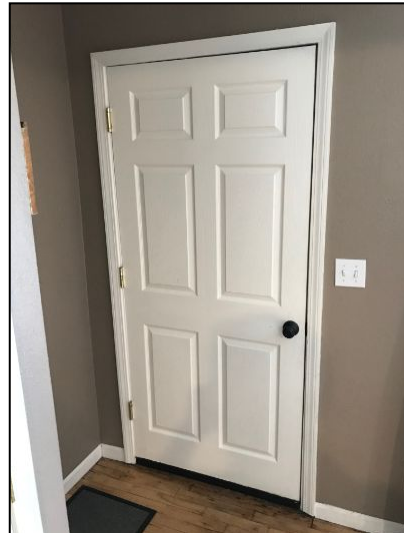
2. Doors

- Entrance door for living room was in good serviceable condition at time of inspection.
- There are gaps on the door seal. Recommend repair/replace with new door seals.

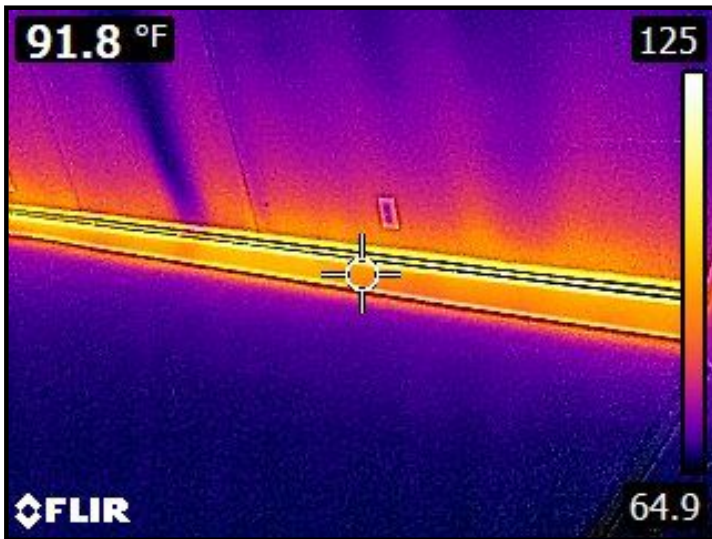
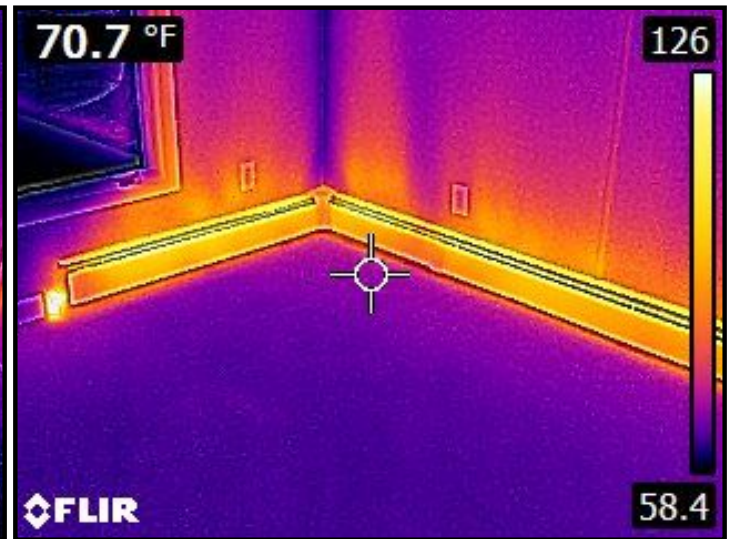
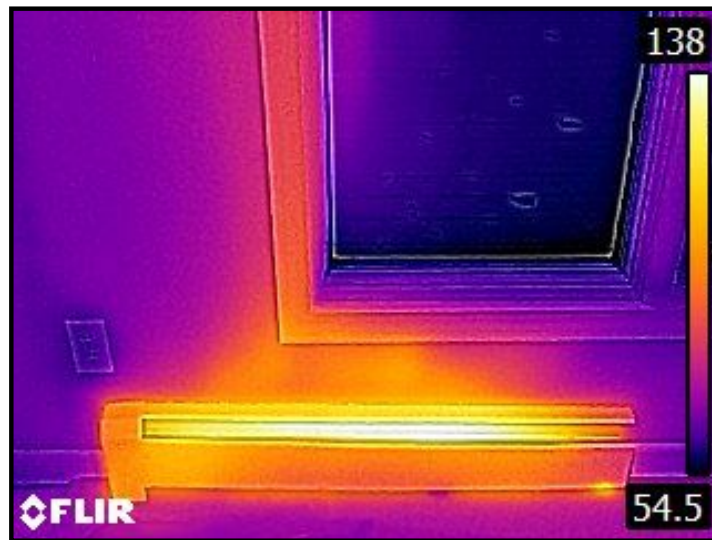
- The slant and fin heating in the living room where functioning properly and no leaks apparent at the time of the inspection.

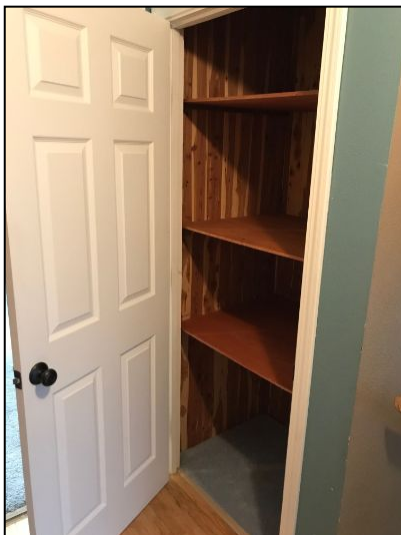
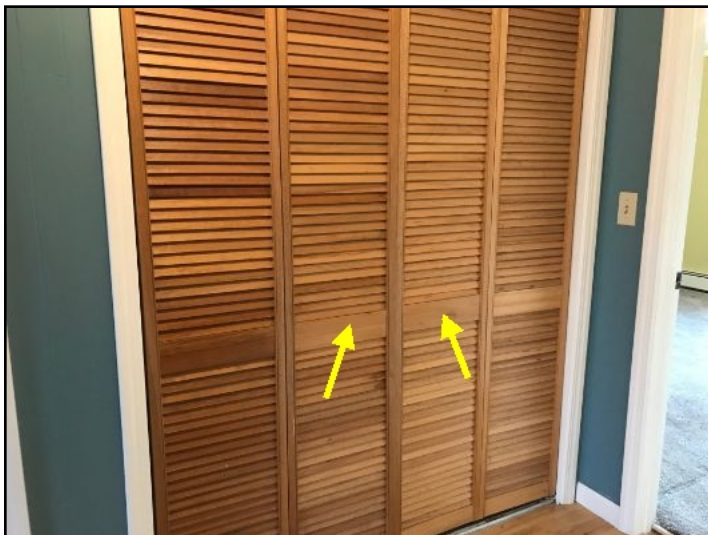
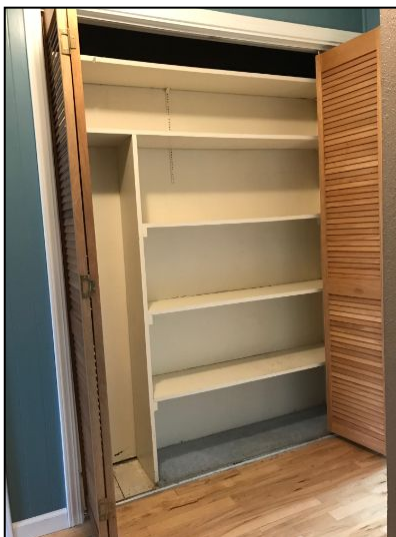
- The closet is in serviceable condition.
- Handel's on the closet doors will help with opening and closing the closet.

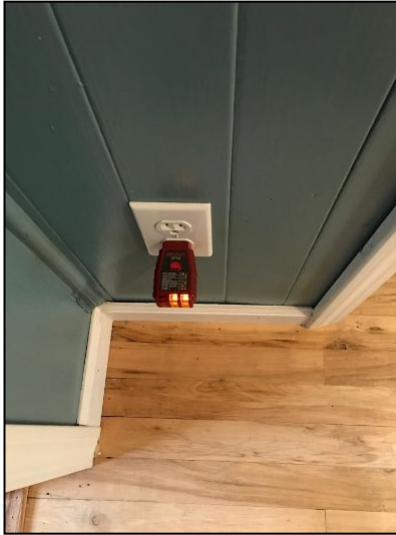
- Hallway electrical was in good working order at time of inspection.

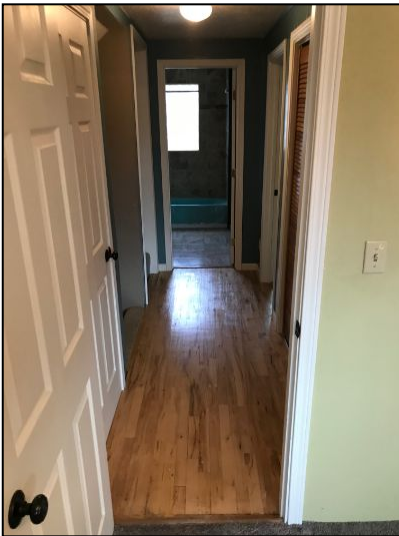
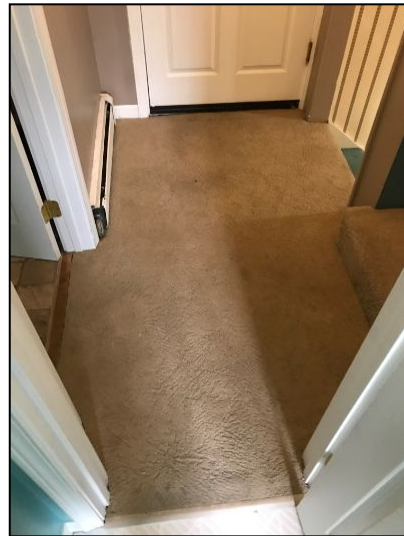
- Flooring appeared to be in good working order and in good condition at time of inspection.

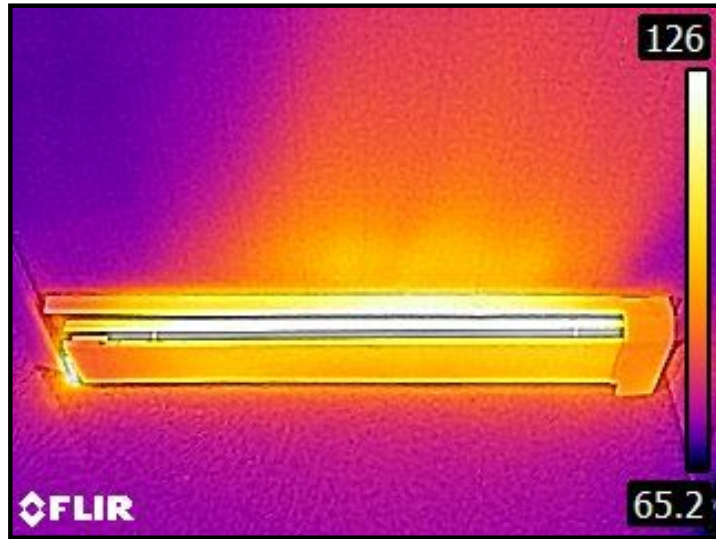
- The slant and fin heating in the living room where functioning properly and no leaks apparent at the time of the inspection.

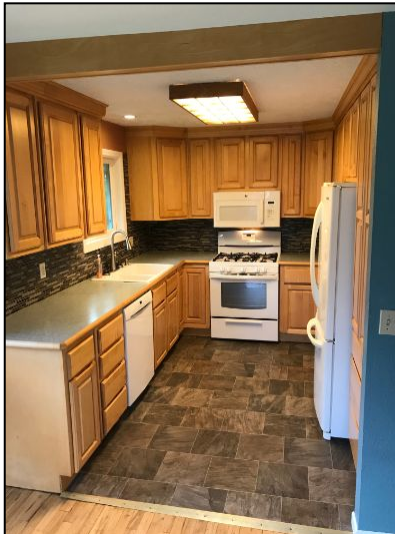
- No deficiencies observed.

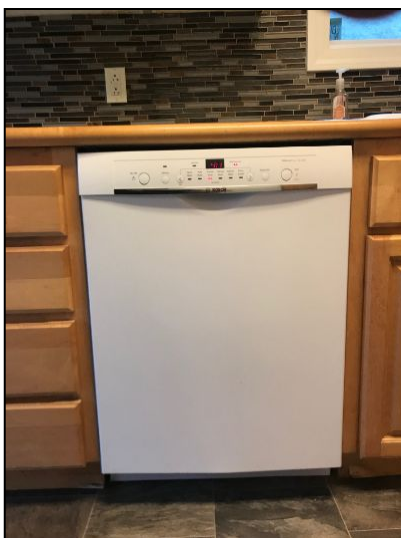
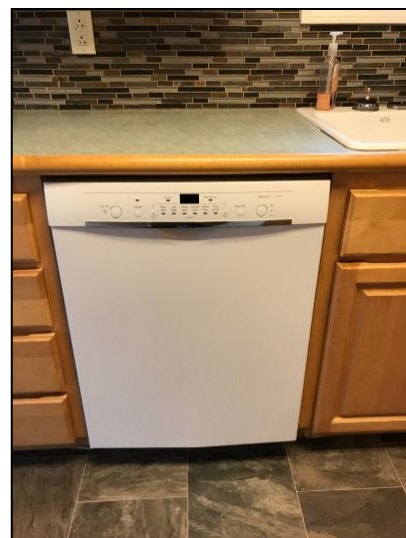
- Operated.
- Dishwasher was operational at the time of inspection. Dishwashers most commonly fail internally at the pump, motor or seals. We do not disassemble these units to inspect these components. We recommend you operate this unit prior to closing.

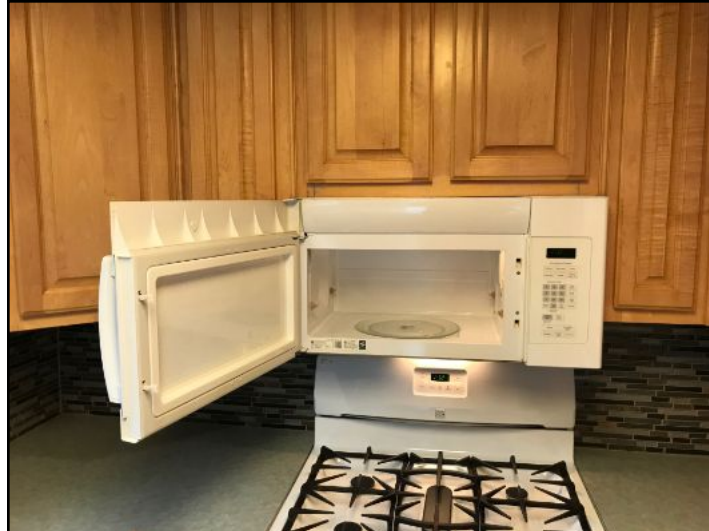
- Built-in microwave ovens are tested using normal operating controls. Unit was tested and appeared to be serviceable at time of inspection. Leak and/or efficiency testing is beyond the scope of this inspection. If concerned, client should seek further review by qualified technician prior to closing.

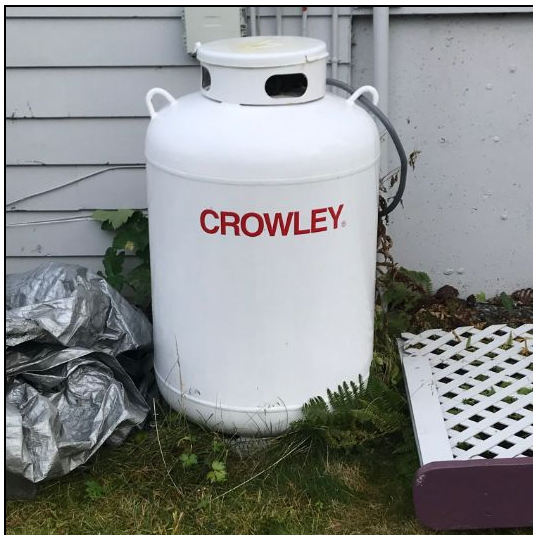
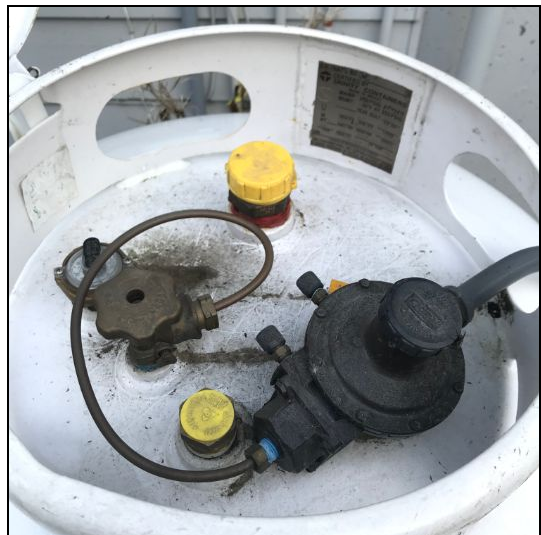
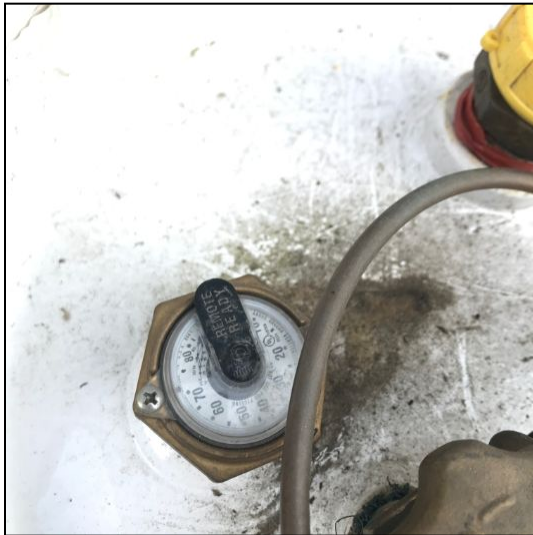
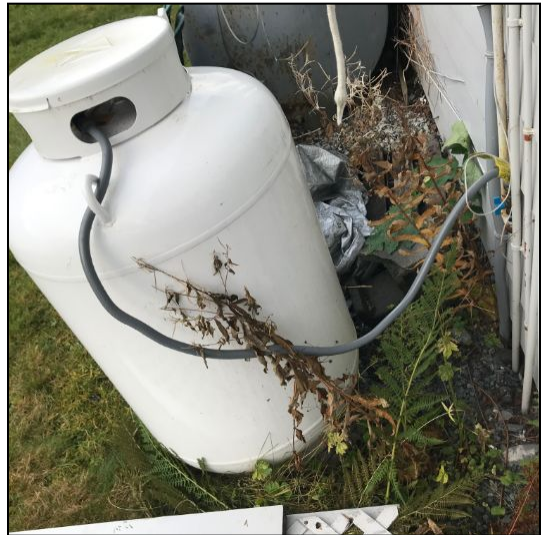
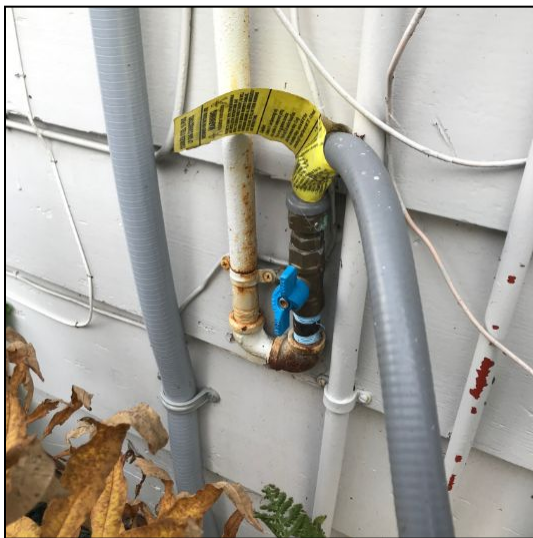
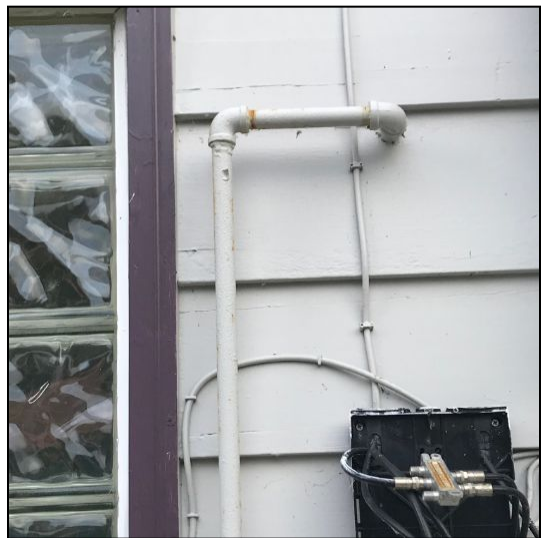
- Propane storage tank was in good serviceable condition and no apparent leaks of propane were detected at time of inspection.

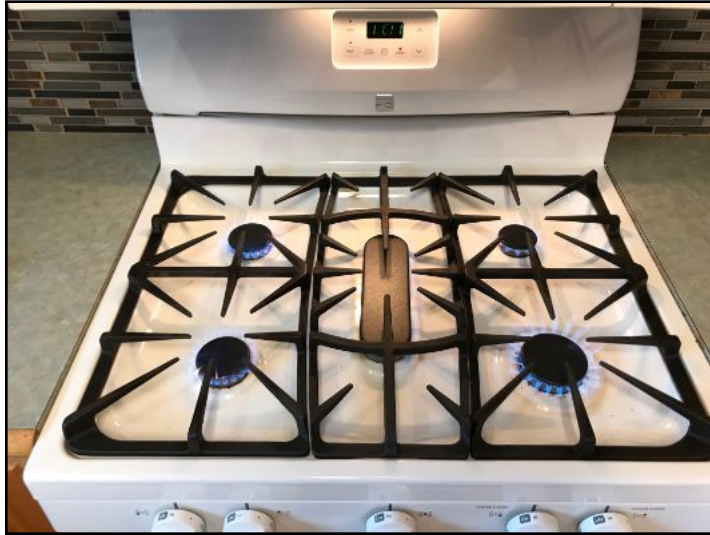
- Gas cook top noted.
- All heating elements operated when tested.
- Oven(s) operated when tested.
- This unit was tested and appeared serviceable at time of inspection. Inspection does not include calibration as this is not a technically exhaustive inspection. No warranties or guarantees of this or any other appliance can be offered.
- **Anti-tip bracket is missing from range installation. See label inside oven door. All free-standing, slide-in ranges include an anti-tip device and is essential in the safe operation of the range. It provides protection when excess force or weight is applied to an open oven door. Carried by home building centers.**
- **SAFETY CONCERN: Free standing range missing anti-tip bracket/device. Should be installed.**

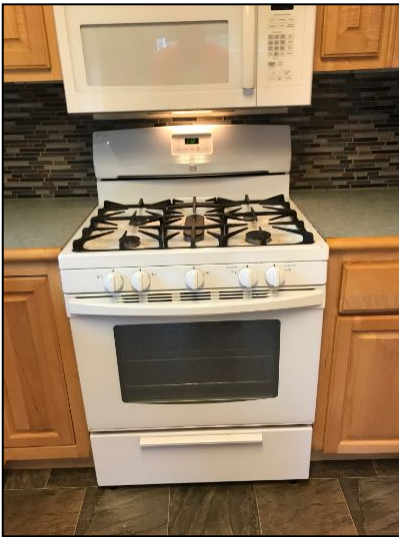
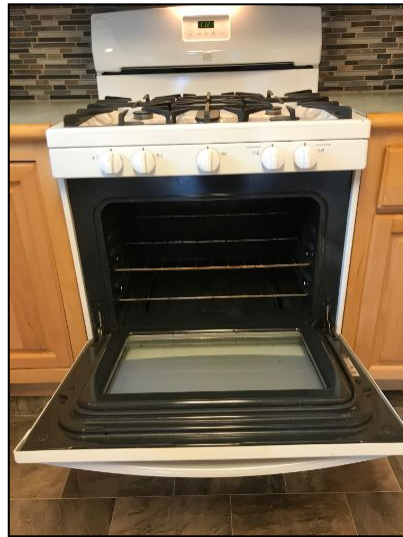
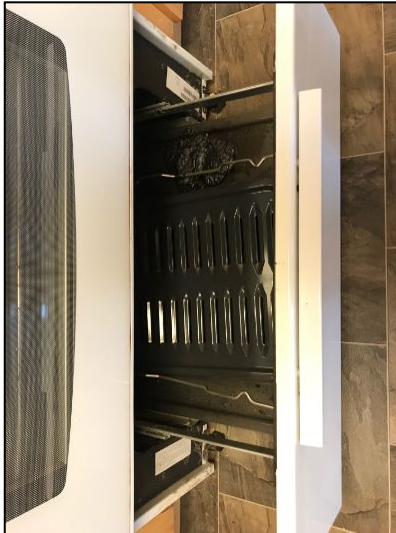
- Oven: Propane gas burners
- Oven(s) operated when tested.

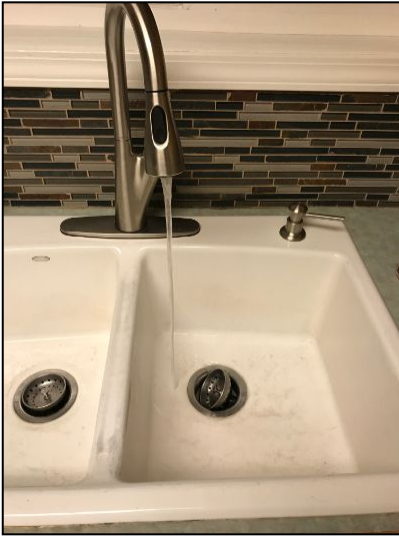
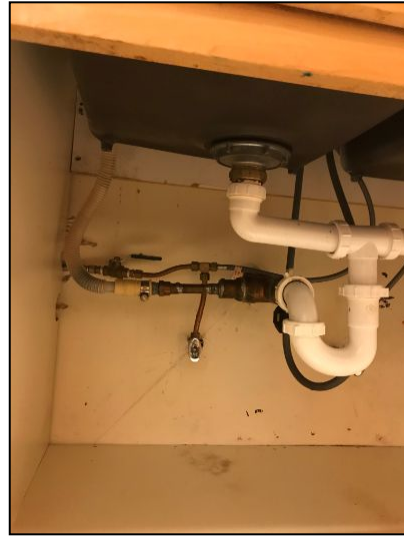
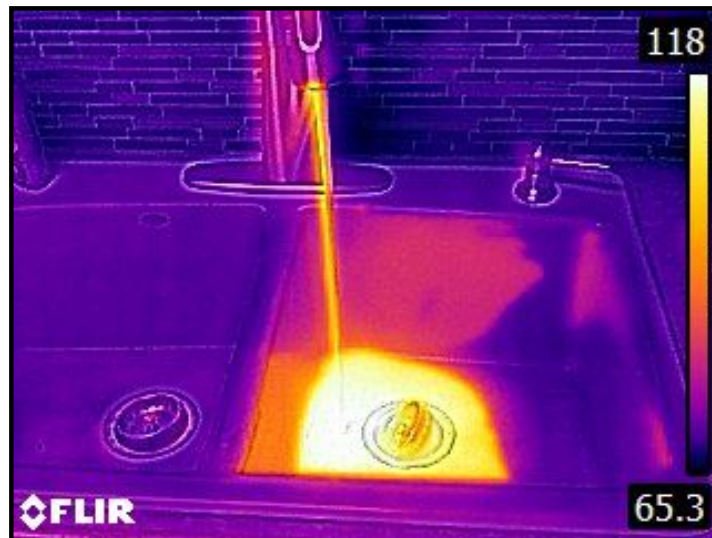
- Operated normally, at time of inspection.

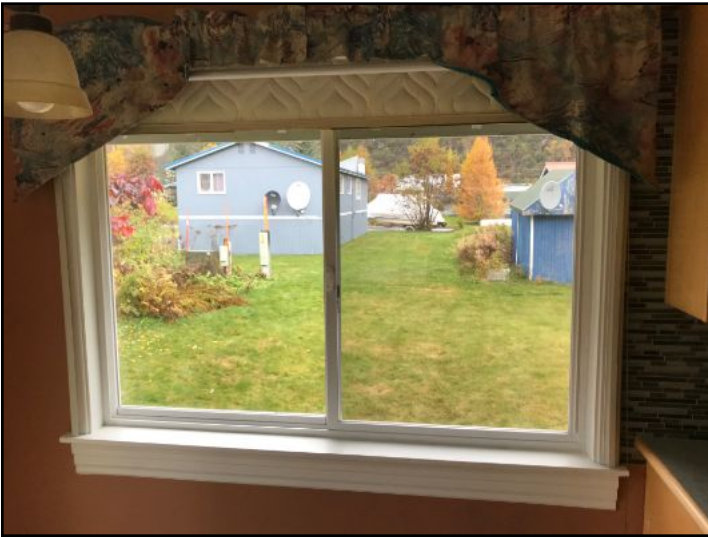
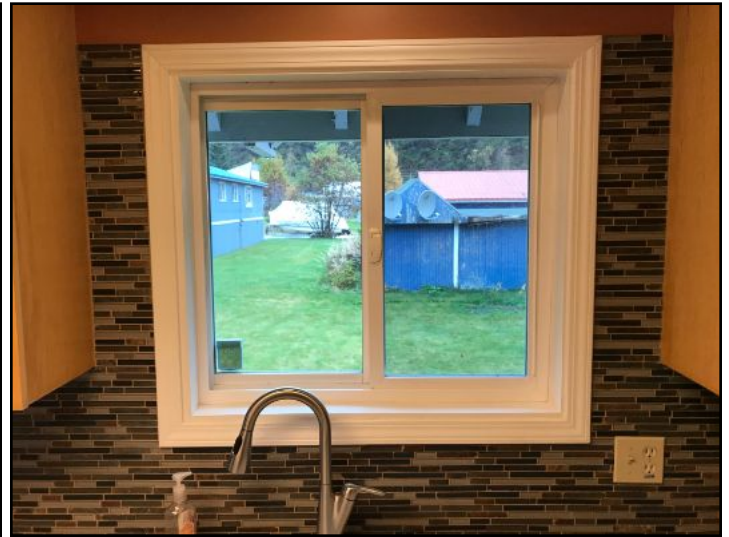
- Operated windows appeared functional, at time of inspection.
- Highly recommend operating all windows during final walk through inspection.

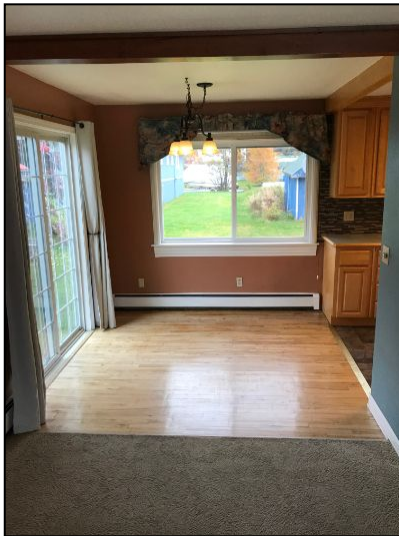
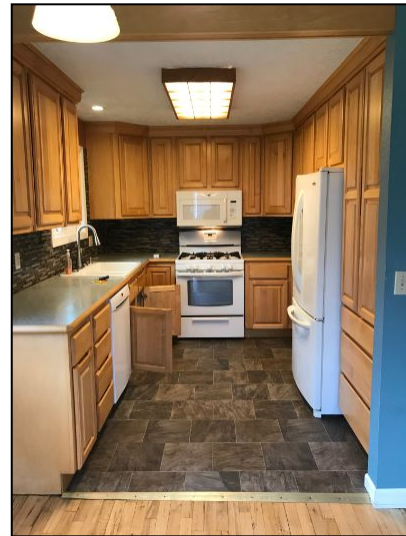
- Flooring appeared to be in good working order and in good condition at time of inspection.

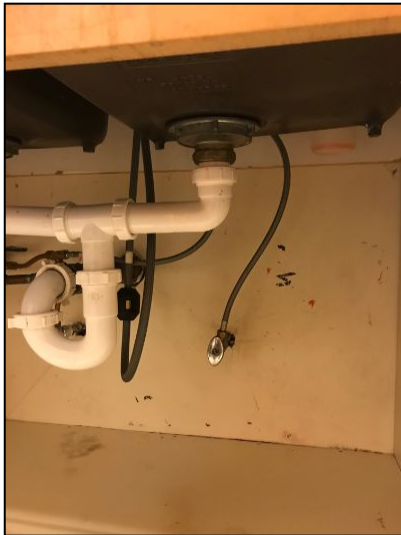
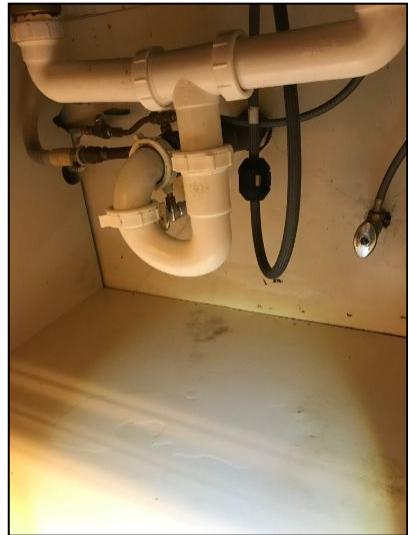
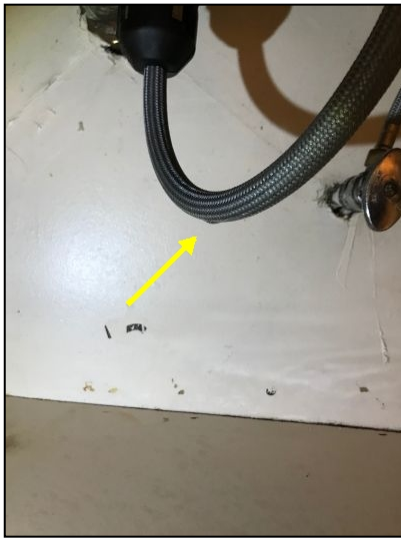
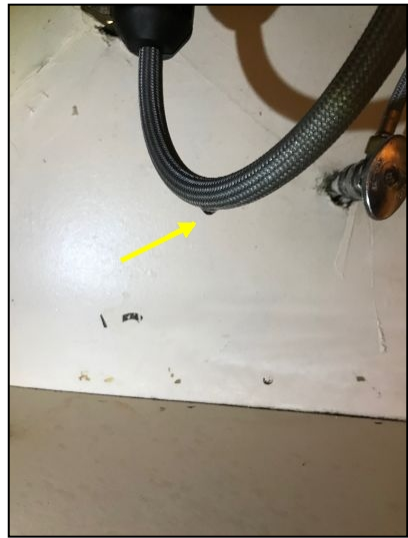
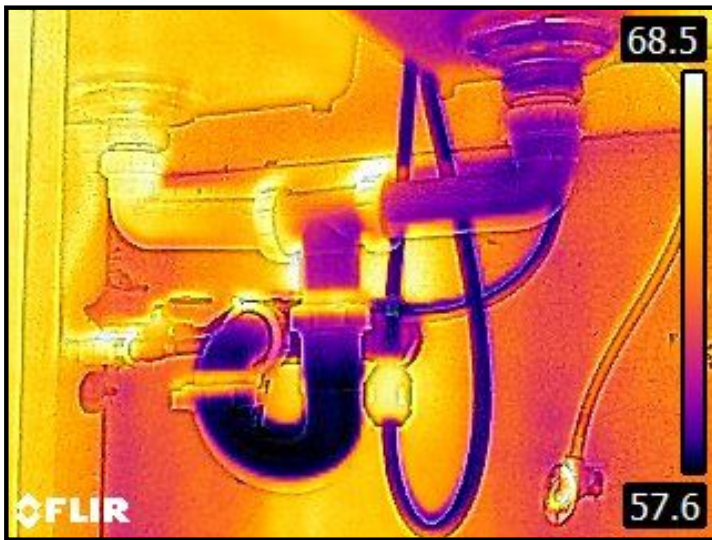
- Proper P trap installed and no leaks detected in the draining plumbing.
- Water line for sink wand leaks. Recommend repair or replace to prevent any water damage.
- Visible leaking noted under the sink. We recommend contacting a licensed plumbing contractor for repair options.

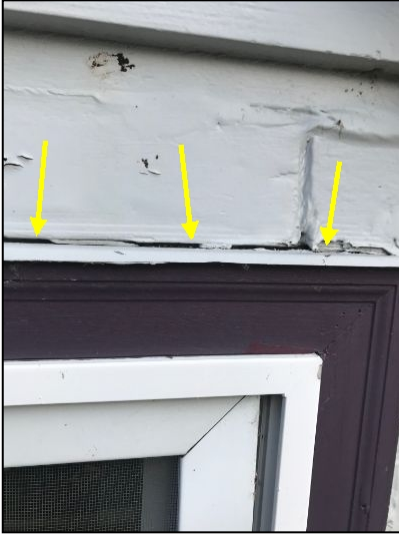
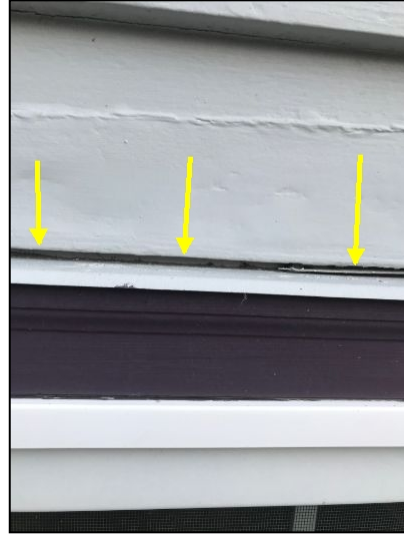
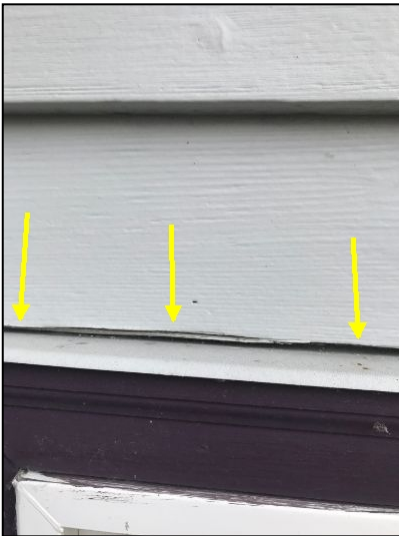
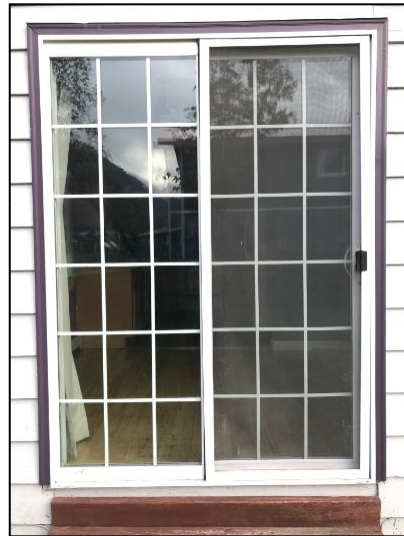
- The sliding patio door was functional during the inspection.
- The doors hardware is showing signs of wear and may be at the end of its useful life. We recommend budgeting for replacement.
- The sliding door tracks appeared dirty at the inspection making the door difficult to operate. We recommend cleaning the tracks and lubricating the doors rollers.
- Tempered glass noted in the patio door.
- **Flashing and sealing is recommended over the top of the patio door. This will help shed water and prevent any water intrusion.**

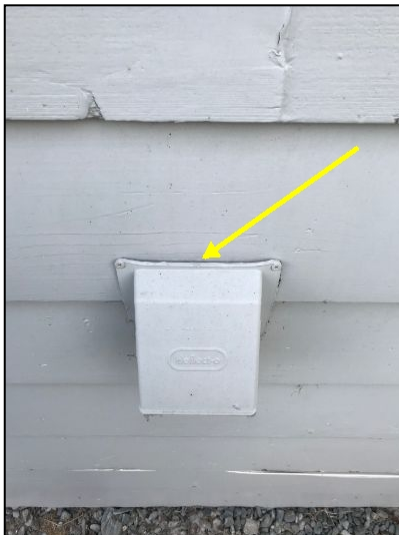
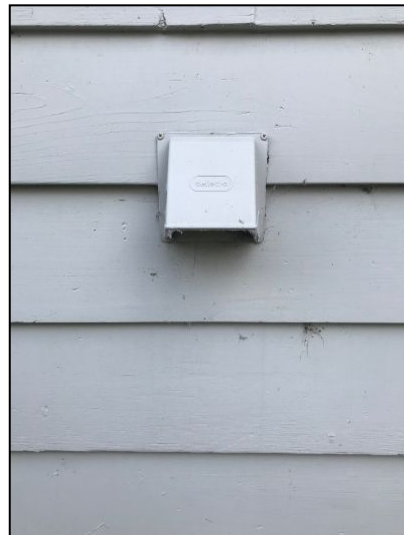
2. Dryer Vent

- Could not fully inspect the dryer vent, it is obscured behind the dryer.
- Dryer vent appeared functional and no problems observed at time of inspection.
- Chalking is recommended to prevent any water damage to siding of the home.

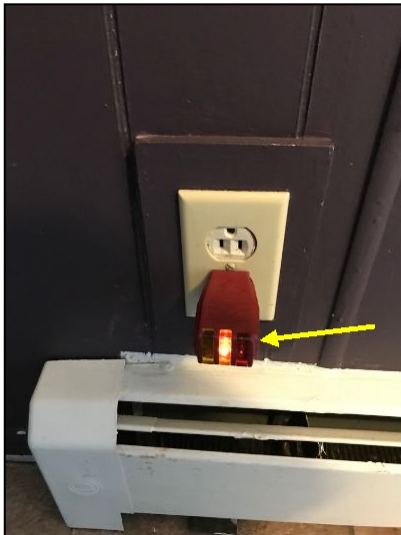
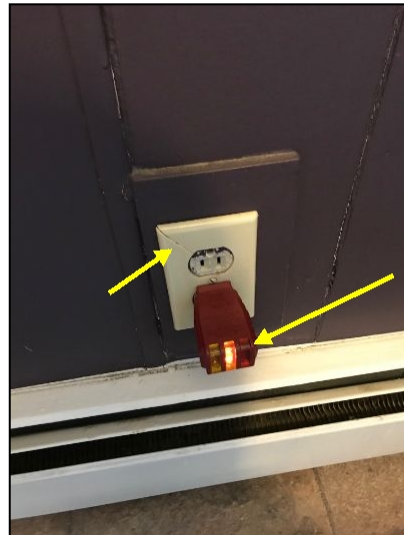
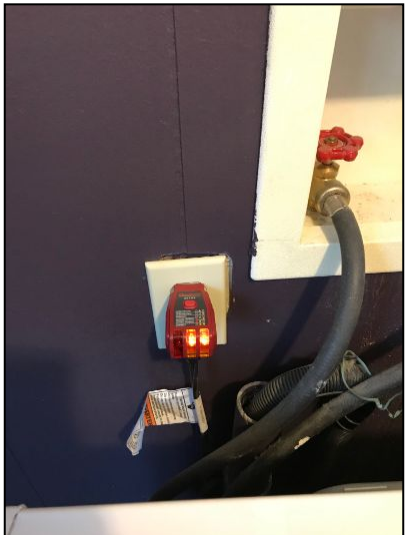
3. Electrical

- Open ground- receptacles in laundry. Recommend licensed electrician to evaluate and repair.

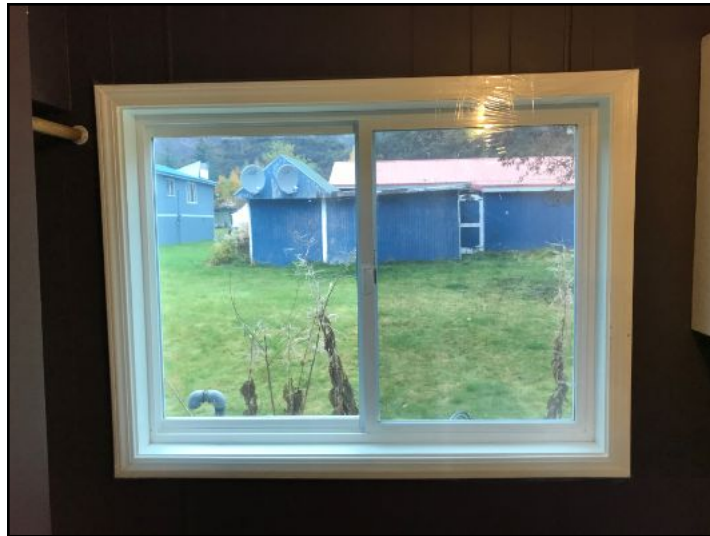
7. Window Condition

- Laundry window appeared functional.
- Was not able to operate window due to plastic film covering the window.

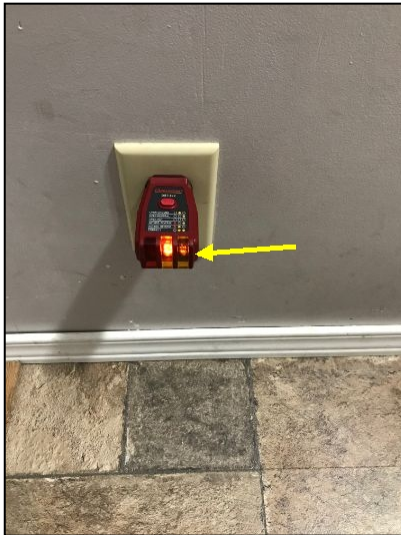
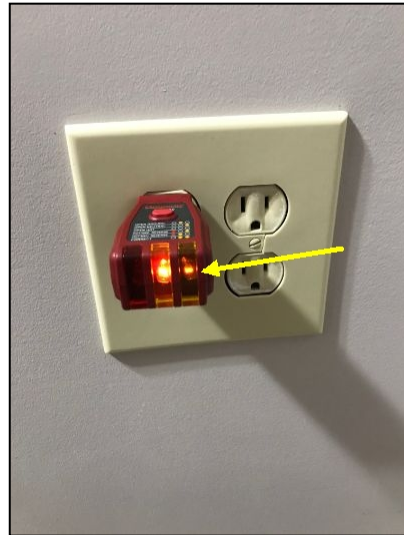
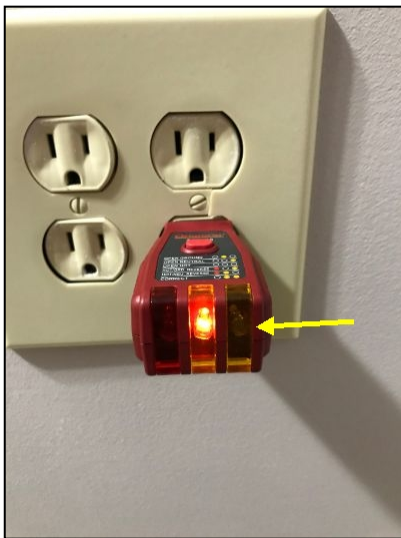
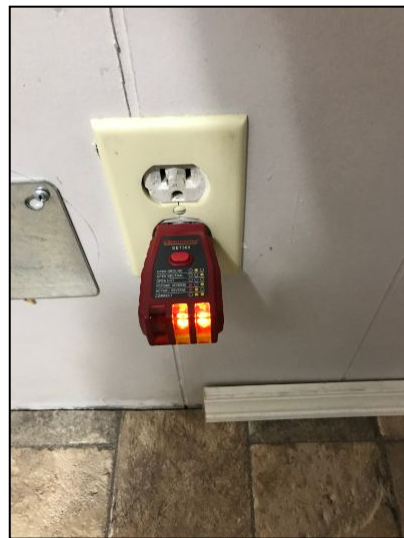
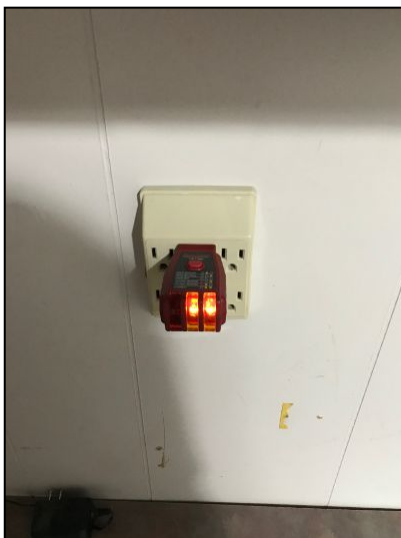
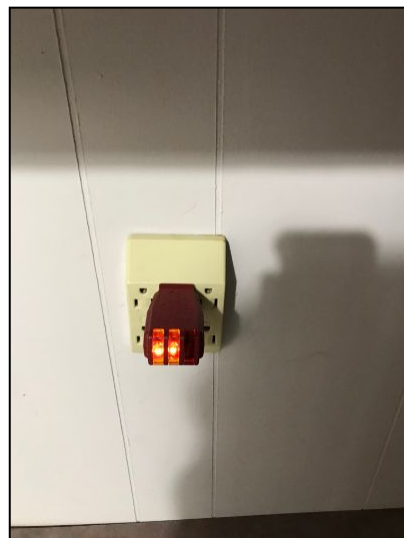
3. Electrical

- Open ground - receptacle in wall across from windows in dining room.
- Weak ground found in the office electrical outlets. Have a licensed electrician evaluate and repair.

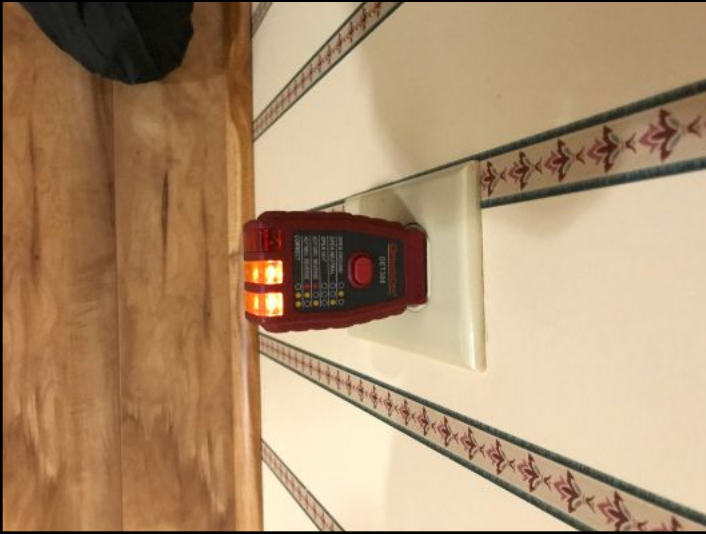
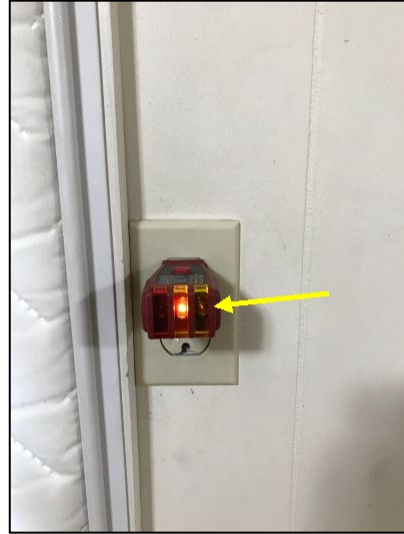
- Electric outlet has open ground in basement. Recommend a licensed electrician to evaluate and repair.

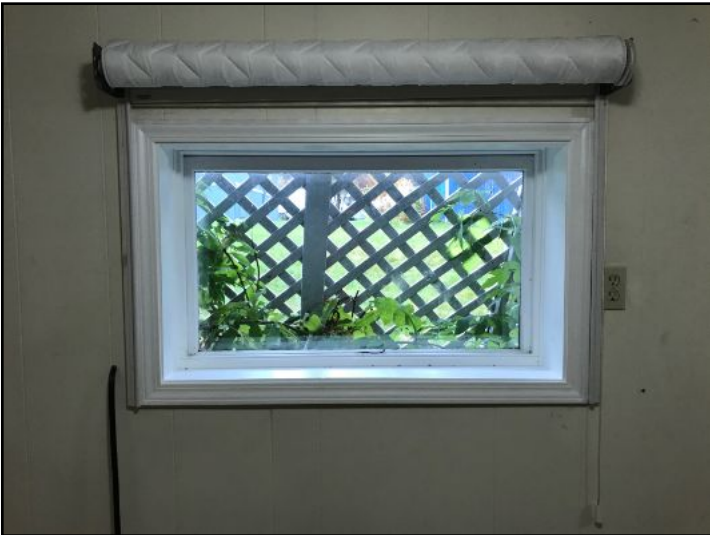
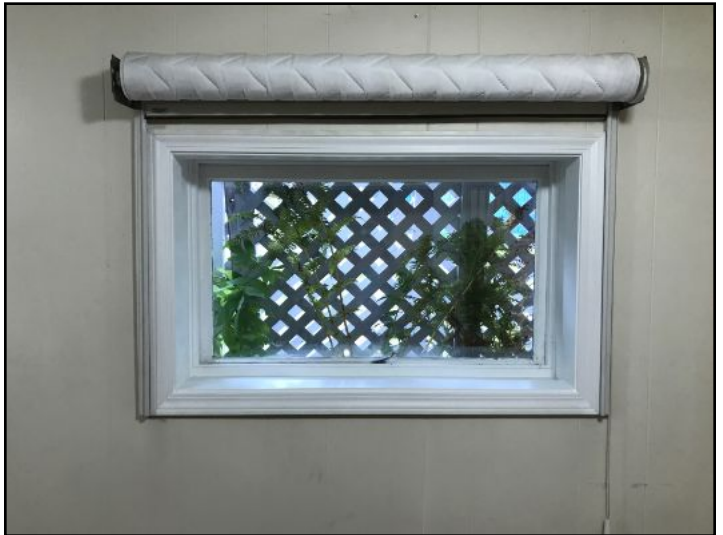
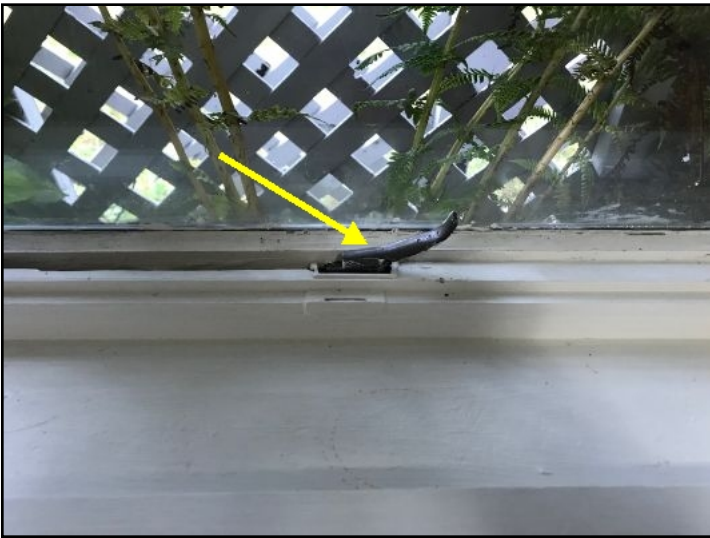
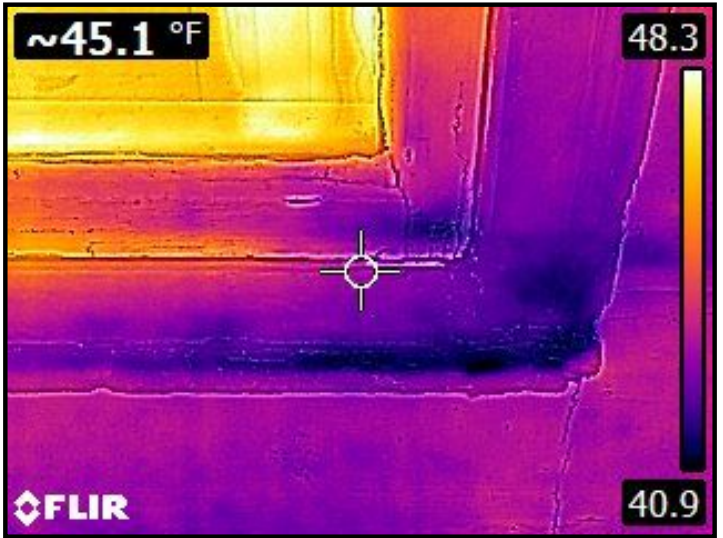
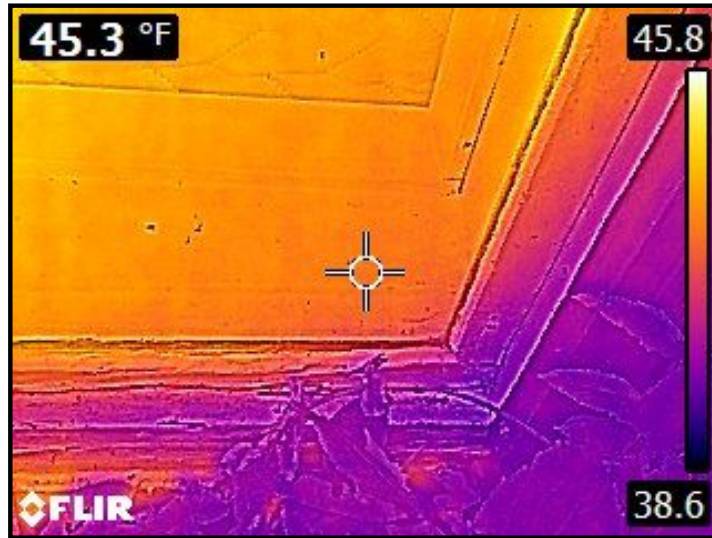
4. Window Condition

- Some windows did not open when tested. Recommend all windows reviewed for proper operation during walkthrough inspection prior to closing
- All accessible windows operated
- Deterioration noted due to contact with moisture, repairs needed.
- One or more windows did not lock/latch properly, recommend repairs for enhanced security/safety to occupants.
