Arctic Home Inspections

Property Inspection Report

Inspection prepared for:
Date of Inspection: 2/22/2022

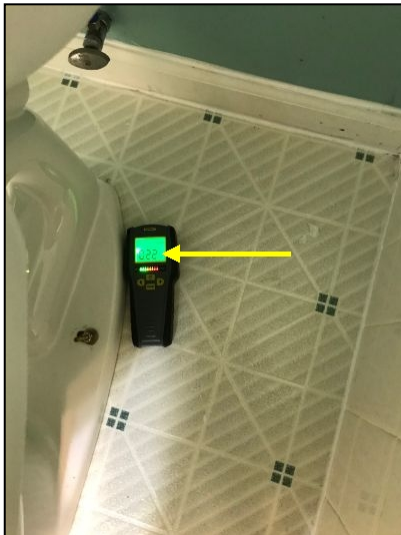
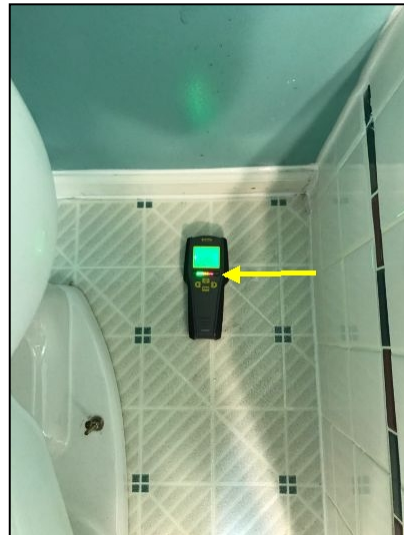
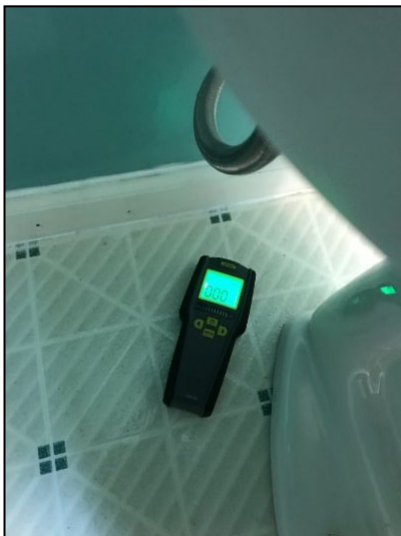
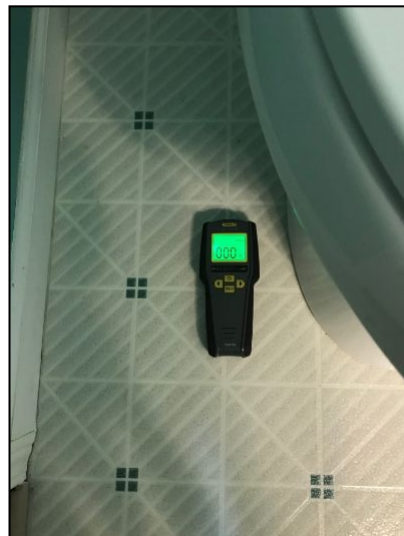
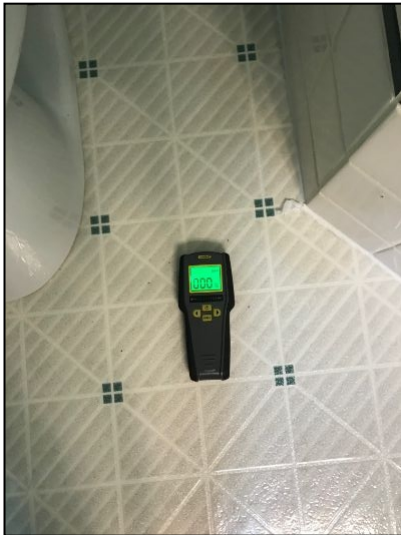
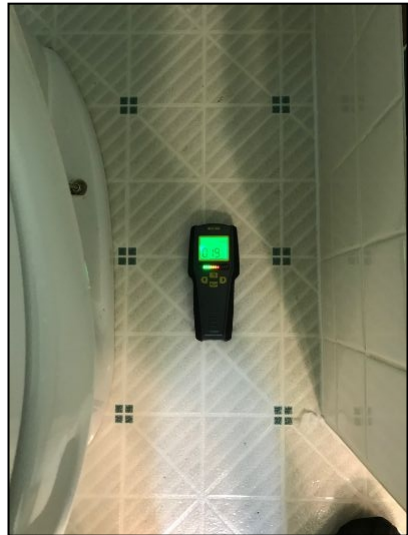
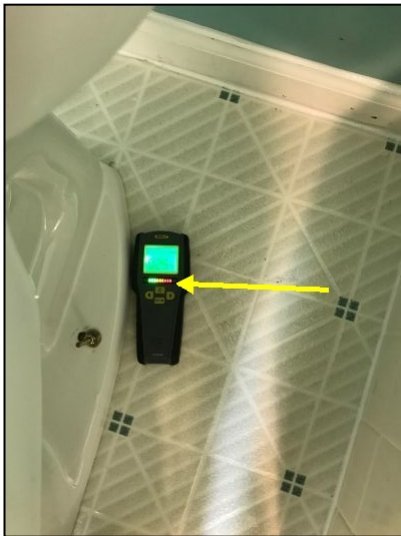
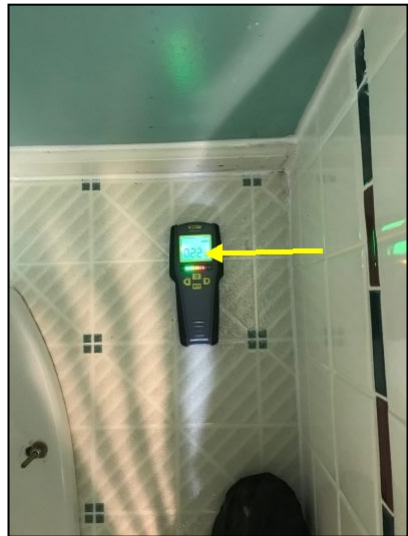
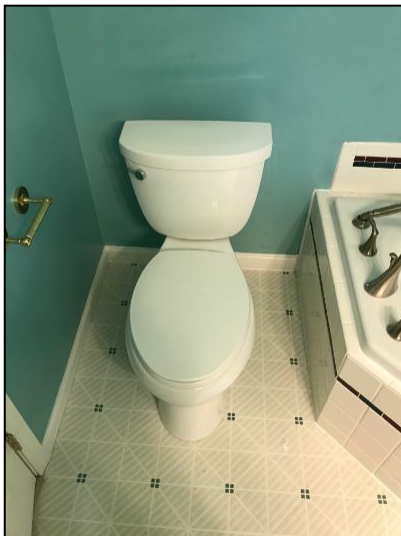
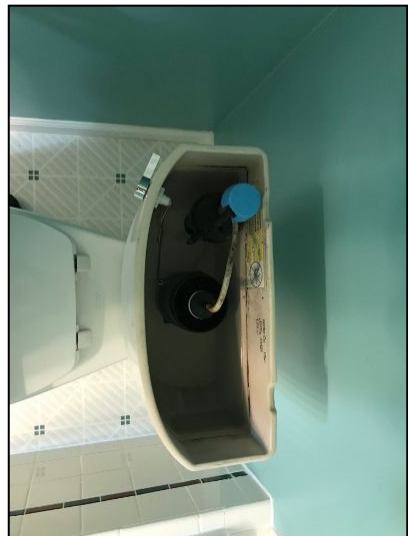
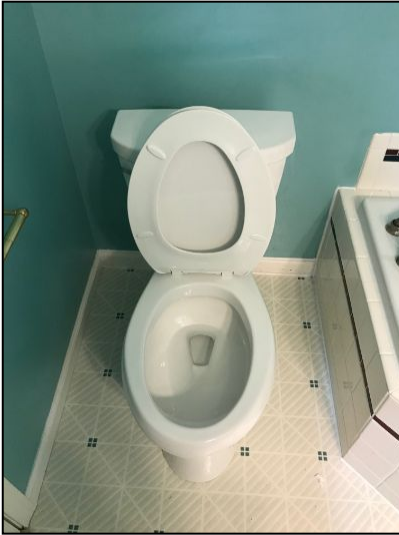
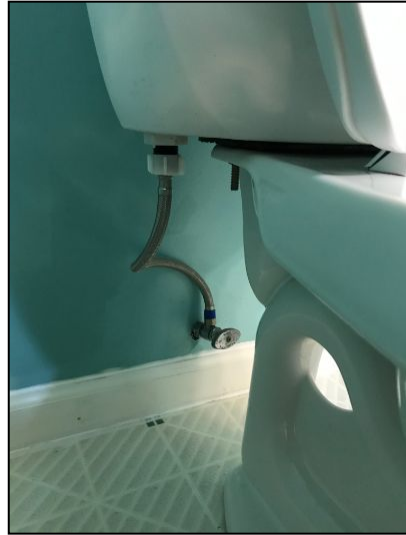
6. Toilets

- Observed as functional and in good visual condition.
- Operated when tested. No deficiencies noted.
- Operated when tested. Appeared functional, at time of inspection - except as noted.
- **Checking the floor around the toilet with a moisture meter and appears there was a leak at some point from the toilet or whirlpool. Recommend a contractor to pinpoint the problem and repair or replace as needed.**

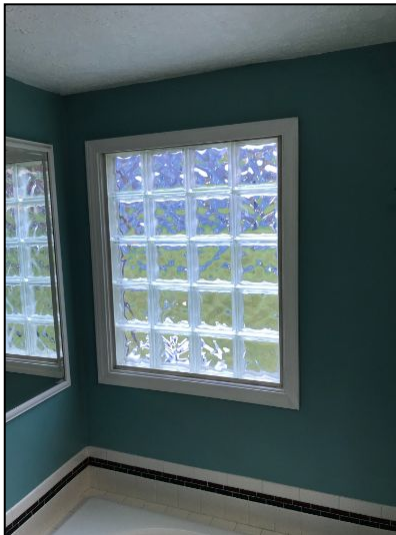
- Window in bathroom #1 is glass block.
- Window was in good working condition at time of the inspection.

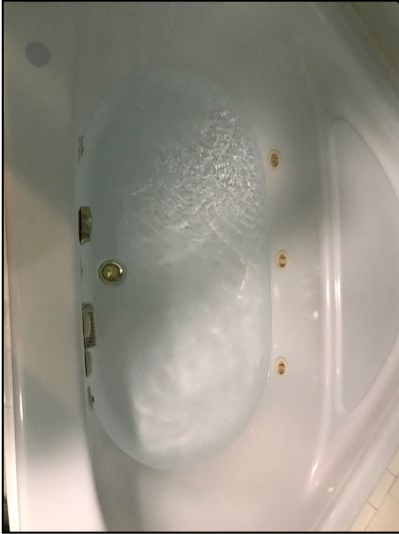
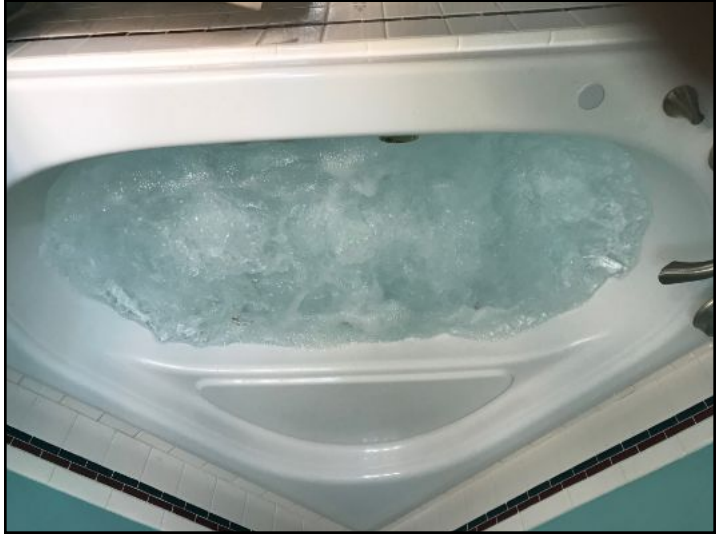
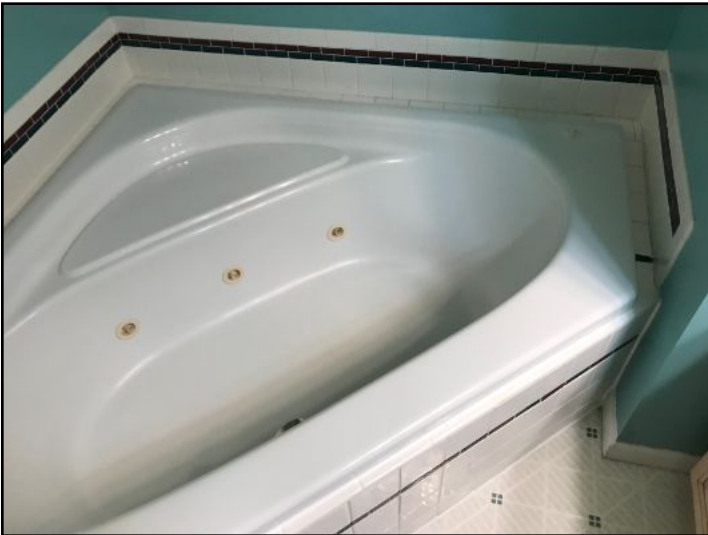
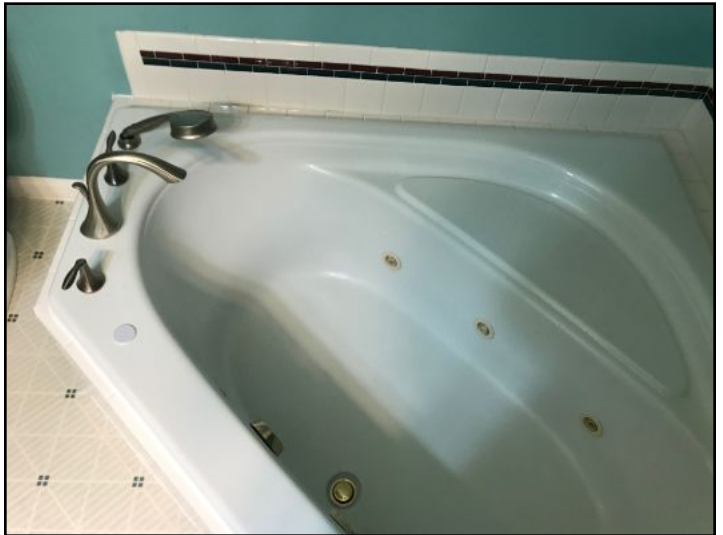
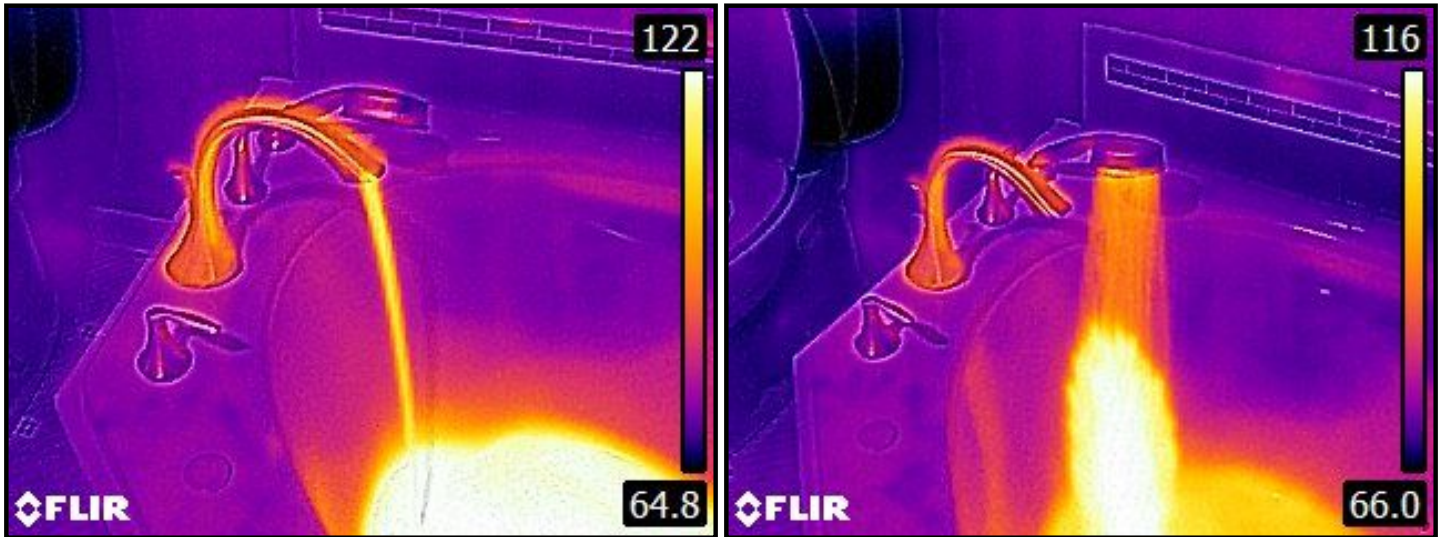
1. Whirlpool Condition

- Whirl pool in bathroom #1 was in good working condition at time of inspection.

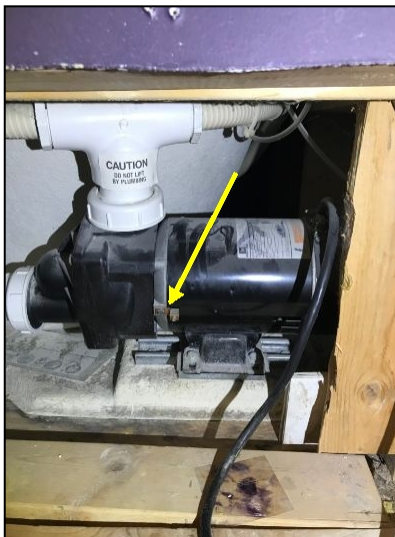
2. Whirlpool Pump

- Pump for the whirl pool should be electrically bonded for protection. A licensed electrician should evaluate the pump and fix as needed.

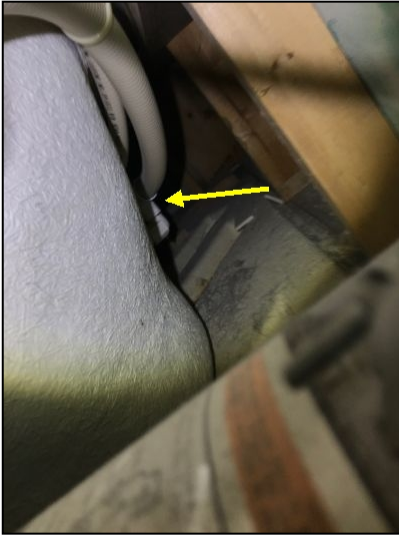
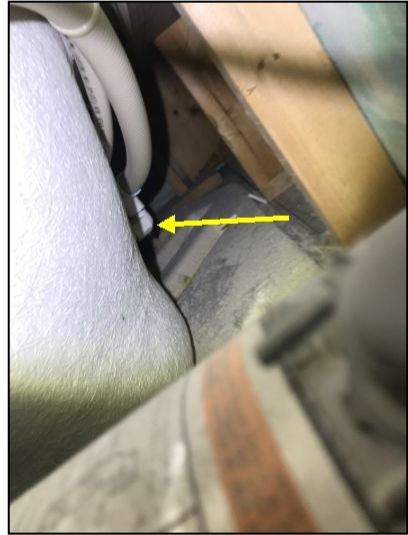
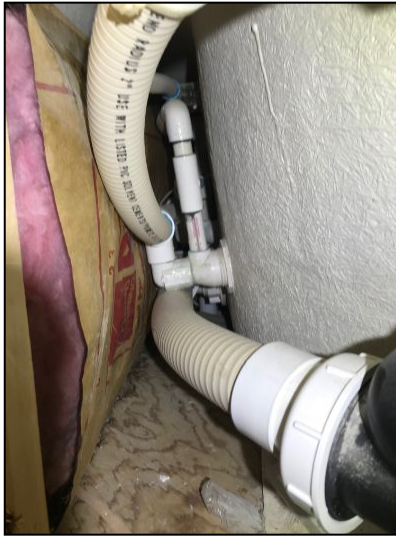
3. Whirlpool Plumbing

- After running whirl pool and checking for leaks. There was on leak detected under the whirlpool in the back corner. I have provided arrows pointing to the leak source. Recommend license contractor to repair.

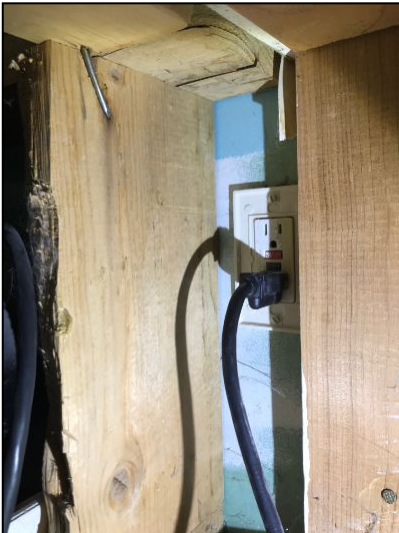
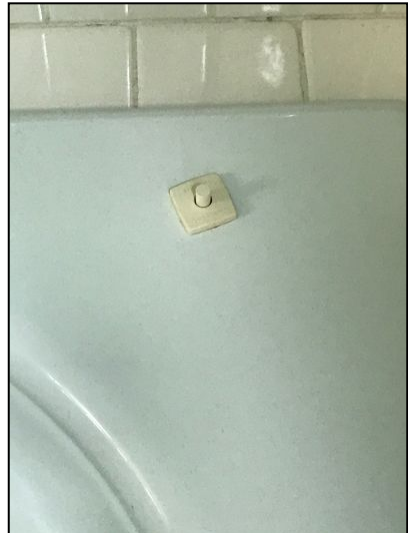
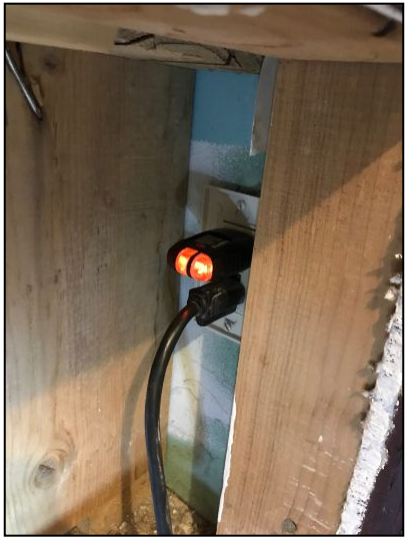
4. Whirlpool Electrical

- Whirlpool electrical was in good working condition at time of inspection.

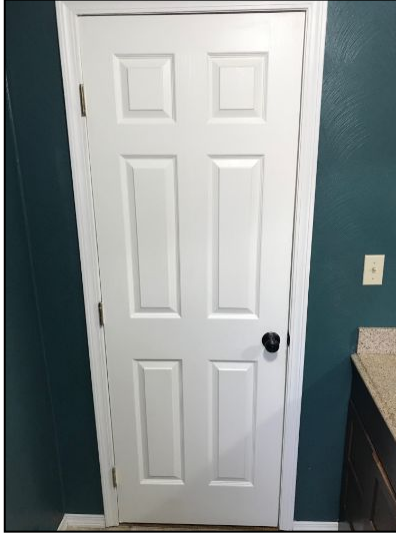
- Bathroom #2 door was in servicable condition.

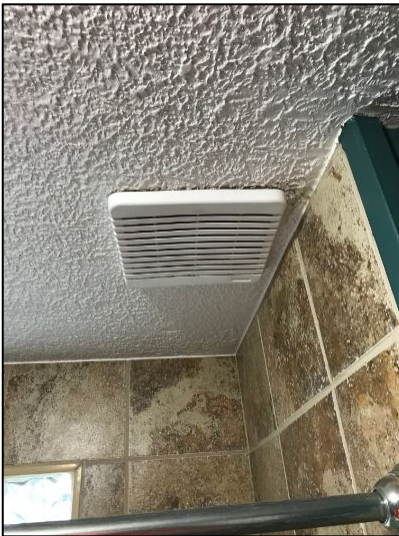
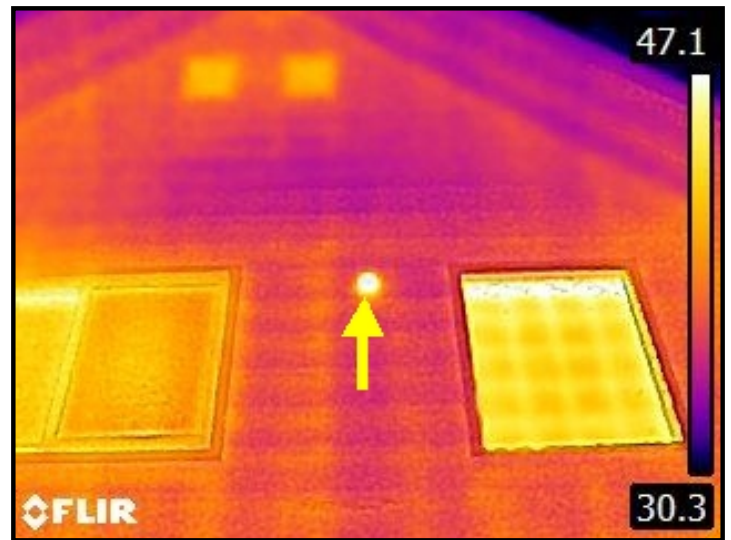
3. Exhaust Fan

- The bath fan was operated and no issues were found.

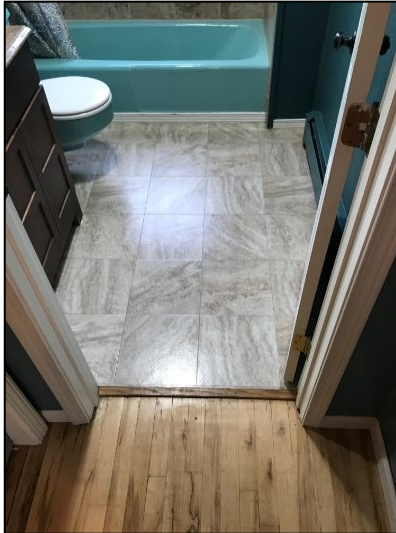
4. Floor Condition

- Flooring was in serviceable condition at time of inspection.

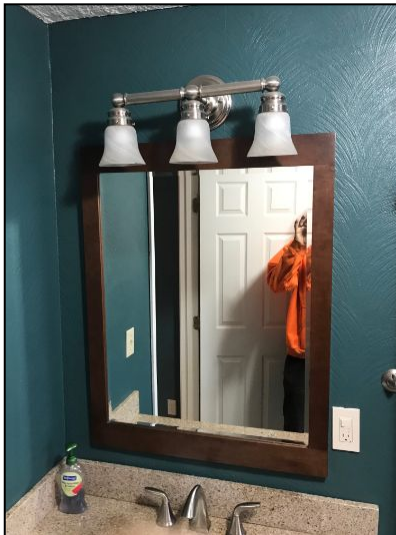
5. Mirrors

- Mirror in bathroom #2 was secure and in proper working order at time of inspection.

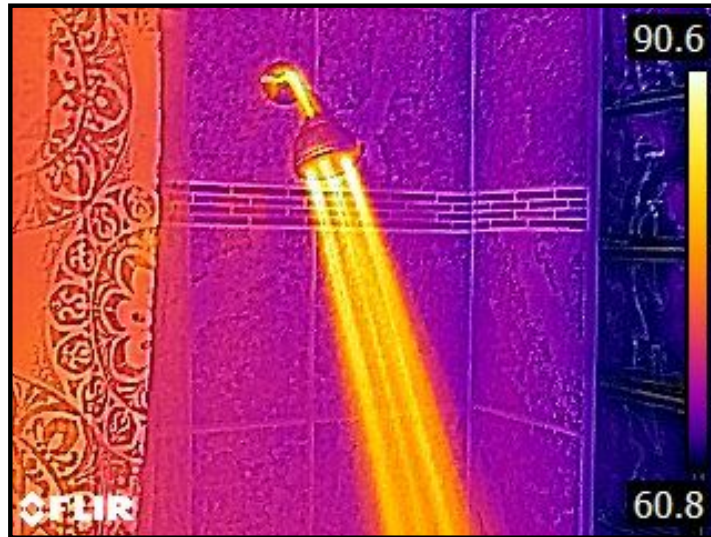
6. Showers

- functional

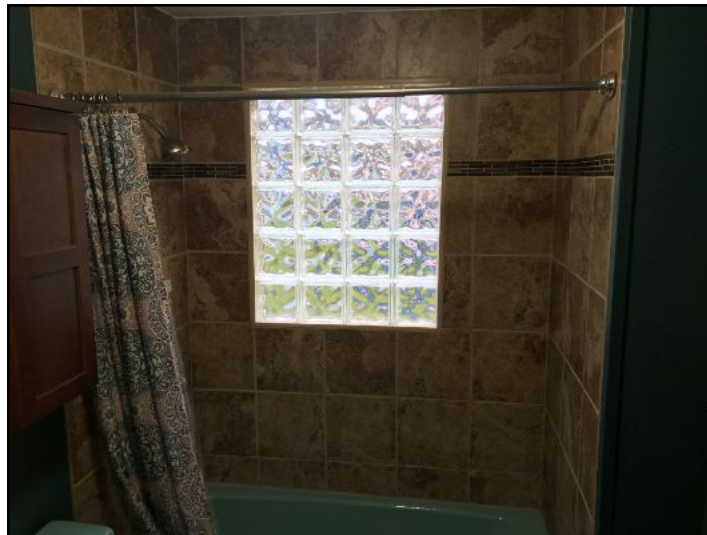
7. Shower Walls

- Ceramic tile noted.
- Recommend caulking as required.
- Suggest all tile edges and tub/shower walls be caulked and sealed to prevent moisture penetration. All missing/damaged grouting should be replaced. Failure to keep walls sealed can cause deterioration and extensive moisture damage to the interior walls and surrounding sub-flooring. This damage is not always visible or accessible to the inspector at the time of inspection.

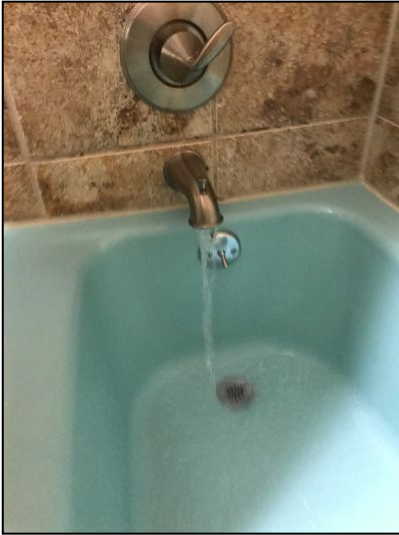
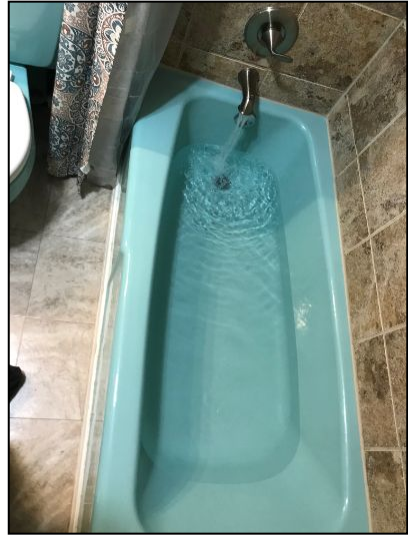
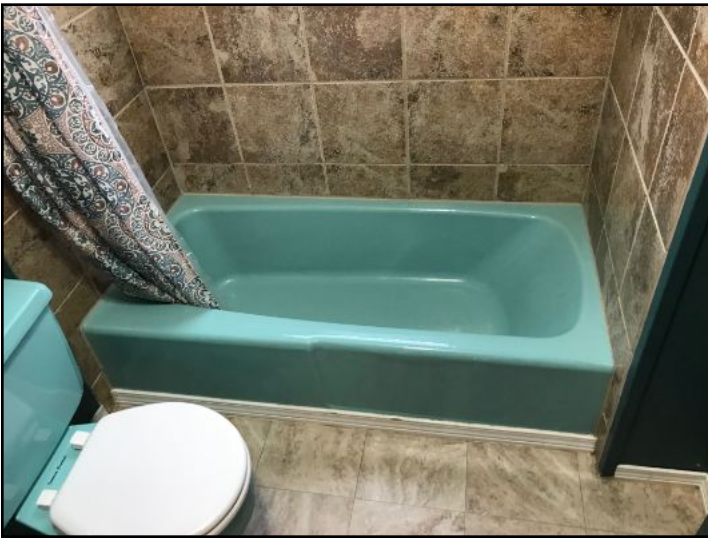
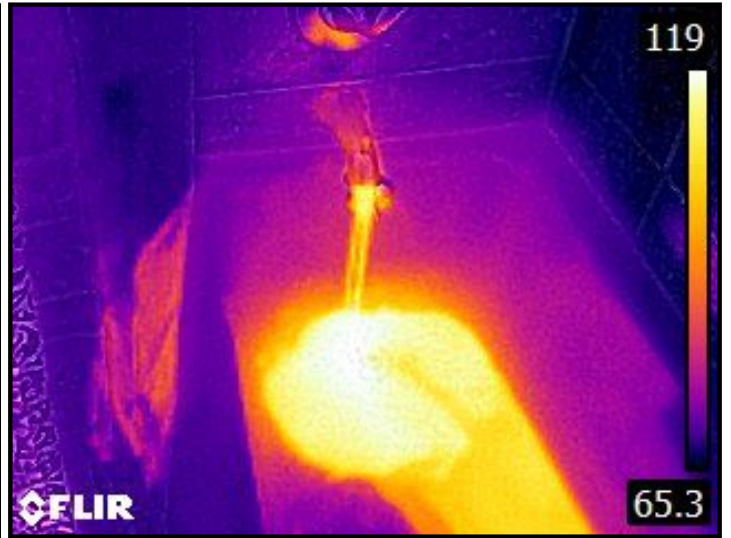
8. Bath Tubs

- Tub
- Tub in bathroom #2 was in good working condition at time of inspection.

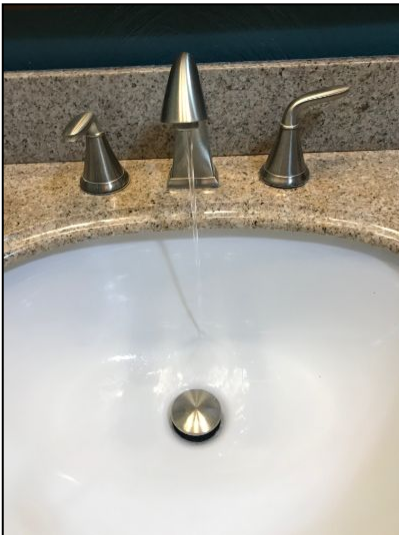
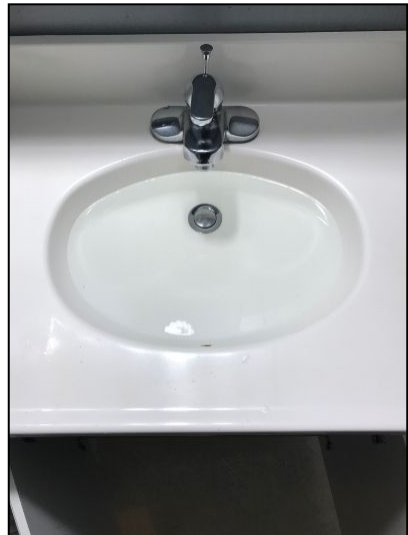
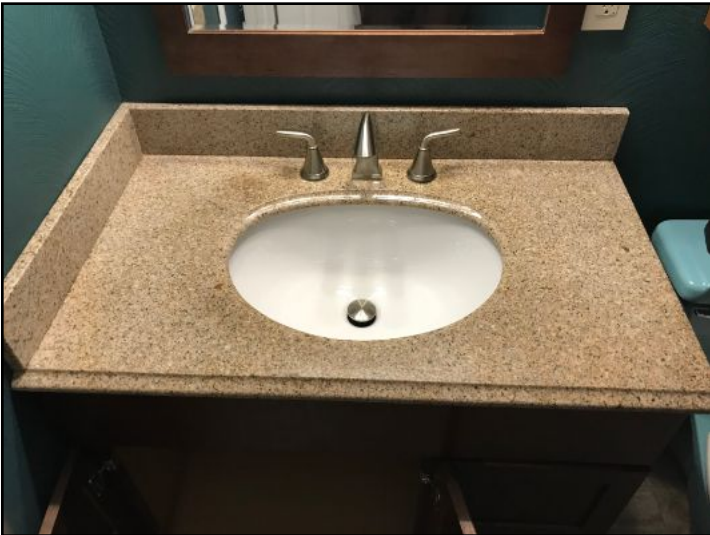
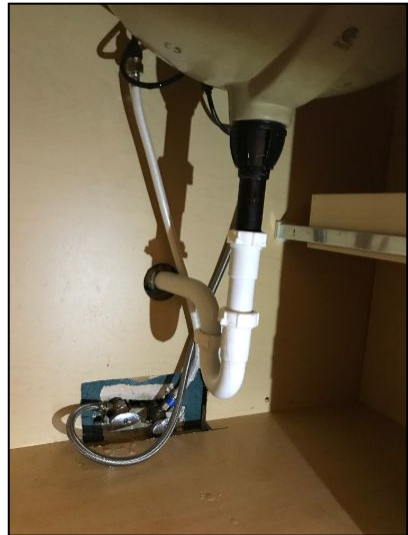
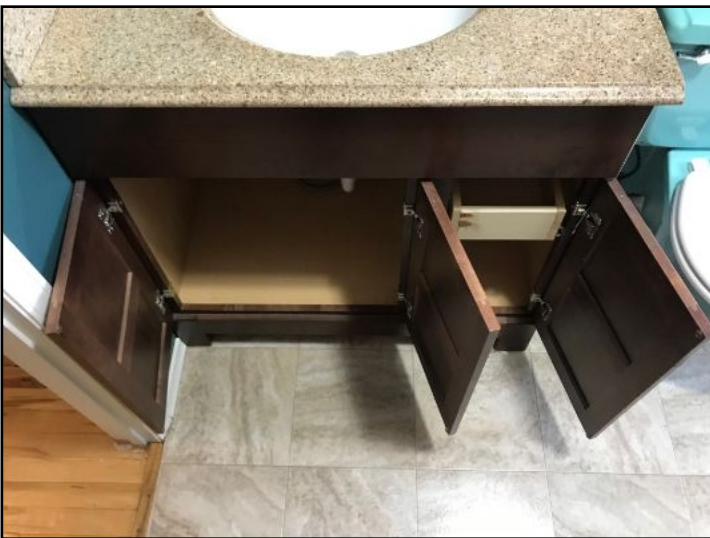
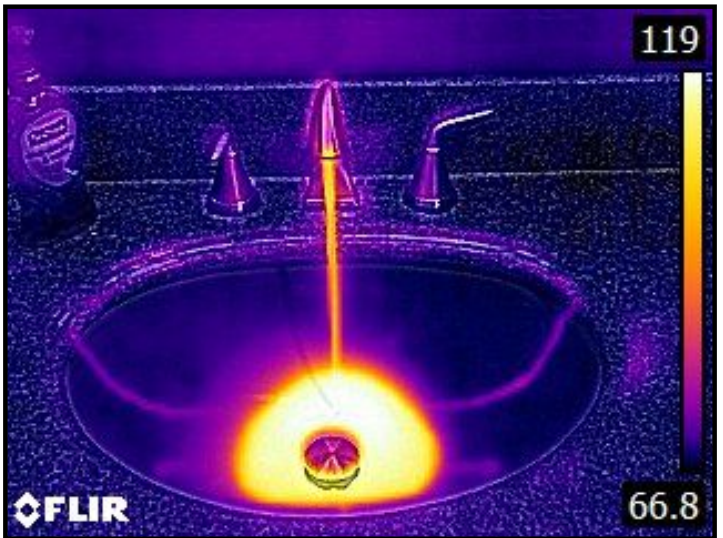
9. Sinks

- No deficiencies observed.
- Operated normally, at time of inspection.

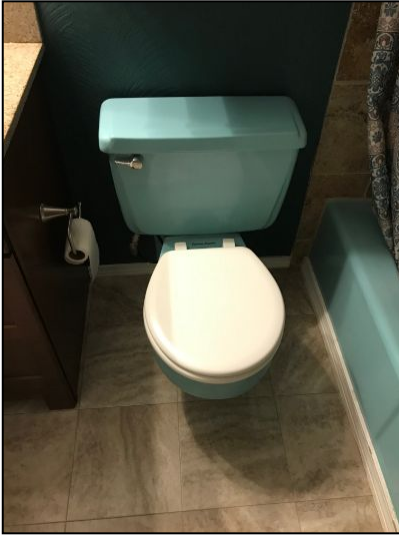
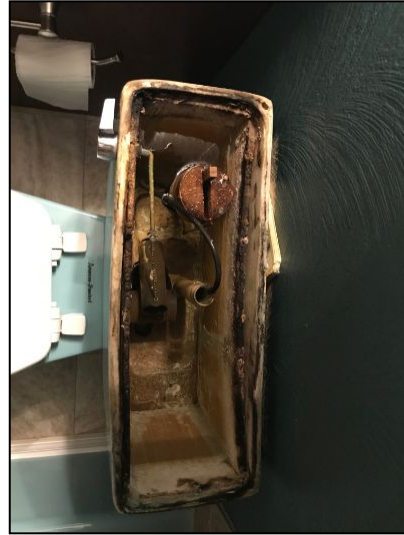
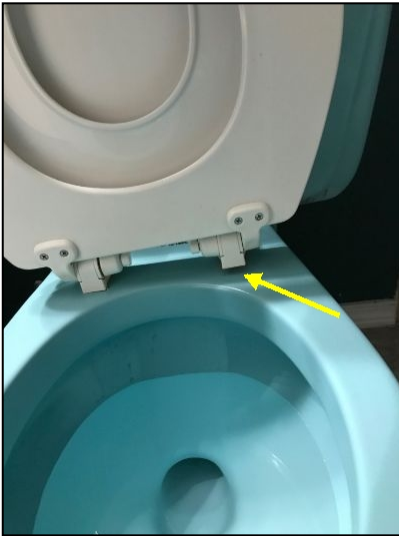
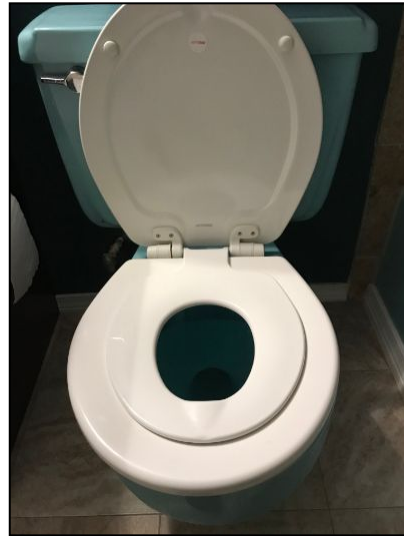
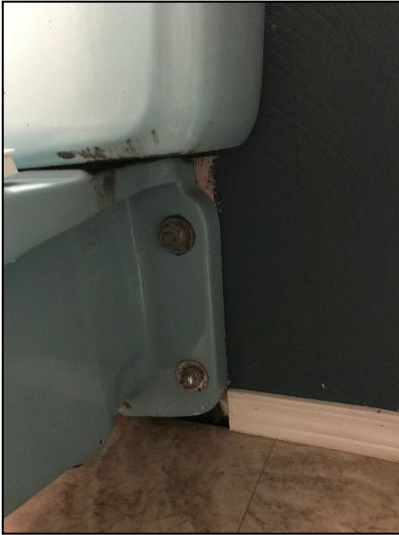
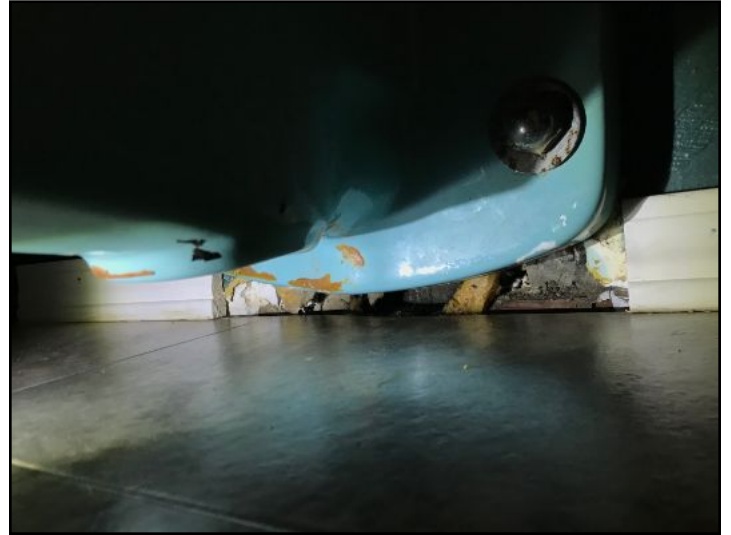
10. Toilets

- Observed as functional and in good visual condition.
- Operated when tested. No deficiencies noted.
- Operated when tested. Appeared functional, at time of inspection - except as noted.
- Toilet seat is a little loose.

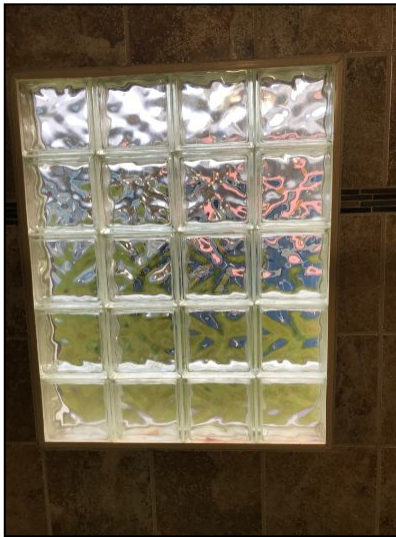
11. Window Condition

- Window was in good working condition at time of the inspection.

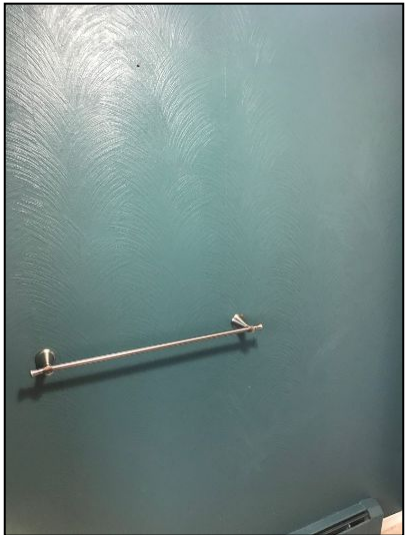
12. Bathroom Walls

- Bathroom #2 walls were in good working condition at time of inspection.

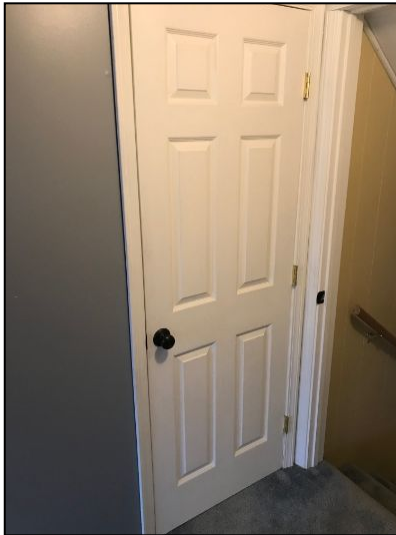
- No major system safety or function concerns noted at time of inspection.

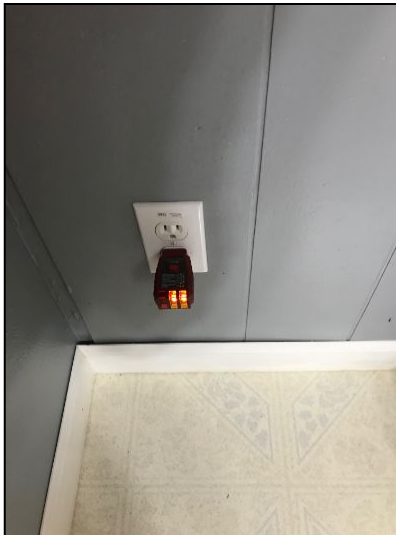
2. Electrical

- No major system safety or function concerns noted at time of inspection.

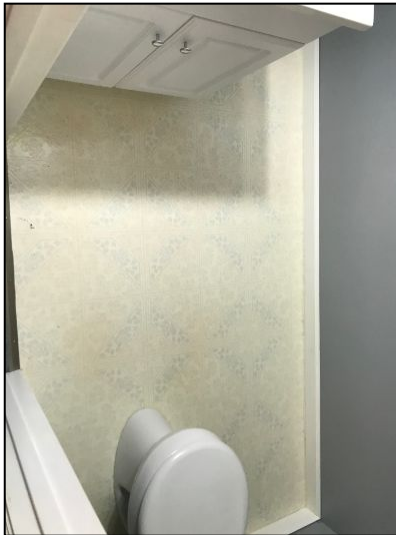
3. Floor Condition

- Flooring in bathroom #3 was in serviceable condition at the time of the inspection.

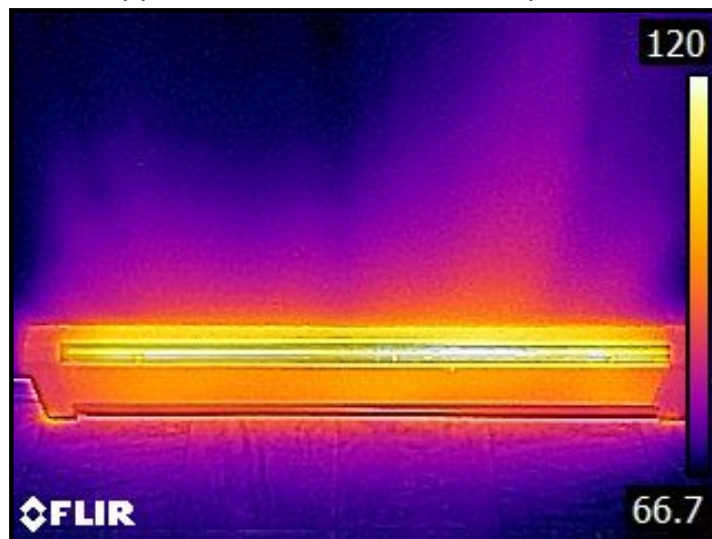
4. Heating

- The slant and fin heating in the living room where functioning properly and no leaks apparent at the time of the inspection.

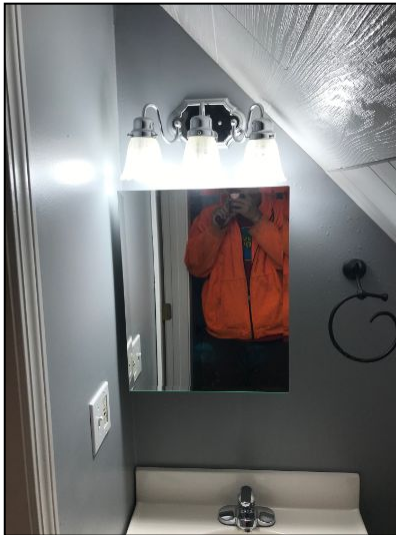
5. Mirrors

- Mirror in bathroom #3 was secure and in proper working order at time of inspection.

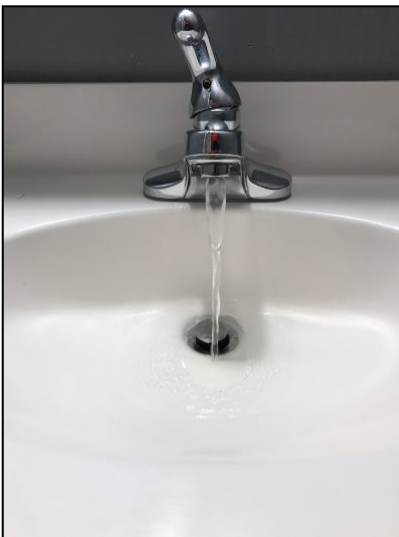
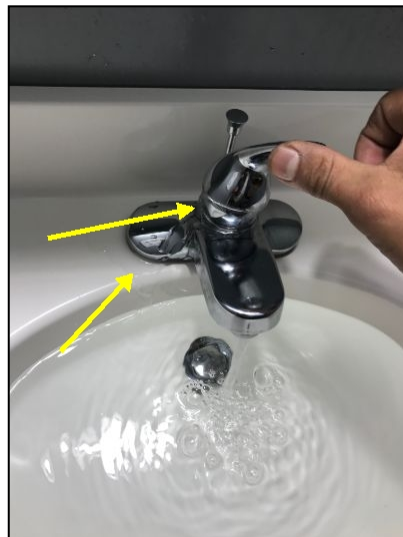
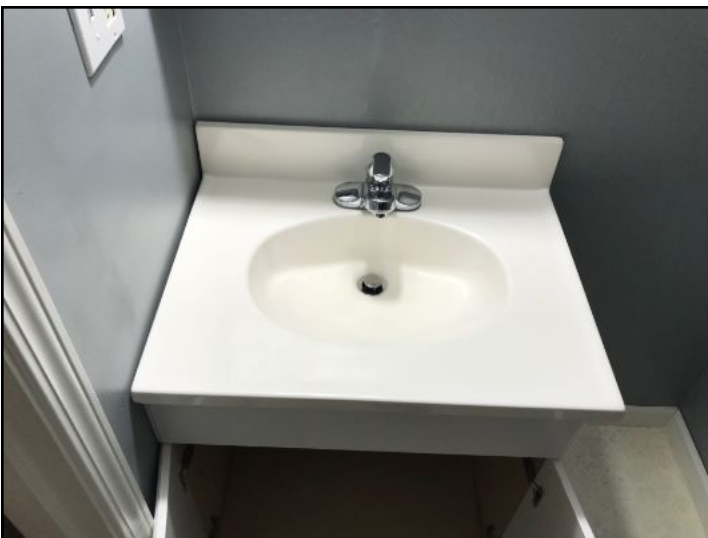
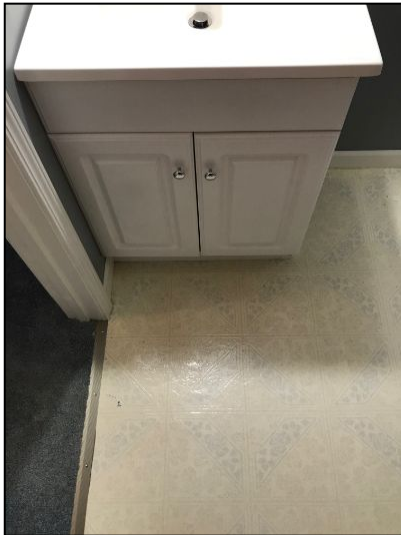
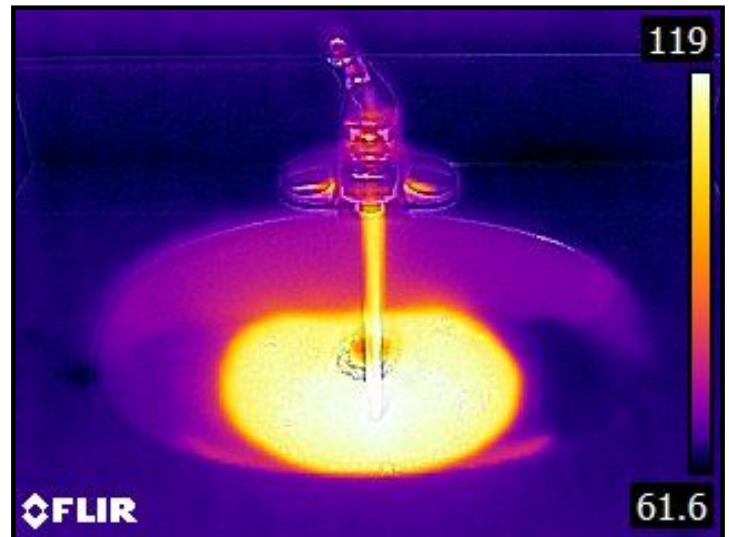
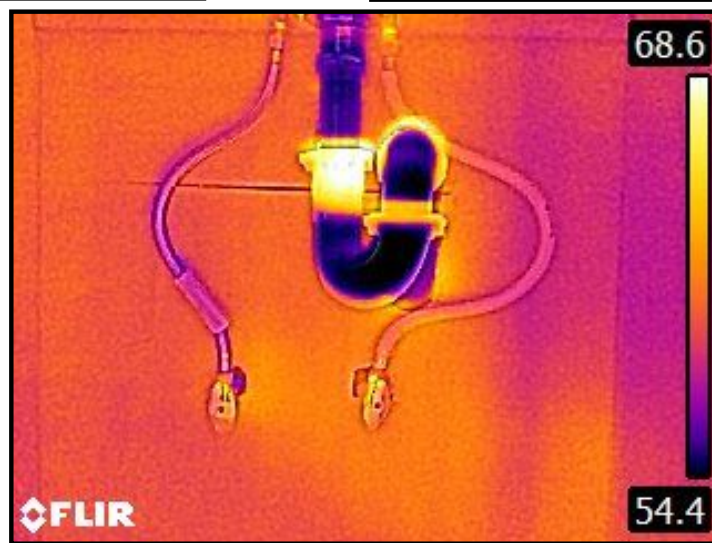
6. Sinks

- Operated normally, at time of inspection.
- **Faucet leaks at base. Recommend a plumber to repair or replace faucet.**

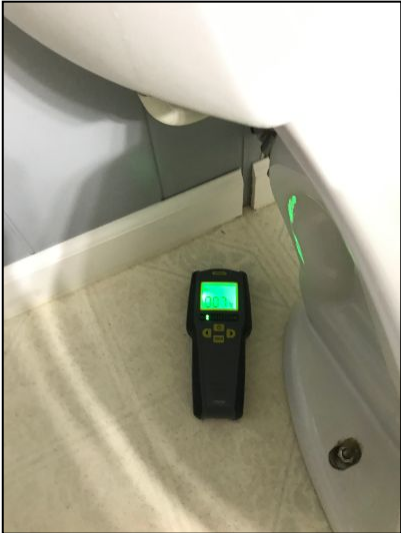
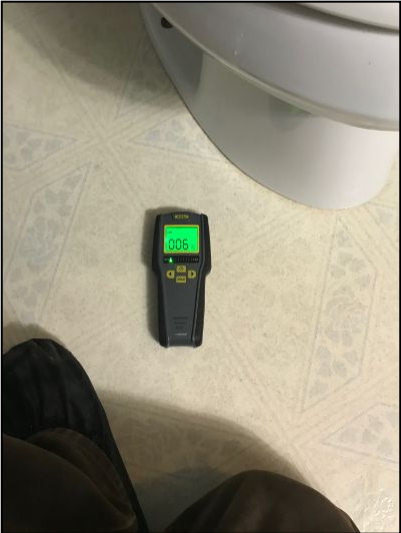
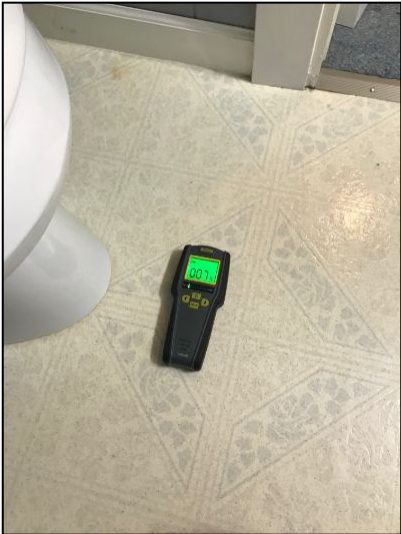
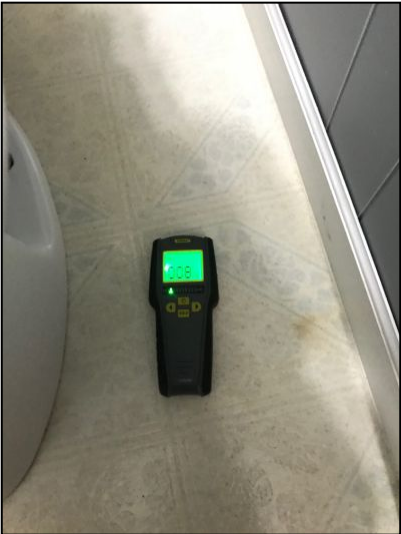
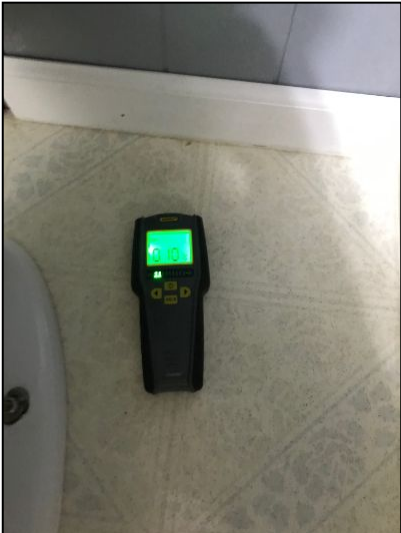
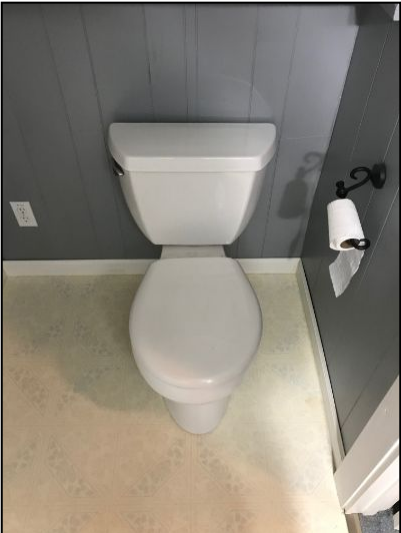
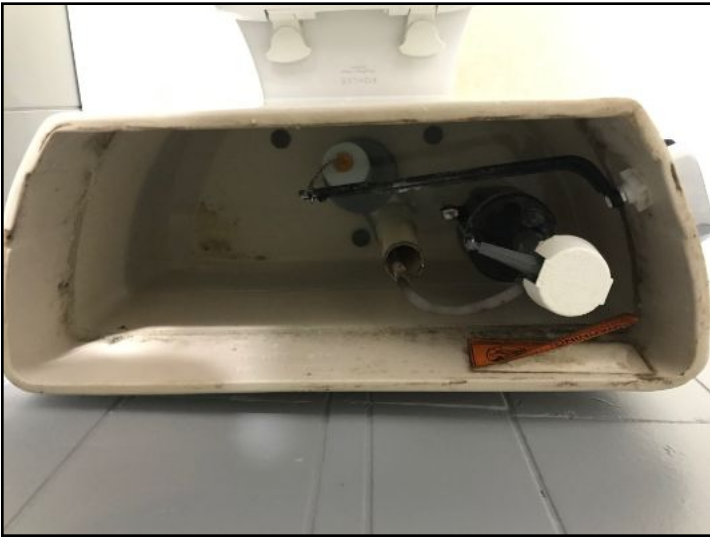
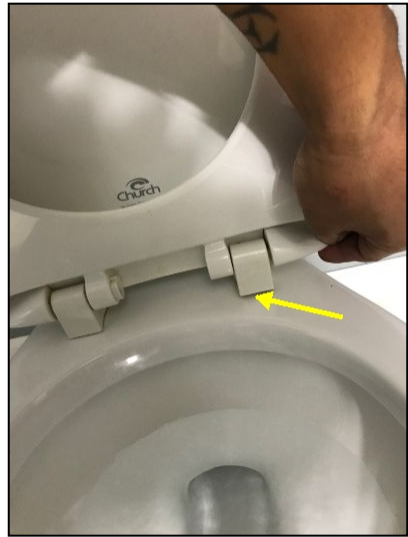
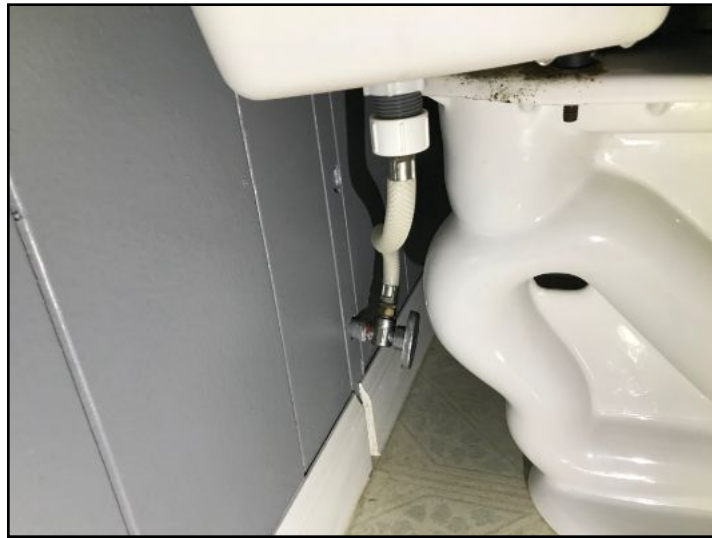
7. Toilets

- Observed as functional and in good visual condition.
- Operated when tested. No deficiencies noted.
- Operated when tested. Appeared functional, at time of inspection - except as noted.
- Toilet seat is a little loose.
